RE: Juniper Mountain Gravel, Permit No. M-2003-073, Unresolved Problem(s) Noted in a Past Inspection Report

MINERALS PROGRAM INSPECTION REPORT PHONE: (303) 866-3567

MINE NAME:	MINE/PROSPECTING ID#:	MINERAL:	COUNTY:
Juniper Mountain Gravel	M-2003-073	Gravel	Moffat
INSPECTION TYPE:	INSPECTOR(S):	INSP. DATE:	INSP. TIME:
Monitoring	Amy C. Yeldell	July 10, 2019	14:45
OPERATOR:	OPERATOR REPRESENTATIVE:	TYPE OF OPERATION:	
Moffat Limestone Company	Mike Anson	112c - Construction Regular Operation	
REASON FOR INSPECTION:	BOND CALCULATION TYPE:	BOND AMOUNT:	
Normal I&E Program	Complete Bond	\$28,135.00	
DATE OF COMPLAINT:	POST INSP. CONTACTS:	JOINT INSP. AGENCY:	
NA	None	None	
WEATHER:	INSPECTOR'S SIGNATURE:	SIGNATURE DAT	`E:
Clear	Amy Geldell	August 16, 2019

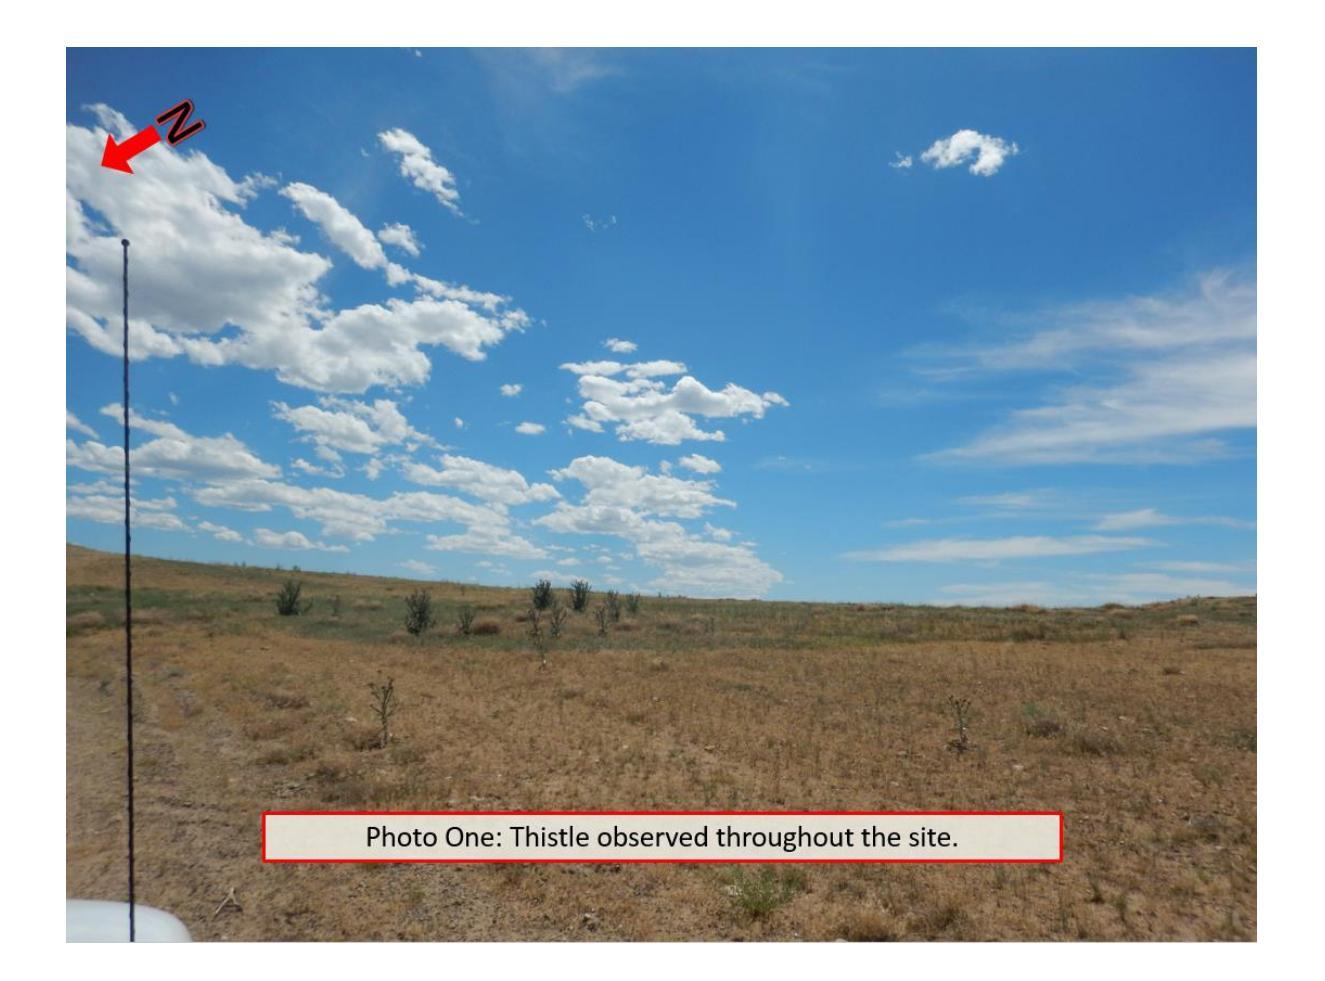
PHOTOGRAPHS

The active portion of the mine site still remains within the 5 acre footprint. The reclaimed portions associated with TR-3 and reducing the overall liability has had poor success. Only a small portion of the reclaimed areas has established vegetation. The majority of the reclaimed areas remains bare or has mostly undesirable vegetation growing. This site would likely benefit from a secondary seeding of areas with poor reclamation success thus far.

Large amounts of scotch thistle were observed throughout the site. This site has a Noxious Weed Management Plan (TR-1). Failure to control noxious weeds is cites as an inspection problem. Please submit photo documentation that noxious weeds have been treated by the corrective action date. If the current noxious weed management plan is inadequate the Operator may also revise their plan in the form of a technical revision by the corrective action date.

PROBLEM/POSSIBLE VIOLATION: Problem: There are state-listed noxious weeds present on site. This is a problem for failure to employ weed control methods for state listed noxious weed species within the permitted area, and to reduce the spread of weeds to nearby areas as required by Section 3.1.10 (6) of the rule. **CORRECTIVE ACTIONS:** Implement approved weed control plan and provide proof to the Division that this has been done. If a weed control plan is not already in place, the operator shall develop a weed control and management plan in accordance with Section 3.1.10 (6) of the Rule. This plan should be developed in consultation with the county extension agency, or weed control district office and should include specific control measures to be applied, a schedule for when control measures will be applied and a post-treatment monitoring plan. This weed control plan shall be submitted to the Division as a Technical Revision to the approved plan with the appropriate Technical Revision fee of \$216.00 by the corrective action date.
