Review Response Notification of Water Quality Analysis Parameter Exceedance February 27, Re: 2020, M-1980-244

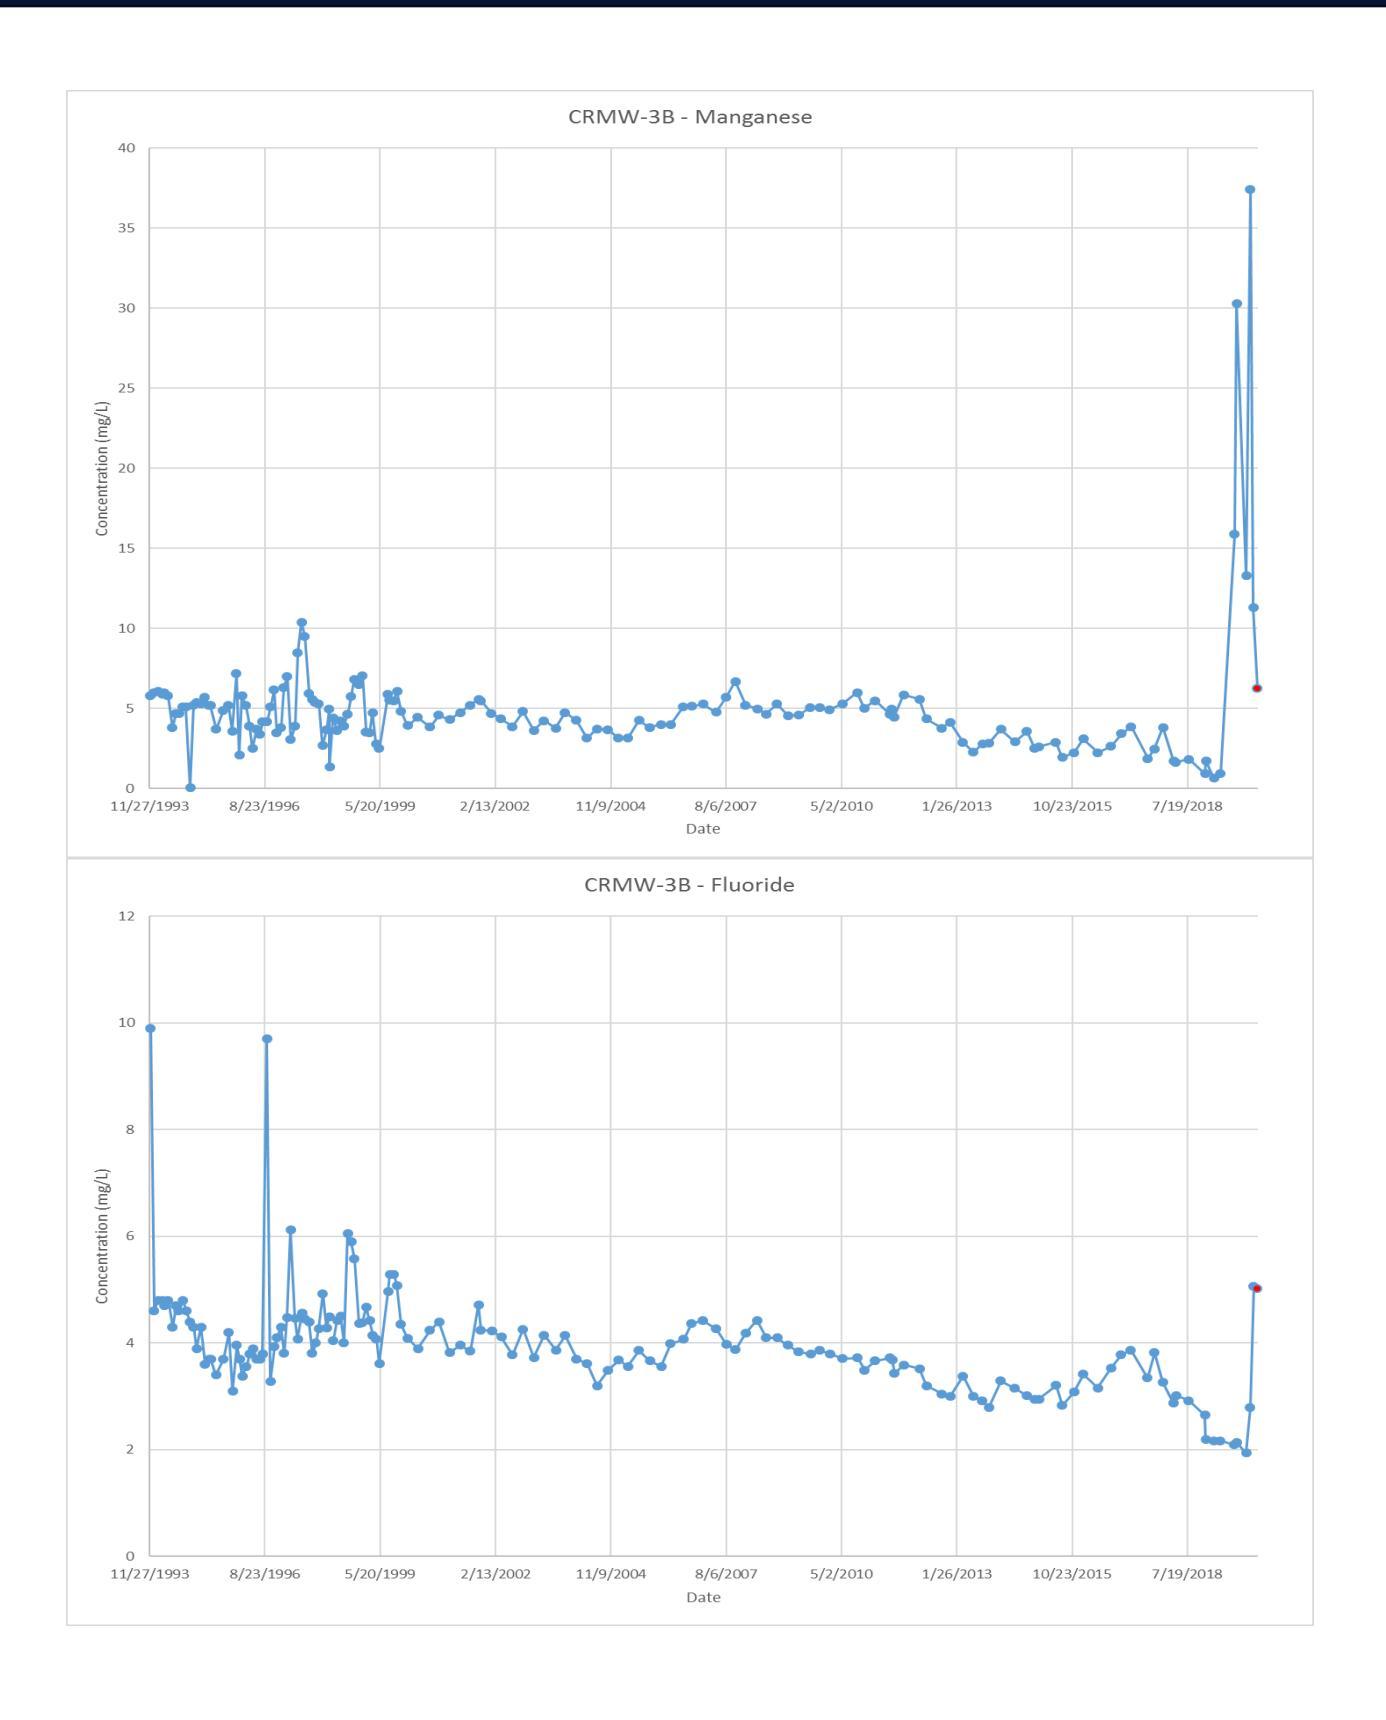
Observed fluoride concentrations at monitoring well CRMW-3B are hypothesized to be the result of groundwater elevation increase and stagnation within the CRMW-3B monitoring well and surrounding area. In 2019 CC&V experienced a failure of the pumping system installed within the monitoring well CRMW-3B, and are in the process of completing repairs. The reduction in pumping volume has increased the groundwater elevation at the location, and as a result, fluoride concentrations observed at the monitoring well are returning to concentrations recorded closer to the time of monitoring well construction. It is anticipated that fluoride concentrations will decline again as monitor well pumping continues. Please see the attached graph of CRMW-3B fluoride concentrations over time.

concentration of 6.26 mg/L. Please see the attached graph of CRMW-3B manganese concentrations over time.

With the completed repairs, CC&V will ensure that monitoring well CRMW-3B will be returned to its previous operation, whereby the well automatically pumps water to the vault at the base of VLF1. Samples will be collected and analyzed monthly for the second quarter of 2020. Data from this additional sampling will be used to determine if the concentrations of fluoride and manganese have returned to historical mean values.
