MINERALS PROGRAM INSPECTION REPORT PHONE: (303) 866-3567

MINE NAME:	MINE/PROSPECTING ID#:	MINERAL:	COUNTY:
Bronco Plains Wind Farm	M-2019-044	Gravel	Cheyenne
INSPECTION TYPE:	INSPECTOR(S):	INSP. DATE:	INSP. TIME:
Surety-Related Inspection	Timothy Cazier	June 11, 2020	14:25
OPERATOR:	OPERATOR REPRESENTATIVE:	TYPE OF OPERA	TION:
Blattner Energy, Inc.	Christopher Bledsoe	110c - Construction	Limited Impact
REASON FOR INSPECTION:	BOND CALCULATION TYPE:	BOND AMOUNT:	
Surety Related	Complete Bond	\$50,000.00	
DATE OF COMPLAINT:	POST INSP. CONTACTS:	JOINT INSP. AGE	ENCY:
NA	None	None	
WEATHER:	INSPECTOR'S SIGNATURE:	SIGNATURE DAT	ſ E :
Clear	him US-	July 2, 2020

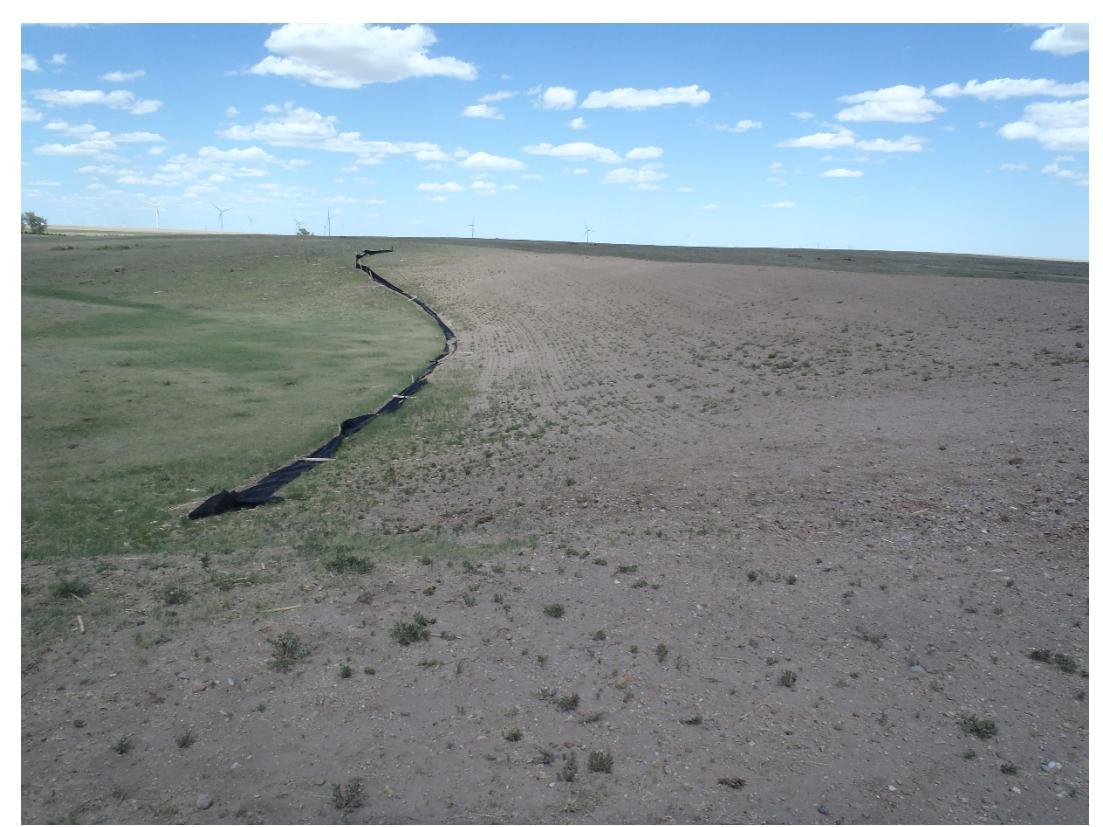
Photo 1. North reclaimed and drill seeded area (looking east from NW corner).

<u>Gen. Compliance with Mine Plan:</u> The operation appeared to be in compliance with the approved mine plan. The maximum allowed disturbed area is 9.28 acres. The extent of the area (5.3 acres, see attached **Post-Inspection Map**) where seed was applied (see **Photos 1**, **2** and **3**) using a drill seeder was measured using a Trimble Juno 3B handheld GPS unit during the inspection. No highwalls were observed.

<u>Reclamation Success</u>: Grading appeared complete as no slopes exceeded 3H:1V, topsoil appeared to have been replaced as no topsoil stockpiles were observed and the site had been drill seeded.

<u>Revegetation</u>: As previously discussed, the site had been seeded. The DRMS prefers to see at least two growing seasons for revegetation prior to considering final release. In this case, not before the fall of 2021.

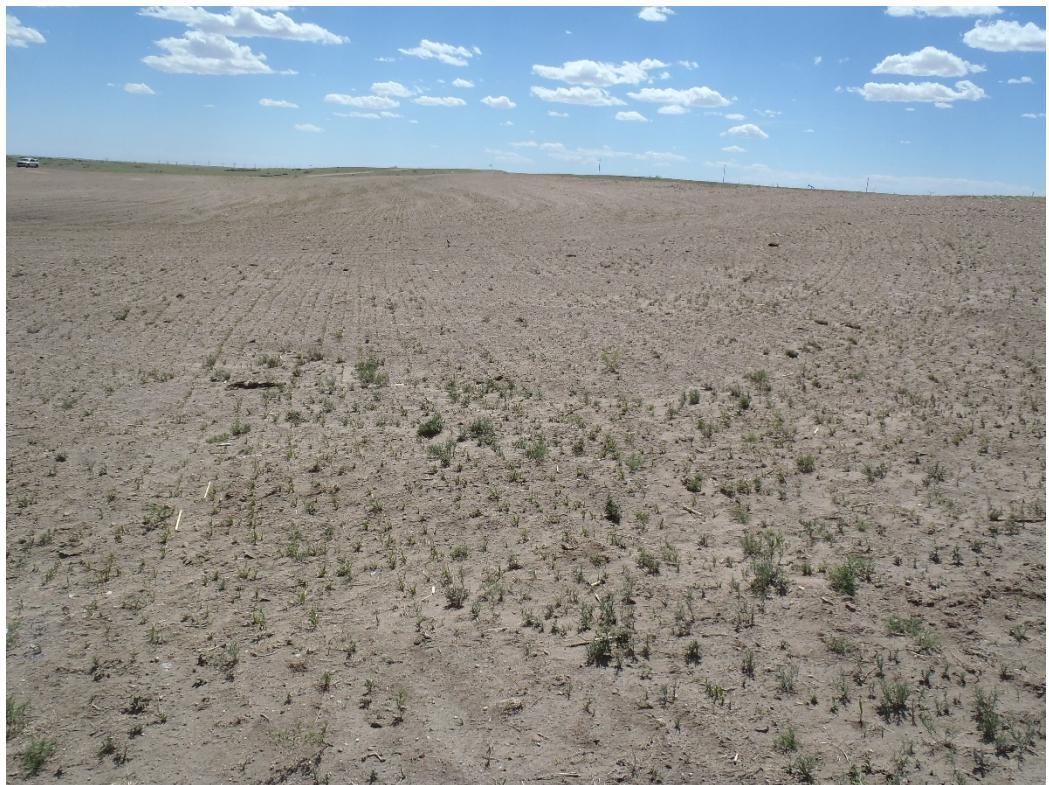
Photo 2. Central reclaimed and drill seeded area (looking west from east side).

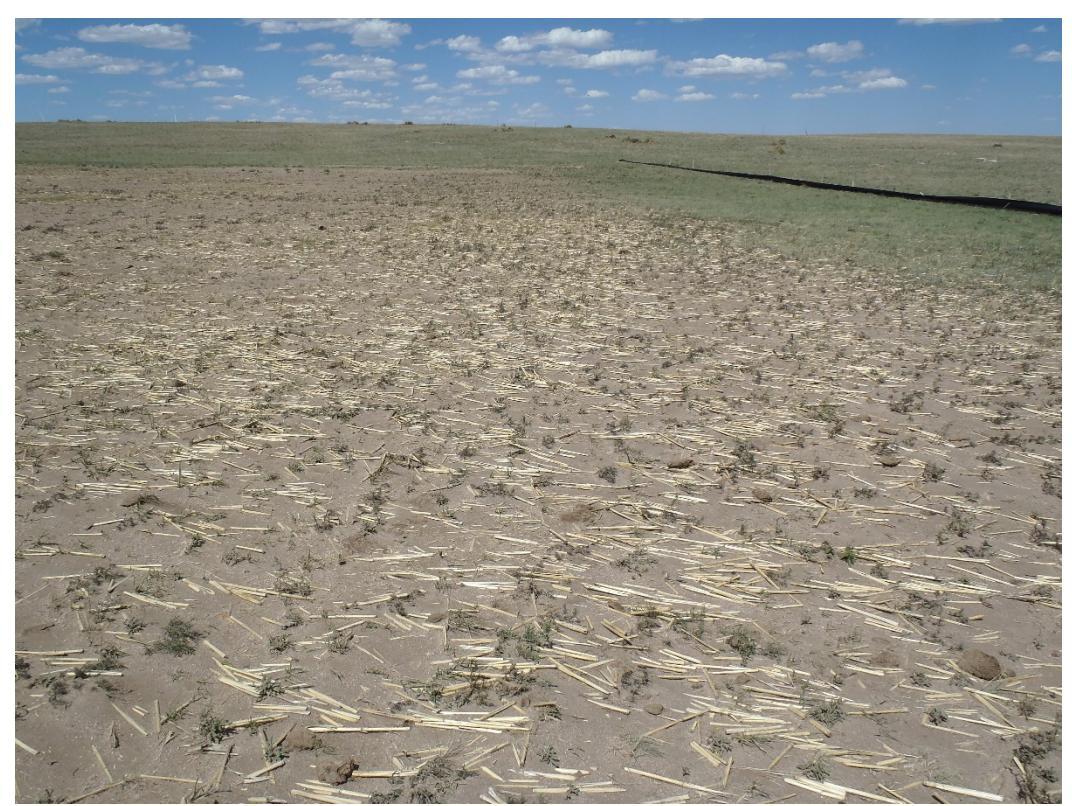
Photo 3. Southeast reclaimed and drill seeded area (looking east from the center on the south side, note mulch on ground).

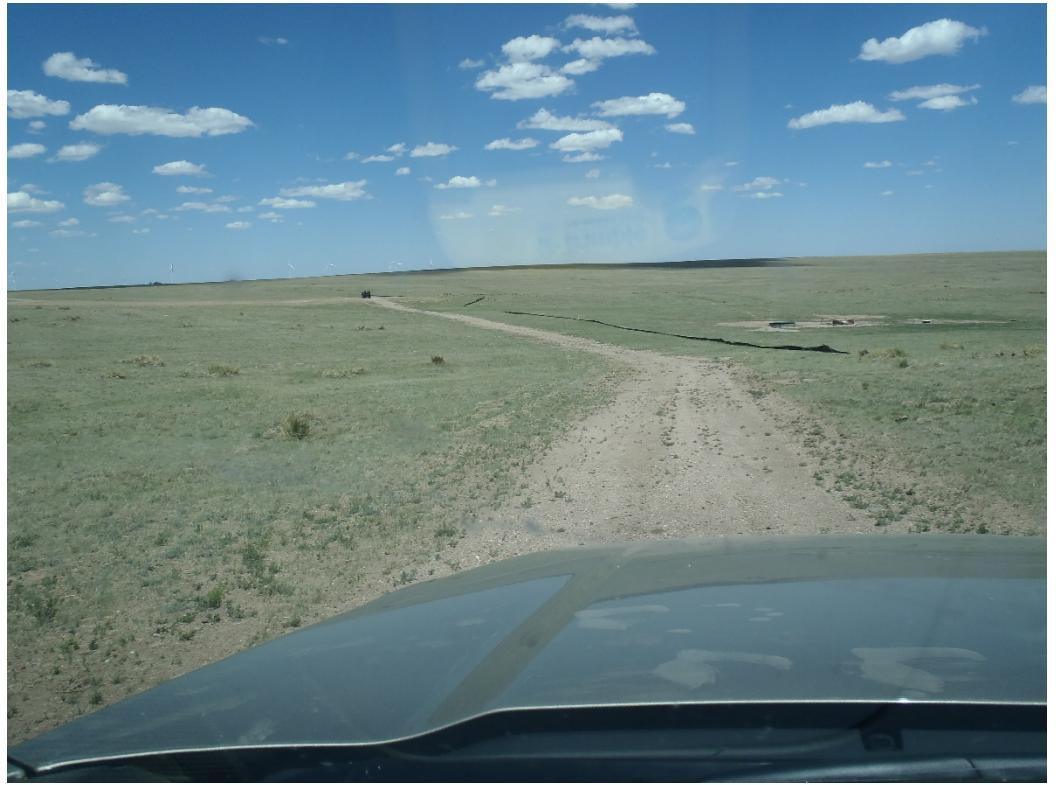
Photo 4. Access road (looking east from entrance).

<u>Roads</u>: The access road (see **Photos 4** and **5**) did not appear to be significantly improved and Mr. Bledsoe stated he told Blattner Energy he did not want it reclaimed.

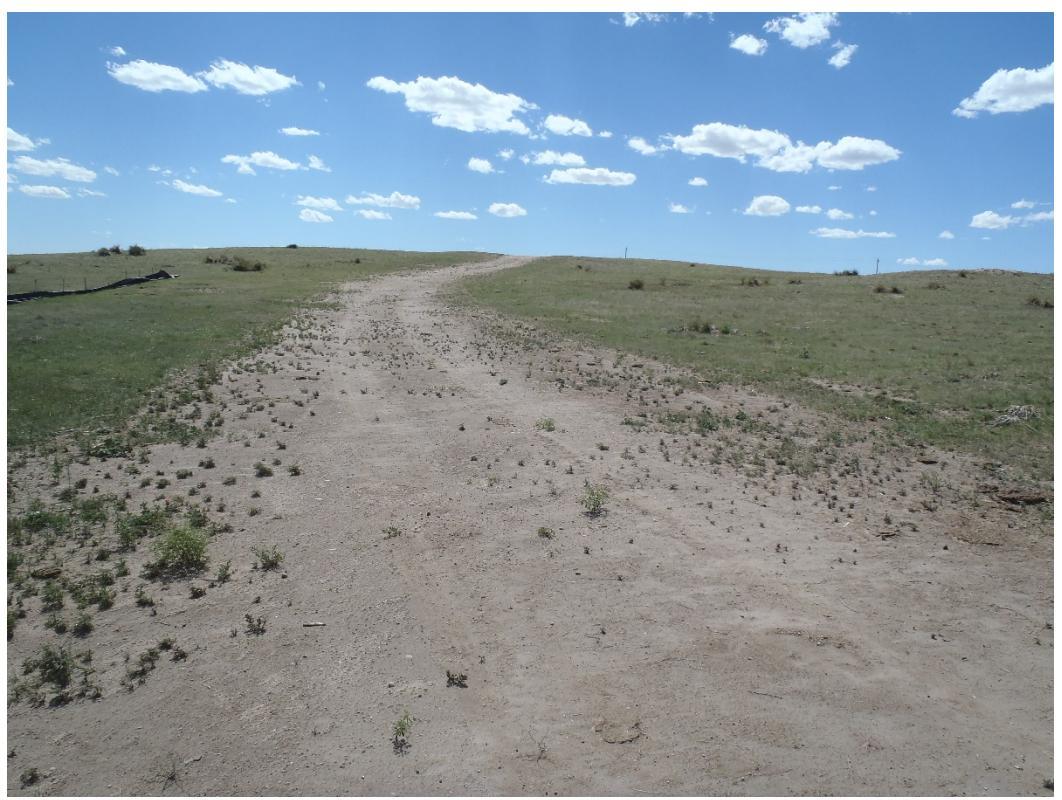
Photo 5. Access road (looking west).

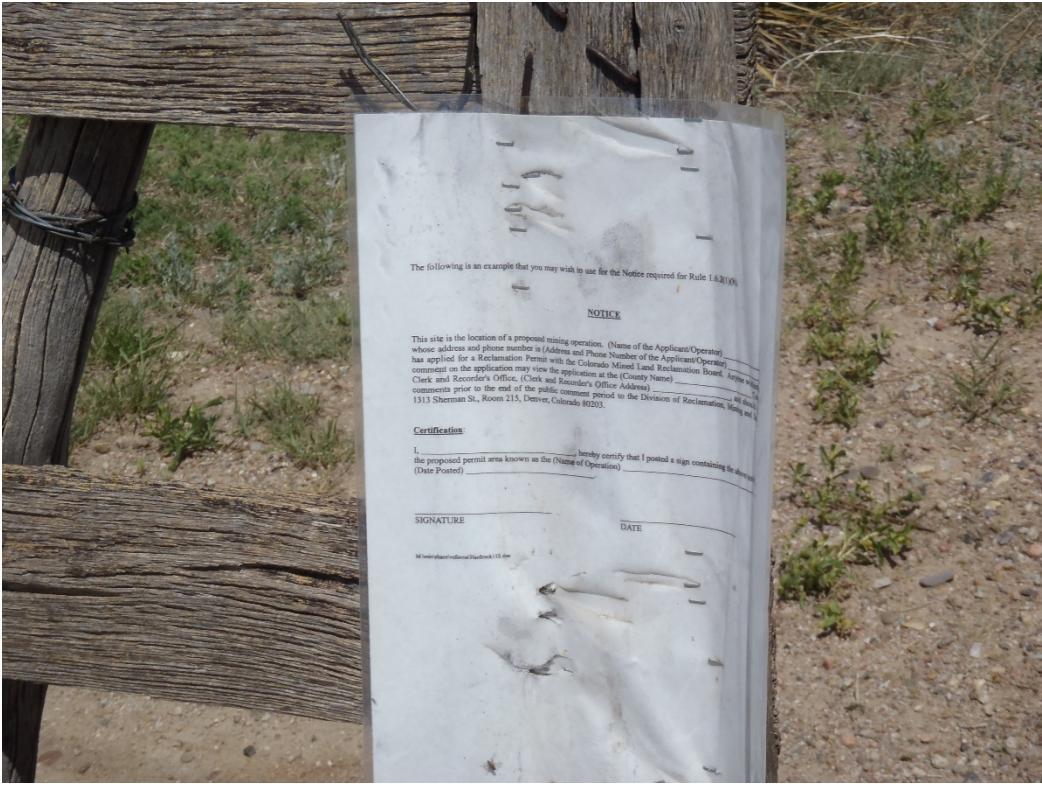
Photo 6. Permit notice sign at entrance.

<u>Signs and Markers</u>: The permit notice sign was properly posted (see **Photo 6**) and boundary markers were observed to delineate the permit boundary (see **Photo 7**).

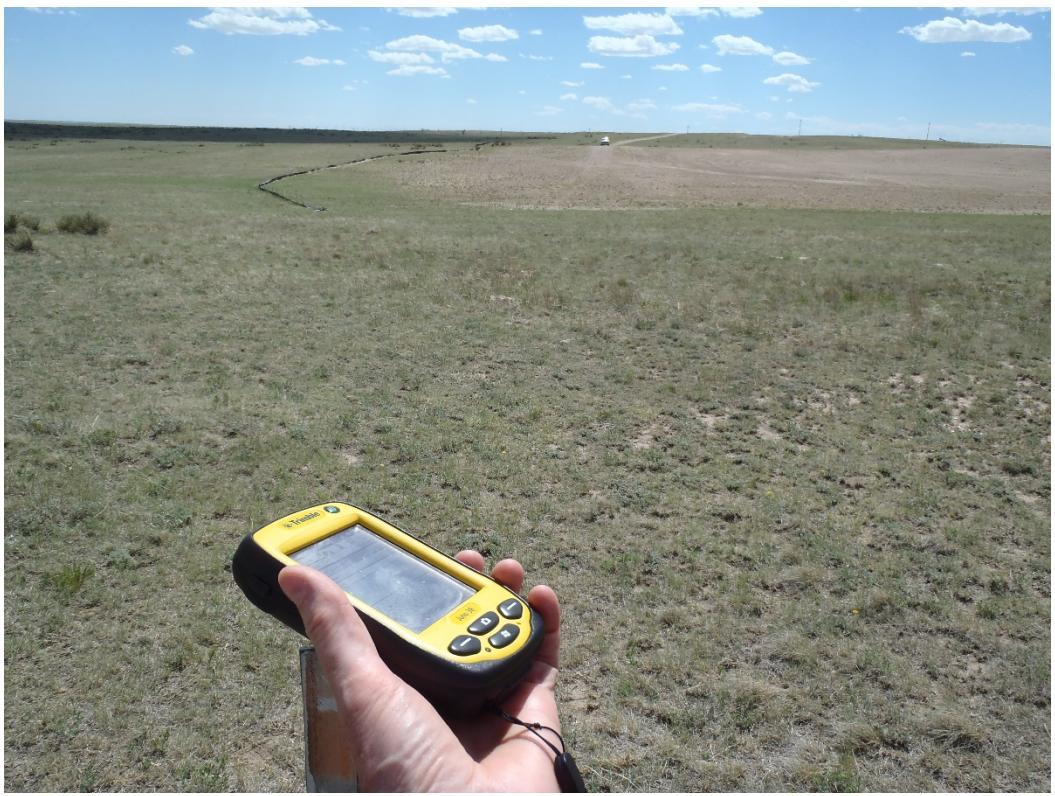
Photo 7. GPS unit on top of SE corner T-post - typical (looking west).
