PERMIT INFORMATION

Permit Number: C-1981-012 Mine Name: New Elk Mine Operator: New Elk Coal Company, LLC Operator Address: Mr. Mark Gray 12250 Highway 12 Weston, CO 81091 County: Las Animas Operation Type: Underground Permit Status: Active Ownership: Private

INSPECTION INFORMATION

This was a partial inspection of the New Elk Mine, Colorado Division of Reclamation, Mining and Safety (DRMS or Division) permit number C-1981-012, operated by New Elk Coal Company, LLC (NECC). I, Connor Drinkard and Jared Ebert with DRMS conducted the inspection. Mr. Nick Mason with NECC accompanied us during the inspection. Mr. Vince Massarotti with NECC was aware of the inspection. Maintenance items are in orange text.

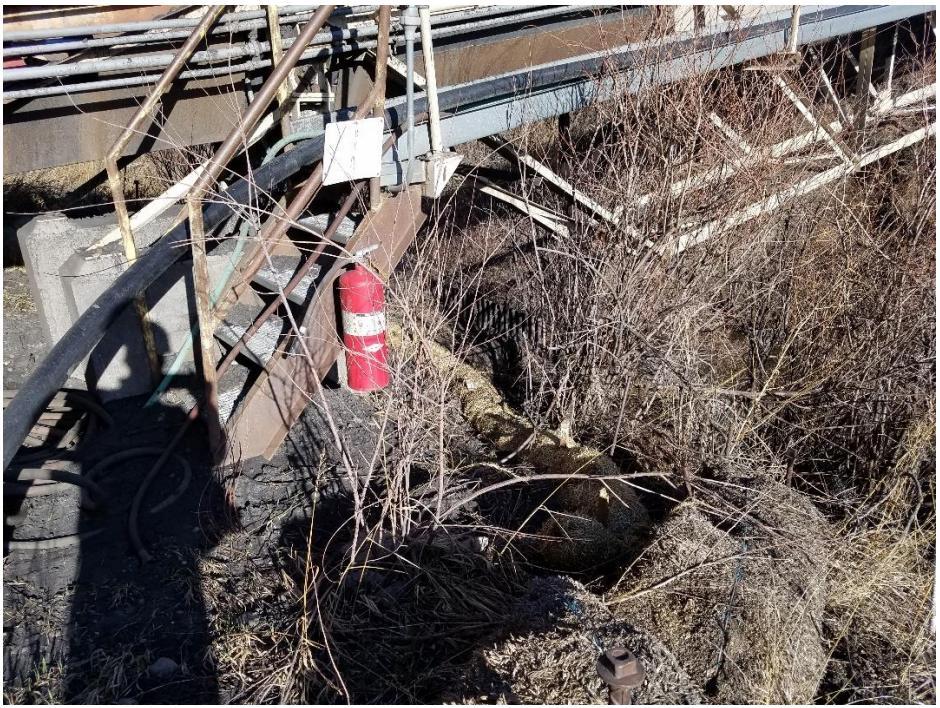
The maintenance item from the March 15, 2022 previous inspection regarding improper drainage in the small area north of the wash plant just under and adjacent to where the conveyor exits the plant has been addressed. Straw waddles for sediment control have been installed.

Figure 1. Area under and adjacent to where the conveyor exists the plant. Straw waddles for sediment control were observed.

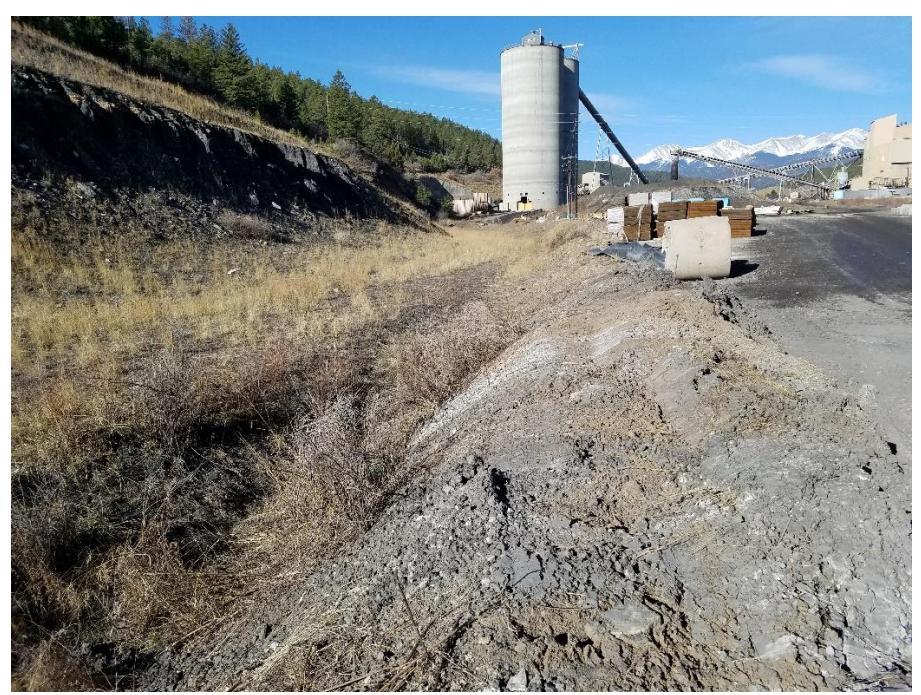
The Small Area Exemption (SAE) south of Pond 007A has maintained a stable berm to direct water towards Pond 007A.

Figure 2. SAE south of Pond 007A looking west.

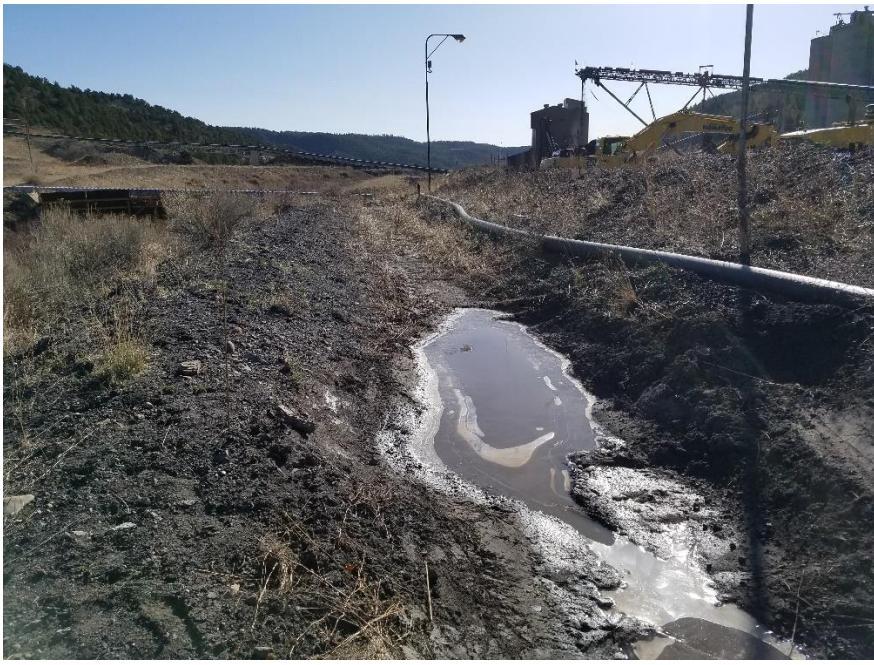
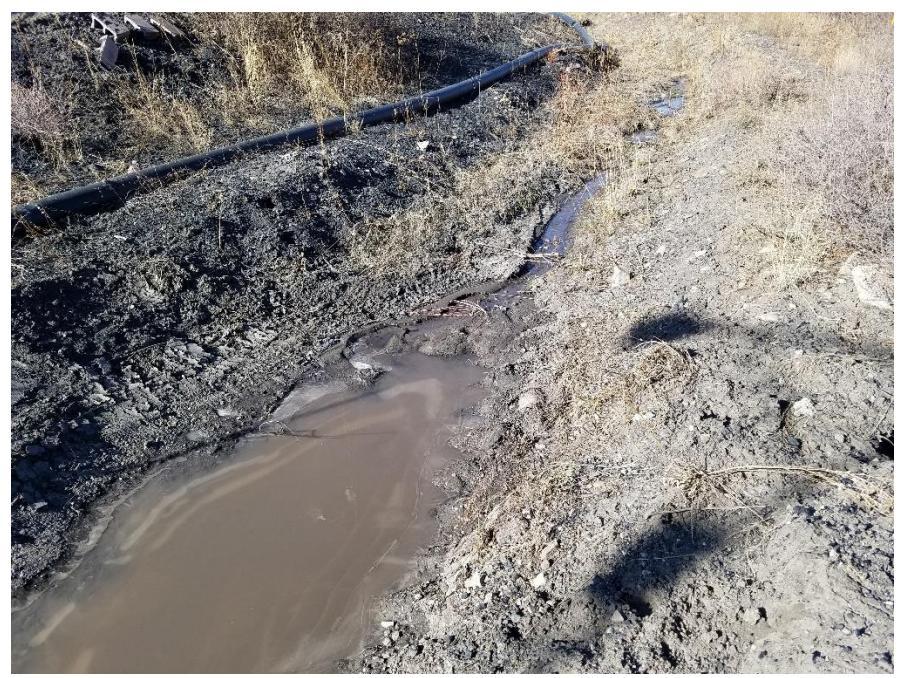
The maintenance item from the March 15, 2022 previous inspection regarding ditch D15 just west of culvert C13 where sediment build up and some of the embankment of the ditch appears to be slightly eroding on the north side remains to be addressed. Mr. Massarotti indicated it will be addressed before the next inspection. NECC should repair this area to ensure mine water does not over-top the ditch and discharge into the river without treatment.

Figure 3. Ditch D15 west of culvert C13 looking east.

Figure 4. Ditch D15 west of culvert C13 looking west.

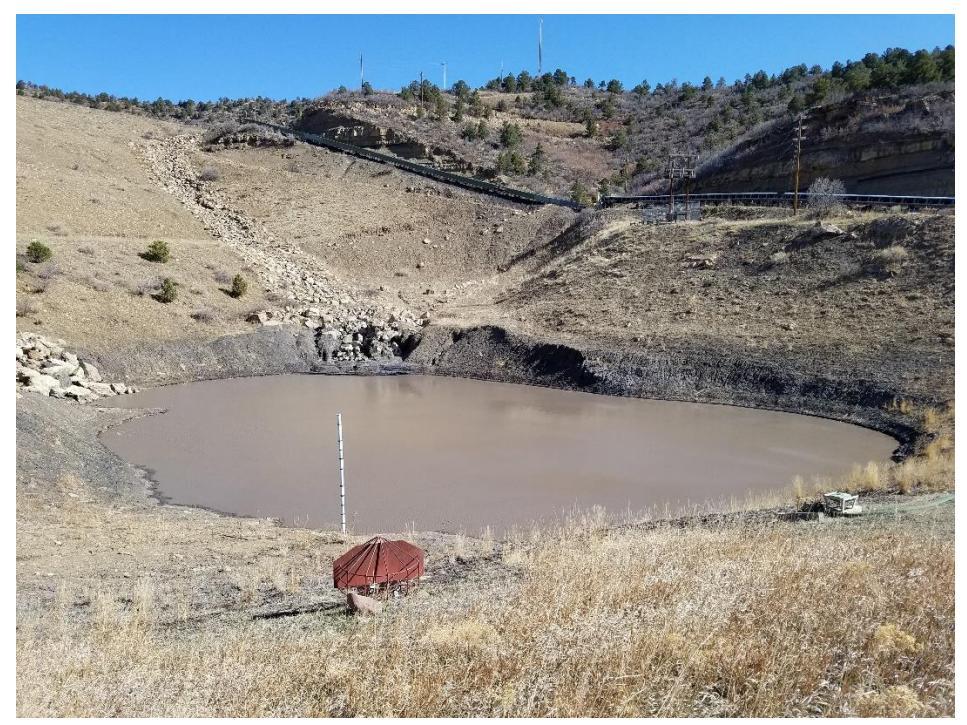
Ponds 004A, 006A, 007A, and 008 were observed stable and not discharging. Primary and emergency spillways appeared clear and functional.

Figure 5. Pond 08.

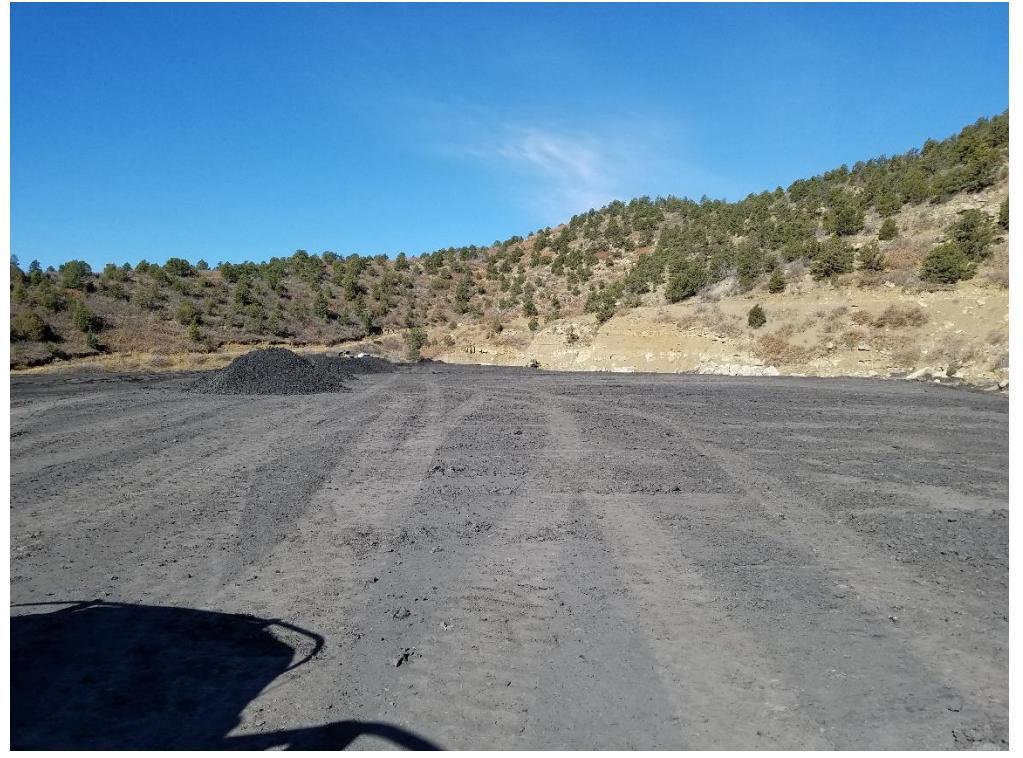
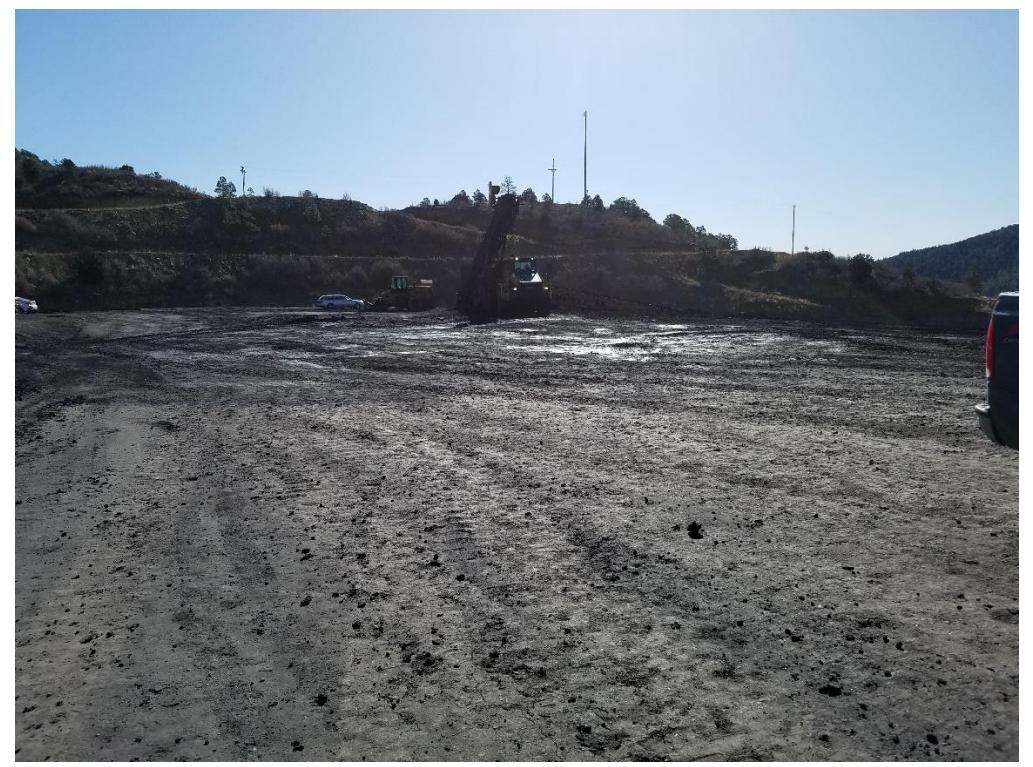
The Refuse Disposal Area (RDA) was observed with no issues noted. Waste was actively being placed on the pile with a truck and dozer crew. A compactor was present onsite but was not active at the time of the inspection.

Figure 6. RDA looking west.

Figure 7. RDA looking east.

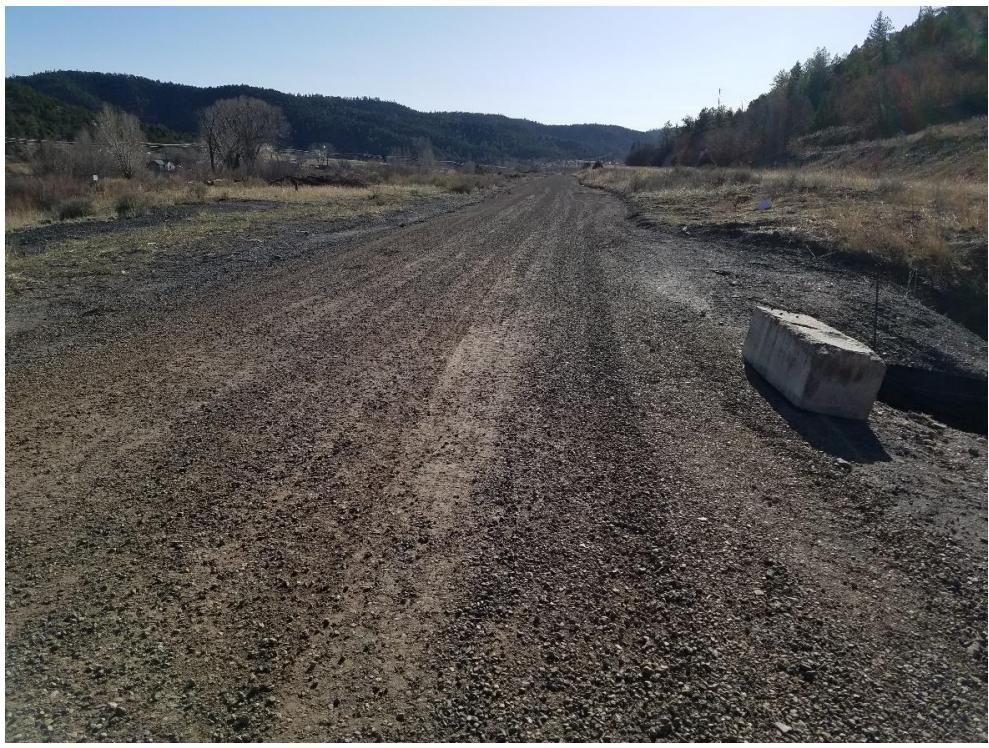
The road that runs east from New Elk Mine along the southern side of the Middle Fork of the Purgatoire River was observed and appears to remain not in use to comply until TR76 is approved.

Figure 8. TR76 road.

TR76 has been submitted, deemed incomplete, and DRMS has received a response to the incompleteness determination from NECC that is under review.
