COLORADO OPERATIONS Henderson Mill 19302 County Road 3 Parshall, CO 80468

Re: Memo Summarizing Dust Control Activities at the Henderson Mill Tailings Storage Facility in May 2022

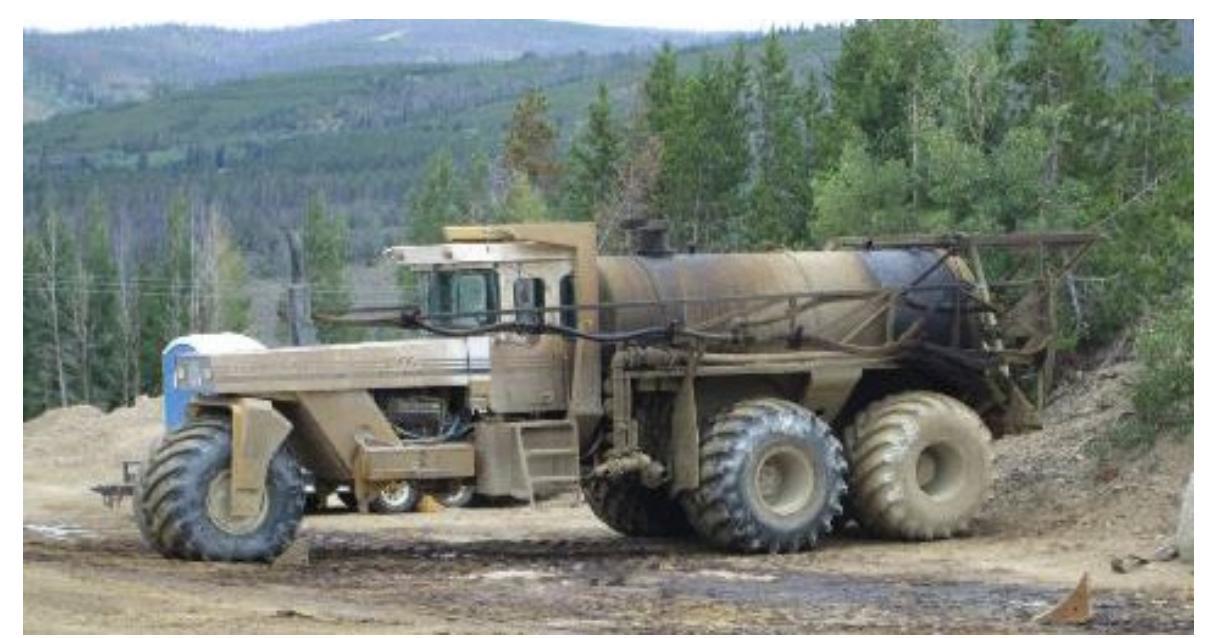
Figure 1. Typical Coherex spray truck. Henderson owns and operates 4 spray vehicles.

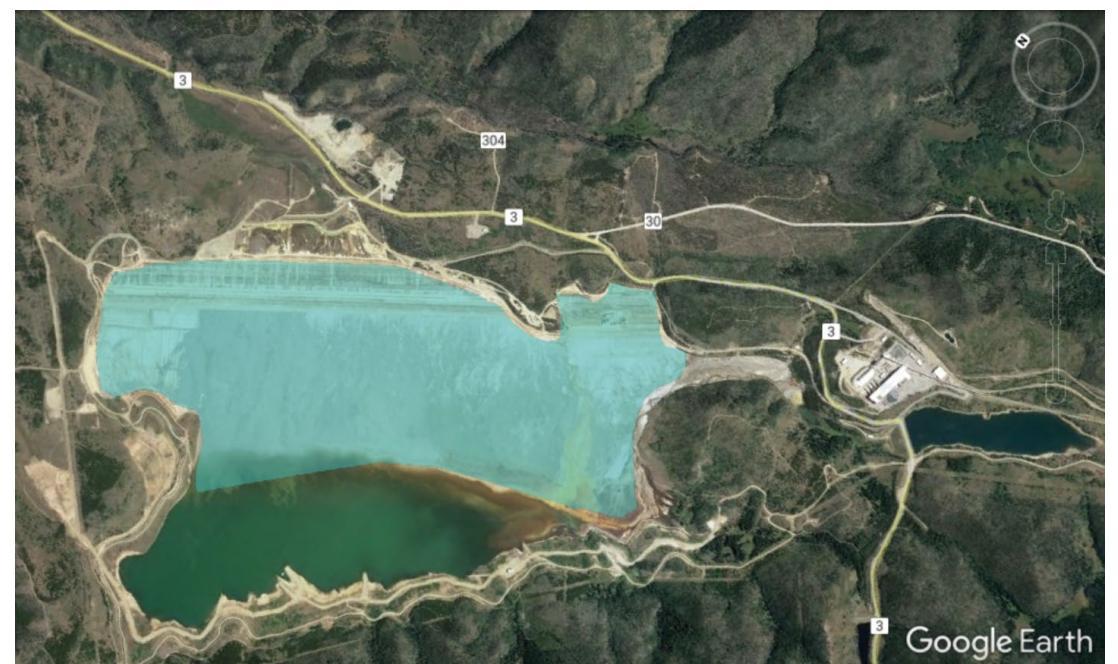
Figure 2. The Henderson Tailings Storage Facility consists of dry tailings impoundment (shaded light green) and reclaim pond (dark green). The dry beach and embankment are treated with Coherex to suppress dust mobilization.

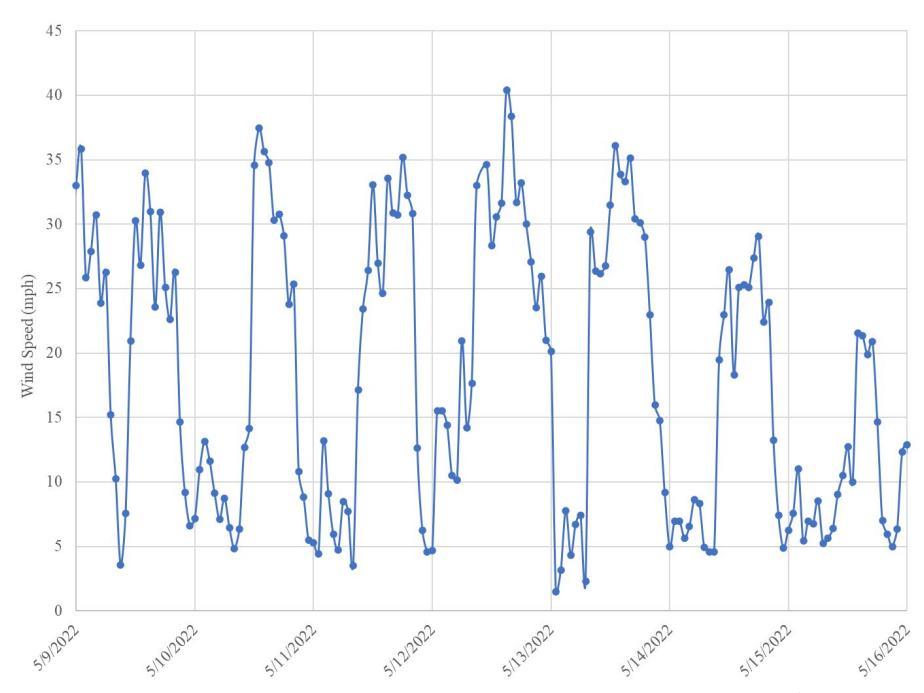
Figure 3. Maximum measured wind speeds at the Henderson Mill for the week of May 9th.

The spring of 2022 presented particularly difficult conditions for applying Coherex. Even though the spray trucks are specially designed with low ground pressure, the tailings beach saturation levels from the snow melt need to dissipate in order to ensure the trucks do not sink in the tailings. Snowpack peak is typically in mid-April and usually thaws over a period of 4-6 weeks. With snowpack at Henderson being below average this year, Henderson anticipated to start the Coherex campaign in mid-May. However, large storm events on May 3rd and 4th increased saturation levels within the tailings. The operations crew started to develop the needed access ramps and paths on the beach on May 6th. Unfortunately, the equipment persistently sank into the tailings on the 6th. The decision was made to wait until the 9th to start spraying Coherex. On the week of the 9th, it was determined that the beach was ready for truck traffic. The operations crew started spraying on the 11th. However, this week also correlated with very high winds throughout the State of Colorado, including in Grand County. The Henderson weather station measured wind speeds in excess of 40 mph during the week (Figure 3). The Henderson anemometer only collects data every 10 minutes, therefore, wind gusts in excess of those shown are likely. Due to the high winds, full crew spray operations were further delayed until May 16th.

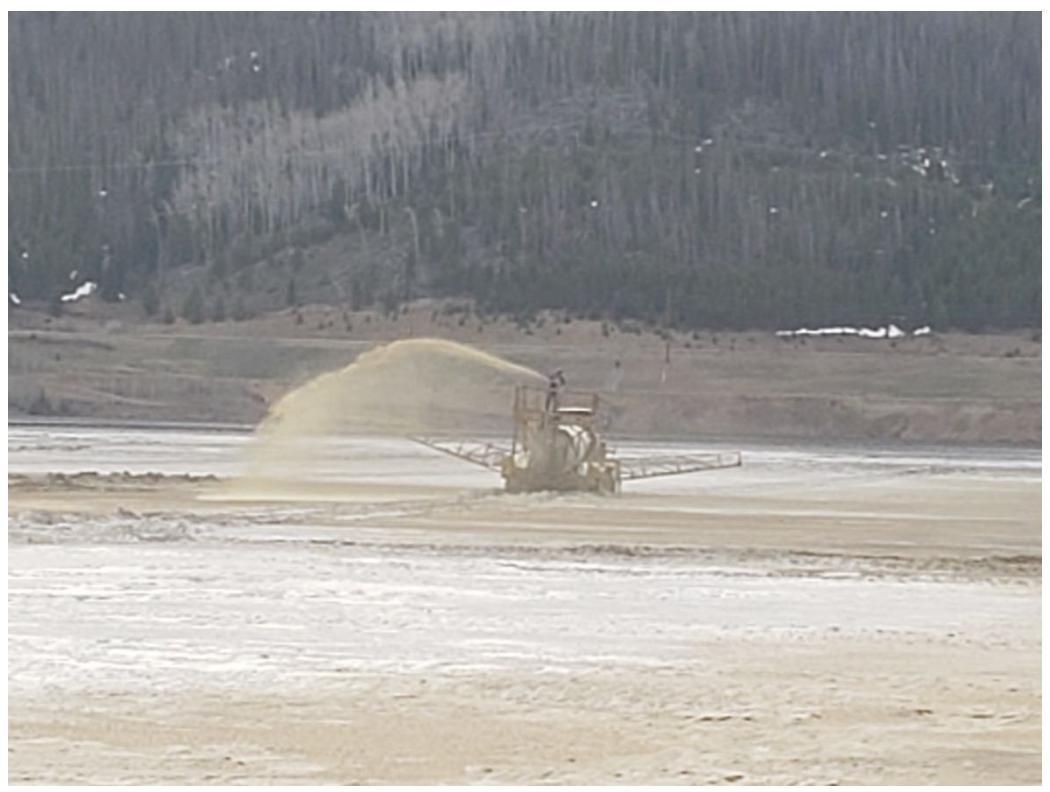
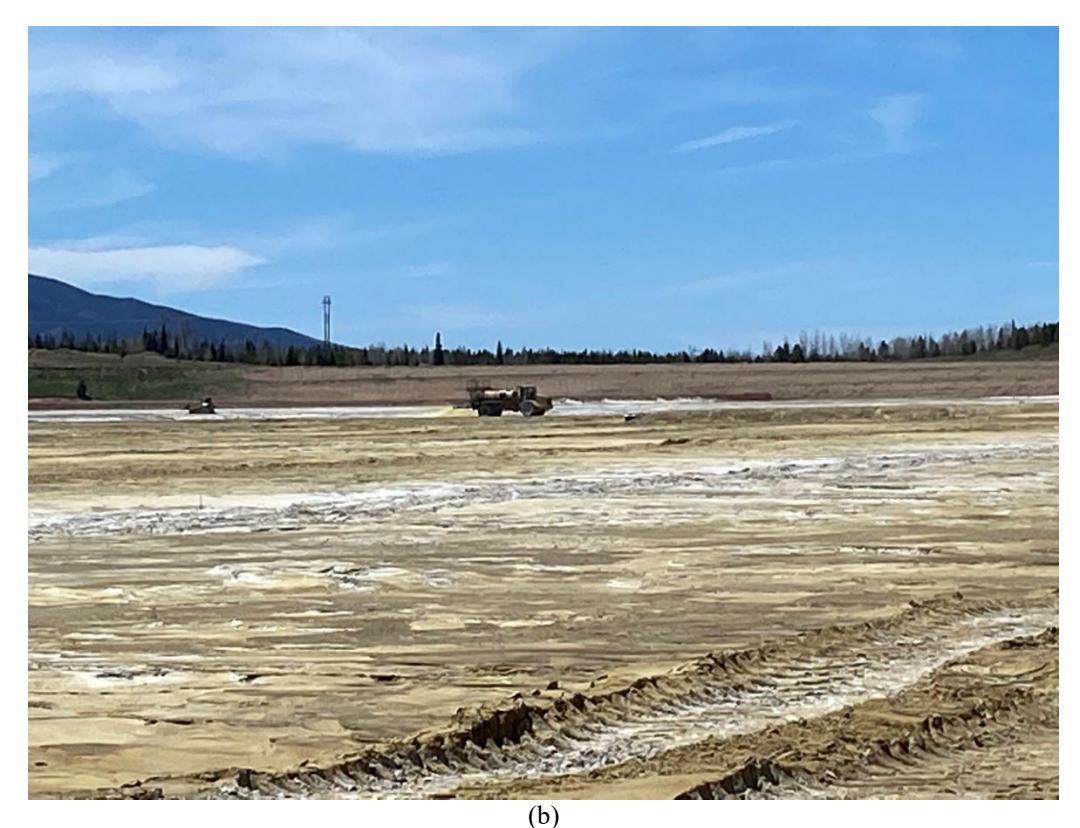
Figure 4. Coherex spray truck on the tailings beach applying Coherex on May 16th (a) and 27th (b).

The crew of operators and mechanics work 10 hour shifts, 5 days a week throughout the summer season to maintain all aspects of the Tailings Storage Facility with dust suppression being a primary focus throughout the season. As of May 27^{th} , the crew had applied just under 150,000 gallons of Coherex with ~65% of the facility covered (Figure 4). In a typical year, the application process takes close to 3 weeks, and utilizes ~250,000 gallons of Coherex.
