MINERALS PROGRAM INSPECTION REPORT PHONE: (303) 866-3567

MINE NAME:		MINE/PROSPECTING ID#:	MINERAL:	COUNTY:
Arnusch Gravel Pit 3		M-1981-287	Sand and gravel	Weld
INSPECTION TYPE:		WEATHER: Clear	INSP. DATE:	INSP. TIME:
Preoperation Inspection			May 24, 2023	09:45
OPERATOR:		OPERATOR REPRESENTATIVE:	TYPE OF OPERATION:	
Nikolaus Arnusch		Kurt Arnusch	110c - Construction Limited Impact	
REASON FOR INSPECTION:		BOND CALCULATION TYPE:	BOND AMOUNT:	
Normal I&E Program			\$5,000.00	
DATE OF COMPLAINT:		POST INSP. CONTACTS:	JOINT INSP. AGENCY:	
NA		None	None	
INSPECTOR(S):	INSPECTOR'S SIGNATURE:		SIGNATURE DATE:	
Eric Scott			May 30, 2023	
Michael Cunningham	En	e Aut

Arnusch #3 M1981-287

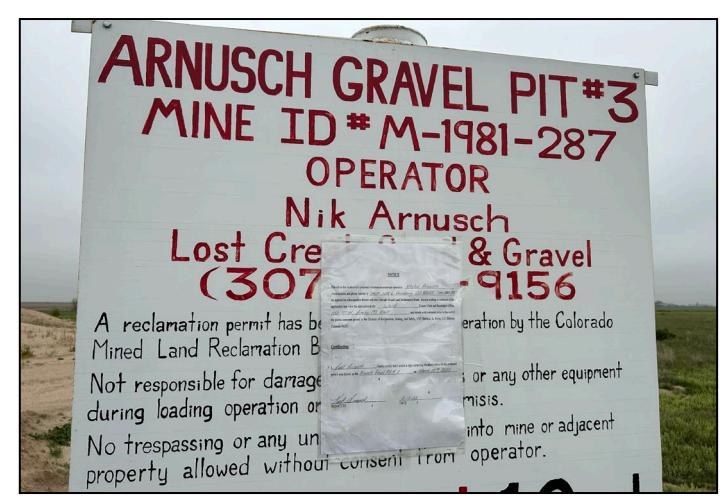
DRMS representatives Eric Scott and Michael Cunningham met the operator representative Kurt Arnusch (son of permittee) at the site at approximately 0945 and toured the proposed permit area. DRMS noted that the notice of permit conversion applied for was present on the site identification sign as required (photo 1).

Photo 1 – Site Identification sign with required notice of CN1 applied for.

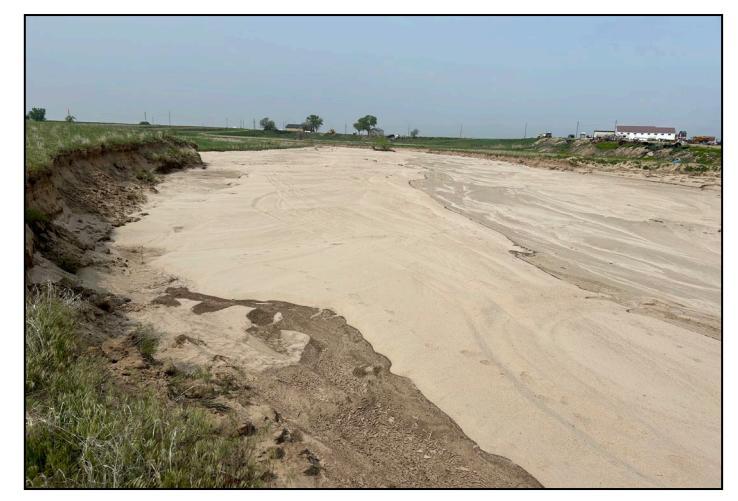
Photo 2 – Bank erosion on east side of West Sand Creek due to flooding earlier in the month.

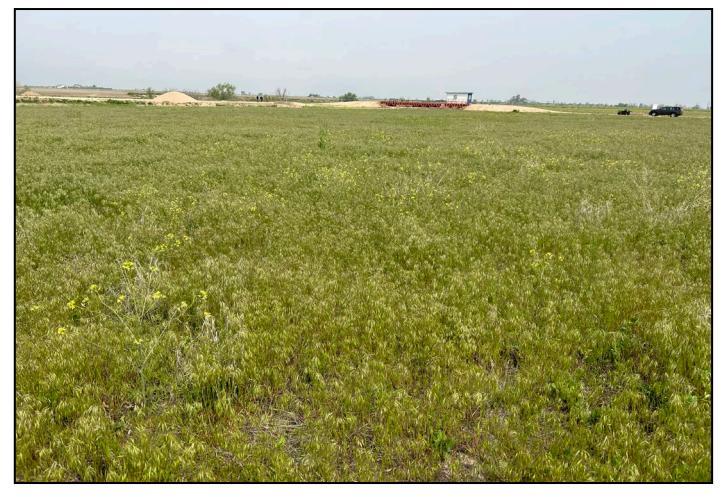
The proposed permit area, along with the included and adjacent features, appear to be accurately shown on the materials provided with the application. Representative photos of the existing conditions have been included in this report. It was noted that the existing vegetation in significant areas of the proposed permit area was primarily cheat-grass and other weedy species (photo 3). Weed control efforts will need to be maintained at the site to achieve a successful reclamation.

Photo 3 – Much of existing vegetation within proposed permit area is cheat-grass and weedy species. Aggressive weed control will be required for reclamation.
