COLORADO DIVISION OF RECLAMATION, MINING AND SAFETY

REQUEST FOR TECHNICAL REVISION (TR) COVER SHEET			
File No.: M- 1979-097	Site Name: East Rigde	n Pit	
County_Larimer	TR#	(DRMS Use only)	
Permittee: City of Fort Col			
Operator (If Other than Permittee):_			
Permittee Representative: Matt F	'arker		
Please provide a brief description of	the proposed revision:

East Rigden Pit Mining Permit #M1979-097 Technical Revision #_____ June 27, 2023

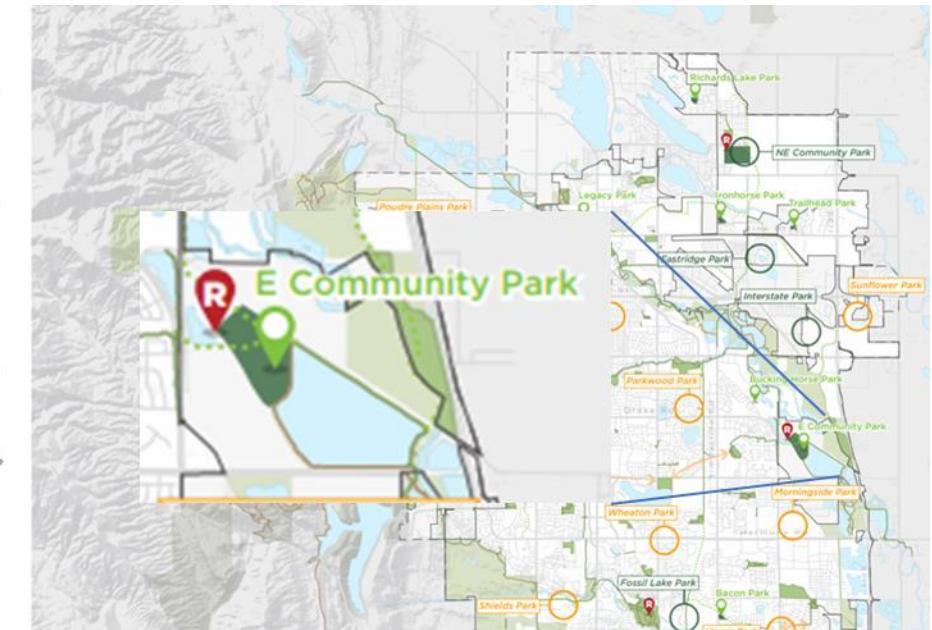
City of Fort Collins Parks and Recreation Master Plan, 2021 (page 166) showing location of future East Community Park on land within the East Rigden Pit #M1979-79.

This Technical Revision seeks to remove any requirement for trees and shrubs to be planted within the permit area, in favor of two management conditions. First, 58 acres of the permit area, owned by the City is slated to become a community park, replete with a variety of native and locally adapted shade trees. Secondly, the Reservoir Parcel is currently managed as a municipal open space property with site goals focused on creating and maintaining high-quality, native habitat at all vegetation structural levels including native grasses, forbs, shrubs, and trees. Rabbitbrush has established extensively throughout the permit area (photo B is an example), and pockets of cottonwoods and peach-leaf willow (photos C and D) have established as well. In both cases, management of the City-owned mining permit area will continue to improve habitat over time with a focus on promoting the natural establishment of tree and shrub species within self-selected habitat niches.

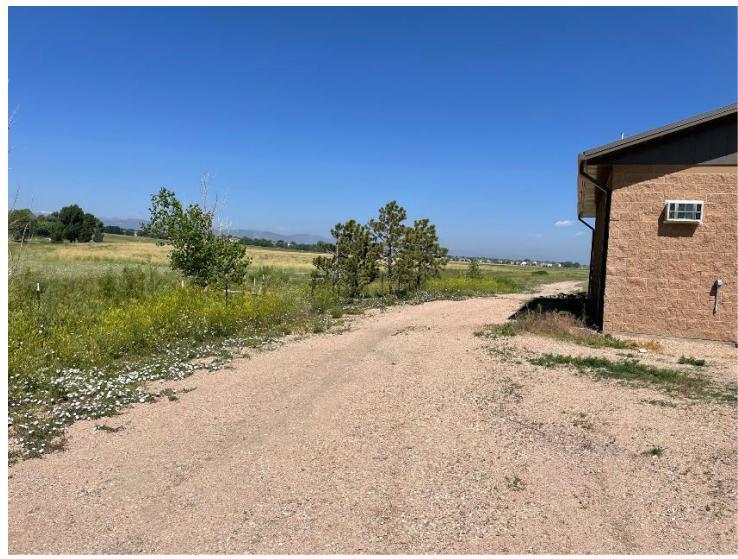
Photo A taken (June 27, 2023) looking NW from the pumphouse area showing Ponderosa pines and a cottonwood, planted and staked.

The above statement does not provide any location information or quantities specific to the species anticipated for planting. While there are currently ponderosa pines and Colorado pinyons planted near the pumphouse structure (see photo A below), a reasonable interpretation of the above statement would indicate a more substantial planting.

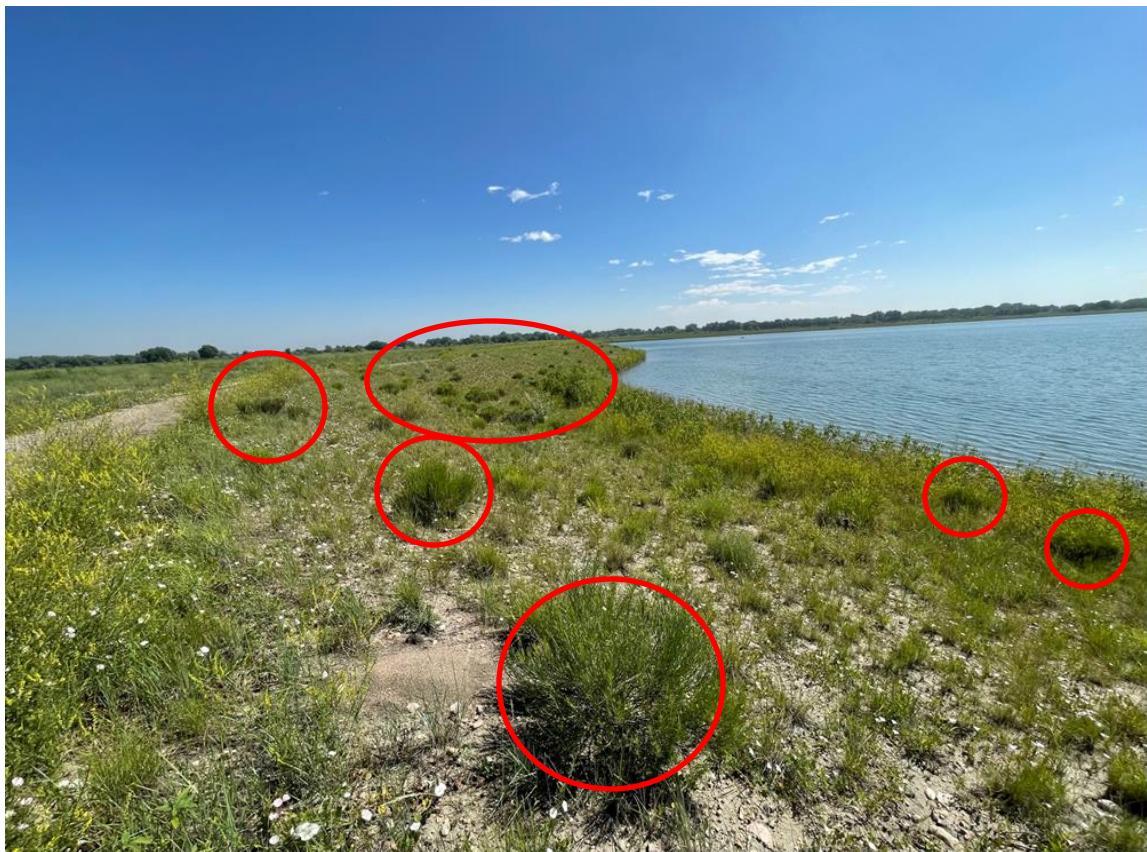
Photo B (taken June 27, 2023) showing an example area of naturally established Rabbitbrush plants along the Rigden Reservoir shoreline.

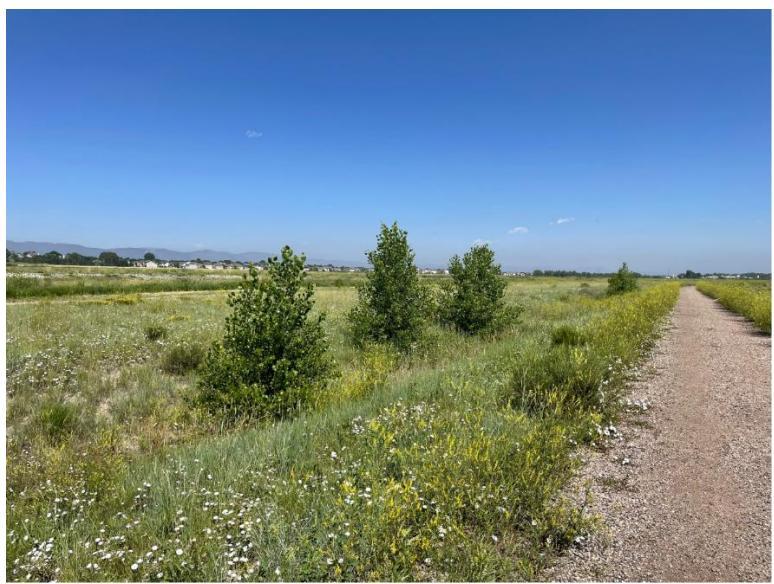
Photo C (taken June 27, 2023) showing Cottonwood trees naturally recruited and growing within a small swale providing natural irrigation.

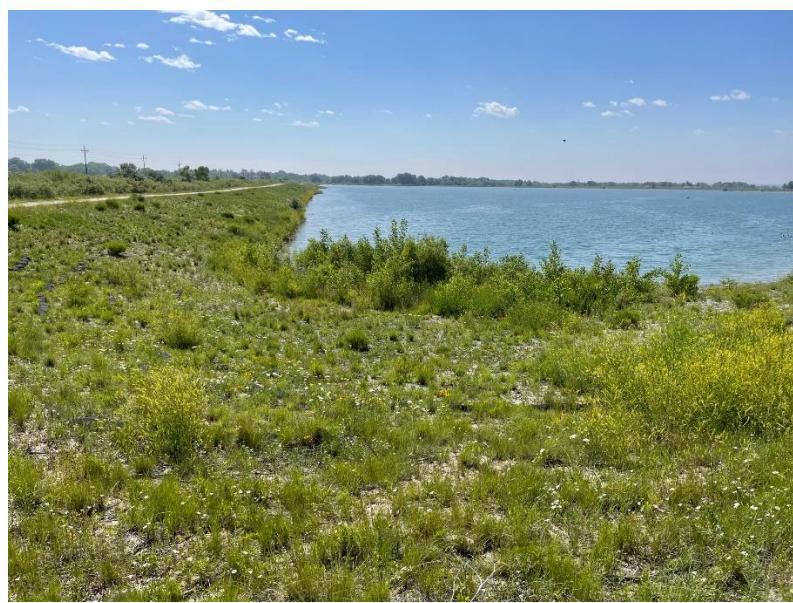
Photo D (taken June 27, 2023) showing naturally established rabbitbrush, cottonwoods, and peach-leaf willow along the shoreline of Rigden Reservoir.
