Inspection Report, Hayden Gulch Loadout, C-1992-081

PERMIT INFORMATION

Permit Number: C-1992-081 Mine Name: Hayden Gulch Loadout Operator: Hayden Gulch Terminal, LLC Operator Address: Ms Miranda Kawcak 29515 Routt County Road 27 Oak Creek, CO 80467 County: Routt Operation Type: Loadout Permit Status: Active Ownership: Private

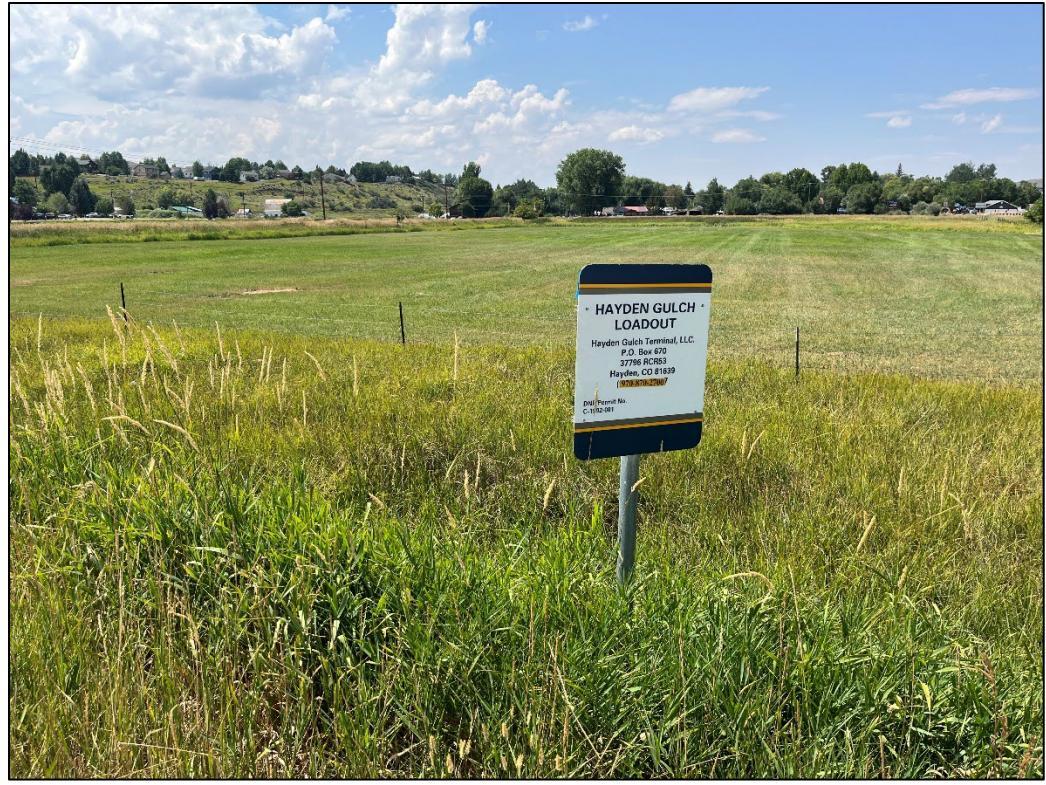
Mine identification markers were observed at the entrance to the unreleased haul road and adjacent to the unreleased agricultural section north and south of Hwy 40 (Photos 1 and 2).

Figure 1: Mine signage located off Hwy 40.

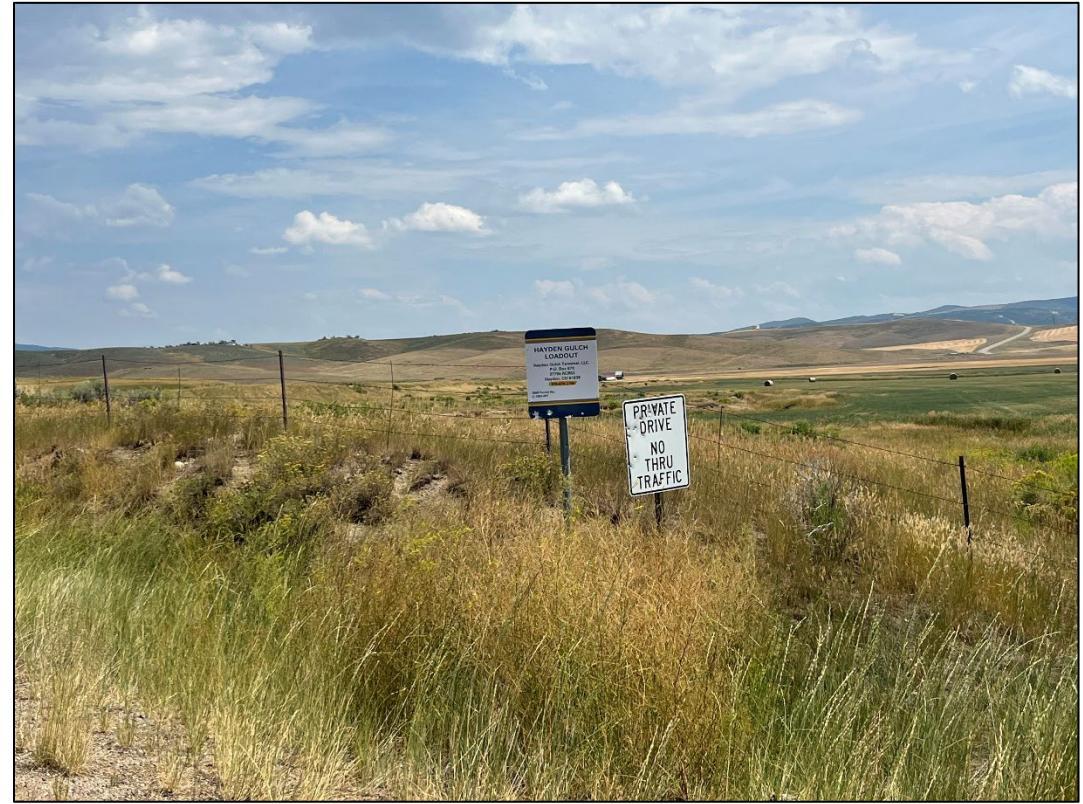
Figure 2: Mine signage located at the western entrance to the unreleased haul road.

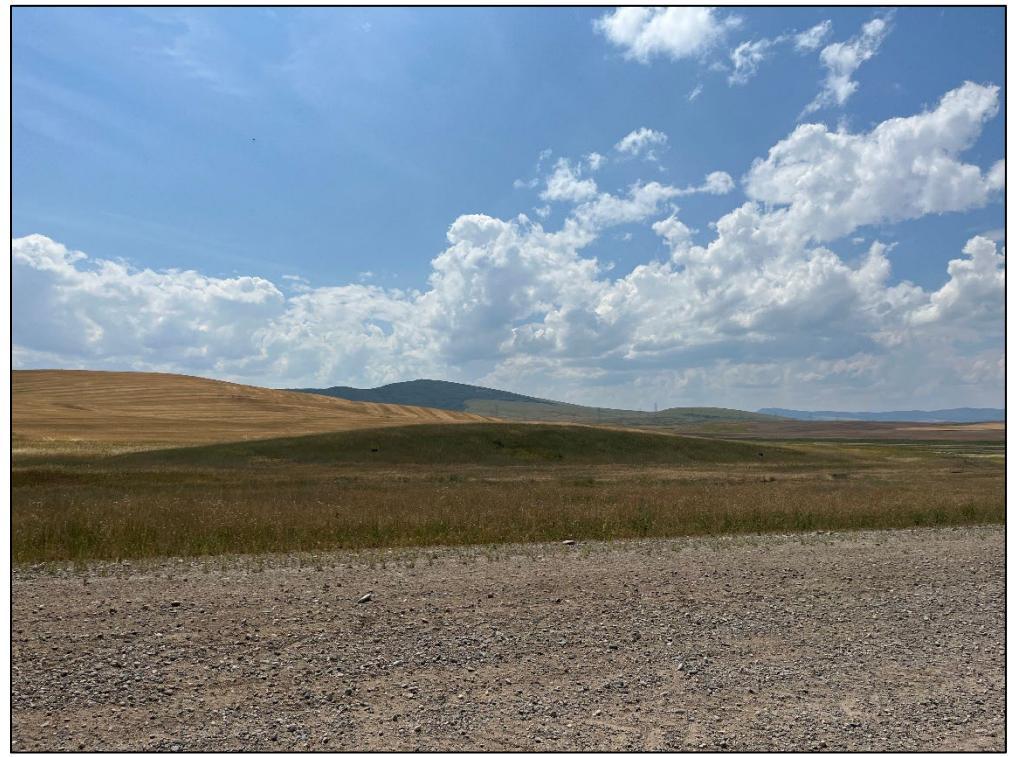
The haul road was well maintained and free of erosional features. This haul road and its associated permanent topsoil pile features to the east will be ready for release this year (Photos 3 and 4).

Figure 3: Topsoil pile located on the eastern end of the unreleased haul road.

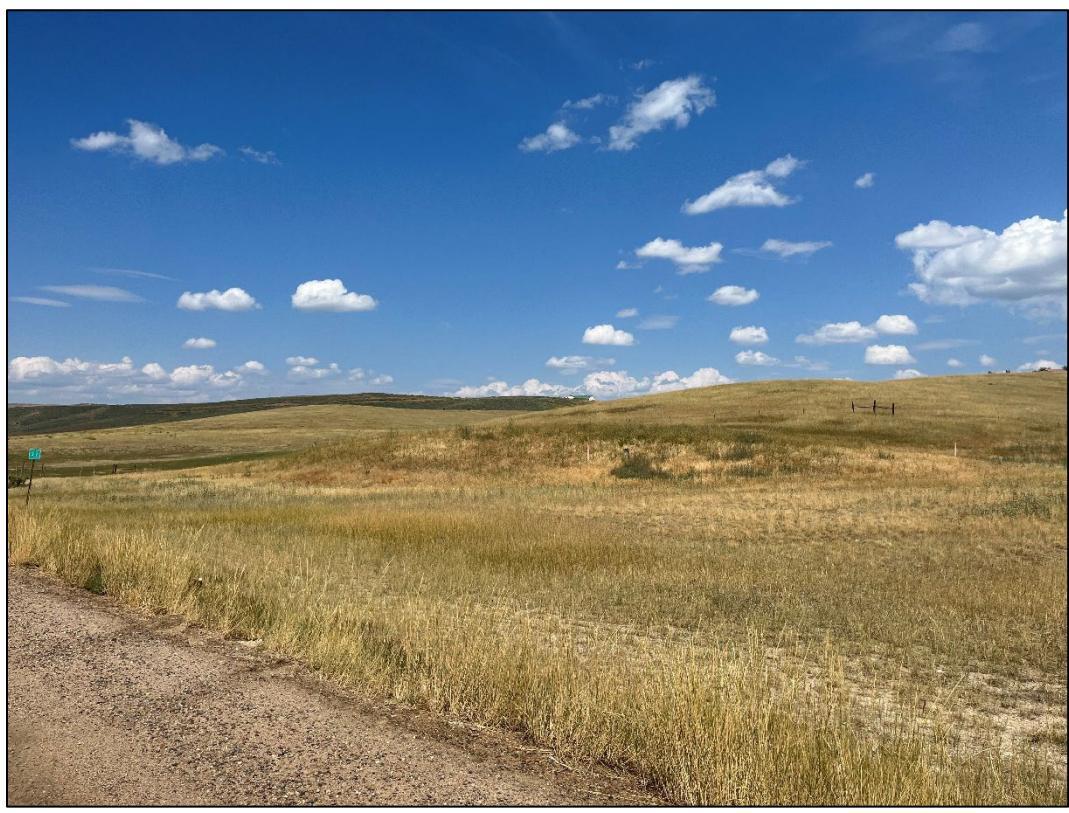
Figure 4: Topsoil pile located on the eastern end of the unreleased haul road.

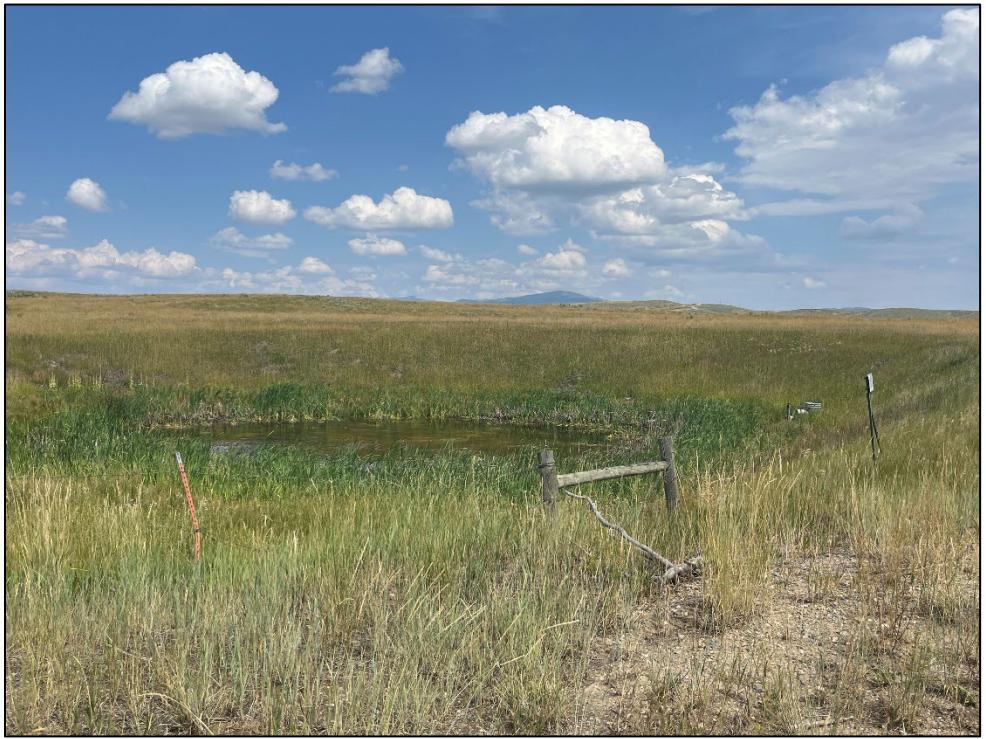
Truck Loop Pond 001 and Rail Loop Pond 002 were both full and functioning properly. Rail Loop Pond 002 is accessed by walking a portion of the Sage Creek Trail located on the site's previously released acreage (Photo 6). Truck Loop Pond 001 is accessed from the side of the southern unreleased haul road (Photo 5).

Figure 5: Truck Loop Pond 001.

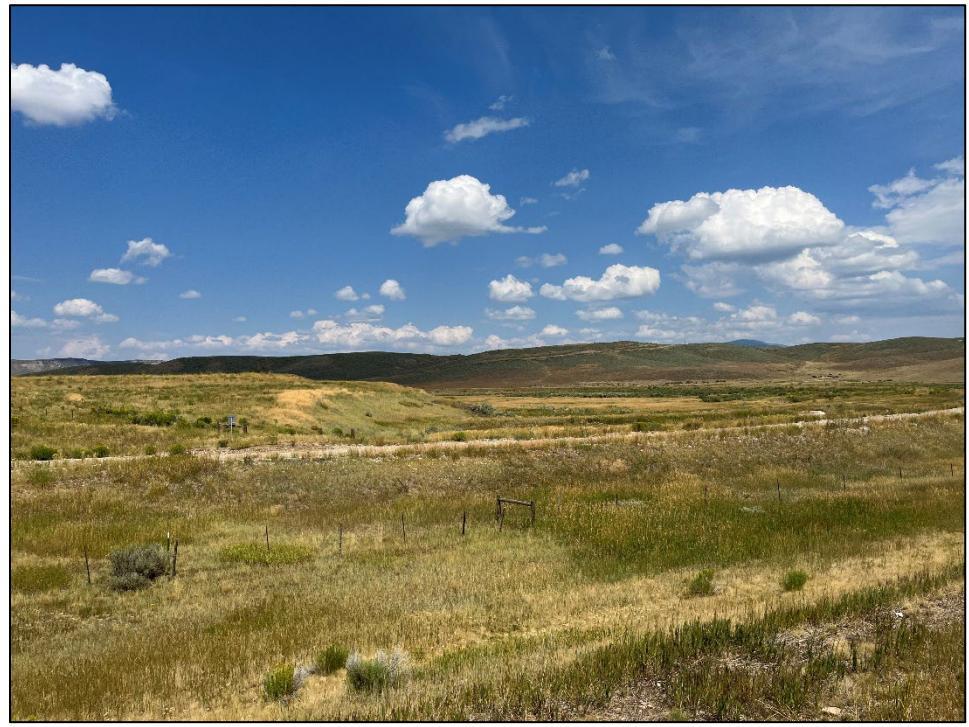
Figure 6: Rail Loop Pond 002 seen from the haul road.

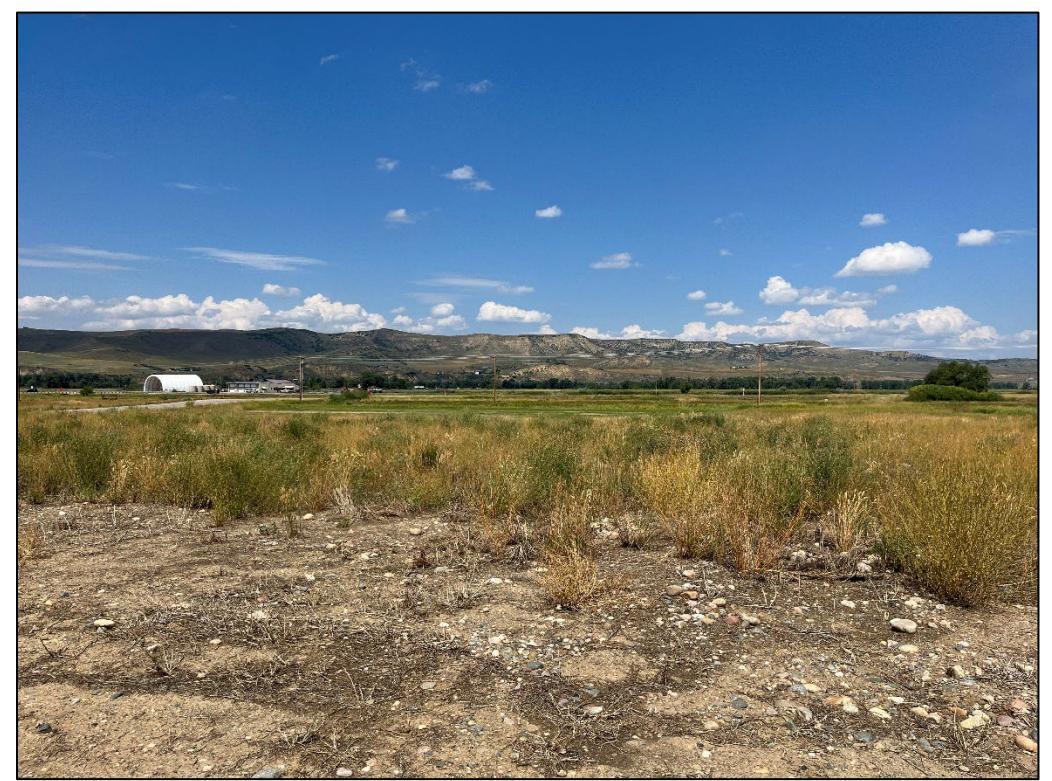
The remaining permit area North of Hwy 40 was well vegetated (Photo 7). This portion of the permit has been incorporated into the adjacent hay fields.

Figure 7: View east of agricultural fields in the northernmost permit boundary. Bare area is the nearby trail parking lot.
