MINERALS PROGRAM INSPECTION REPORT PHONE: (303) 866-3567

MINE NAME:	MINE/PROSPECTING ID#:	MINERAL:	COUNTY:
Grisenti Farms Gravel Pit	M-2001-005	Sand and gravel	Fremont
INSPECTION TYPE:	WEATHER: Clear	INSP. DATE:	INSP. TIME:
Surety-Related Inspection		November 2, 2023	10:15
OPERATOR:	OPERATOR REPRESENTATIVE:	TYPE OF OPERATION:	
Continental Materials Corporation	Jerald Schnabel	112c - Construction Regular Operation	
REASON FOR INSPECTION:	BOND CALCULATION TYPE:	BOND AMOUNT:

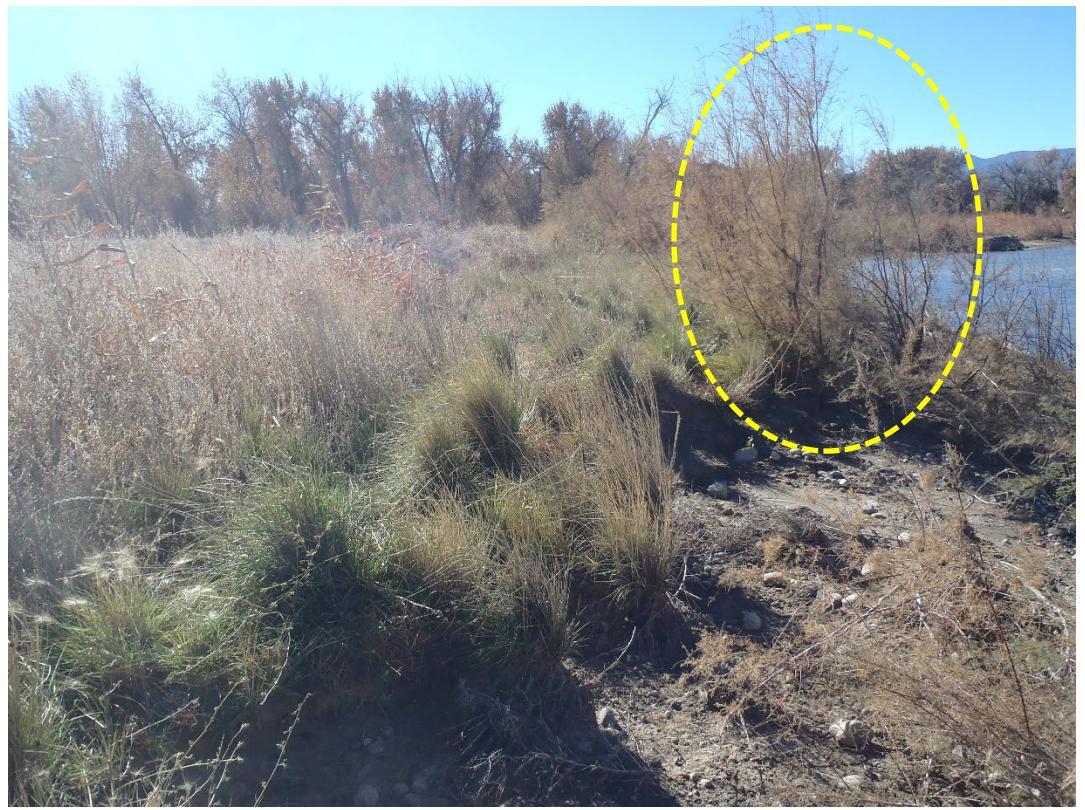
Photo 1. Small area of established grass on east side of Phase 1 pond (Tamarisk circled).

CORRECTIVE ACTIONS: The operator shall implement the existing weed control plan in accordance with Section 3.1.10 (6) of the Rule. Submit documentation demonstrating completed control methods for Russian olive and Tamarisk trees by the corrective action date.

<u>Revegetation:</u> Mr. Schnabel indicated the site had been drill seeded approximately two years ago. Grass has been slow to establish with some areas doing much better than others. Phase 1 (west side) has very little established grass (see **Photos 1** and **2**). Phase 2 has more established grasses (see **Photo 3**) intermixed with kochia and Russian thistle (see **Photo 4**). The kochia and Russian thistle have formed monocultures in some areas. Although these two species are not included in the Colorado Noxious Weeds list, they need to be minimized and replaced with a diverse vegetation mix as approved in the site permit prior to release of reclamation liability. Both Russian olive (see **Photo 5**) and tamarisk (see **Photo 1**) trees were observed within the permit boundary. These are both noxious weed List B species and require treatment. The site has a weed control, approved with technical revision TR-1. <u>The presence of Russian olive and tamarisk is cited as a problem on p. 1 of this report</u>.

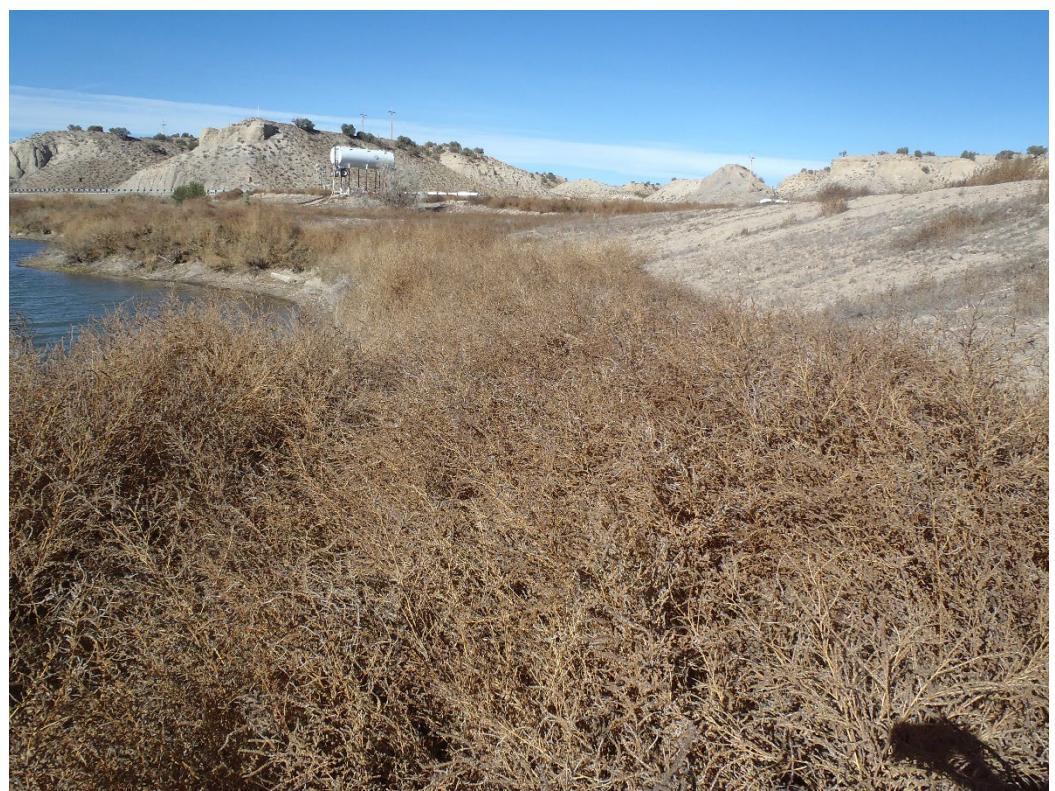
Photo 2. No grasses, bare ground or kochia/Russian thistle mix (north side of Phase 1 pond).

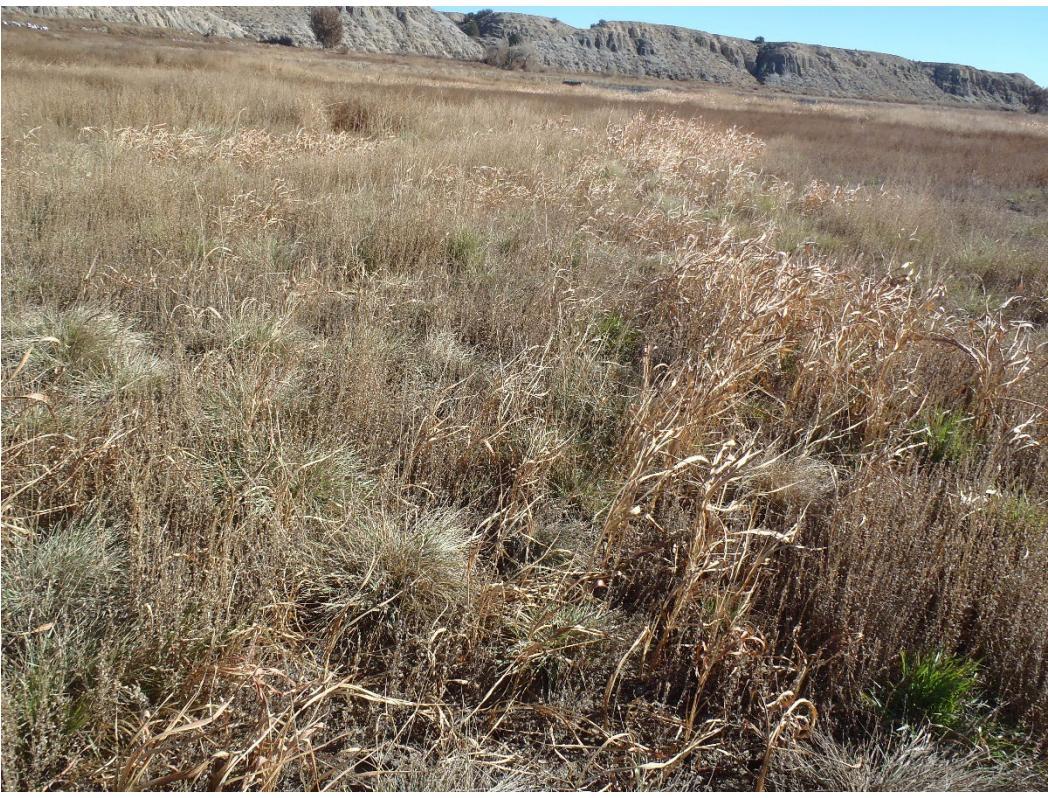
Photo 3. Established grasses on SW side of Phase 2 pond (looking NE).

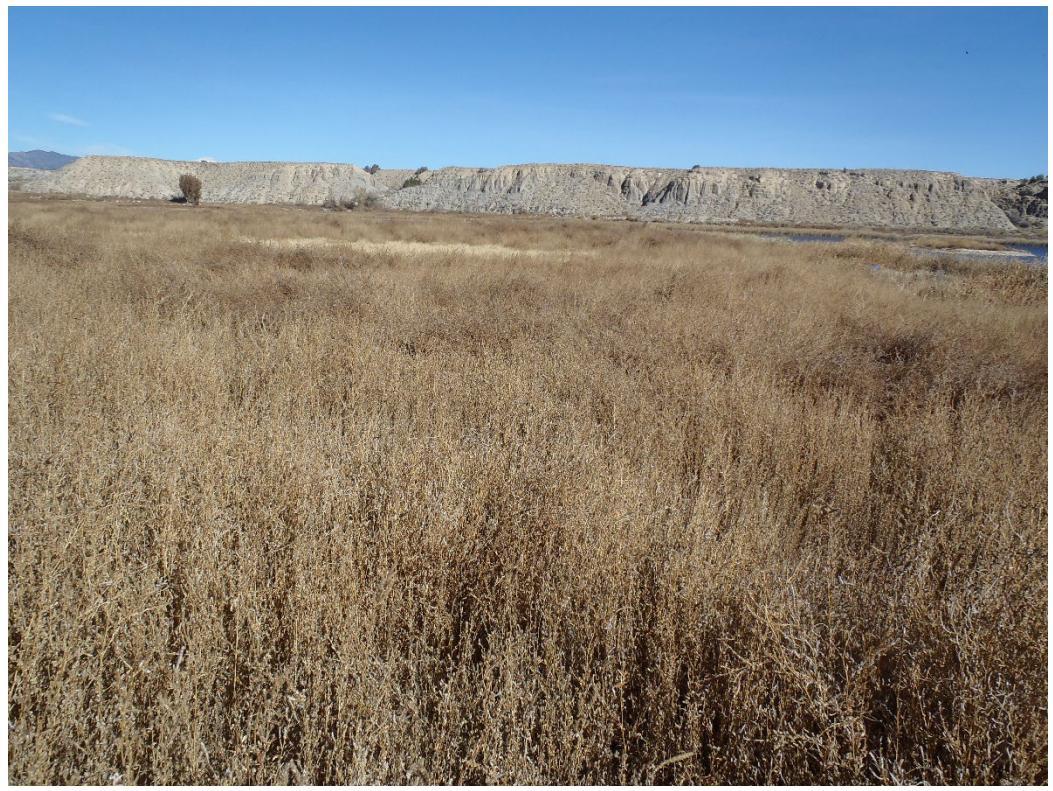
Photo 4. Kochia and Russian thistle on south side of Phase 2 pond (looking north).

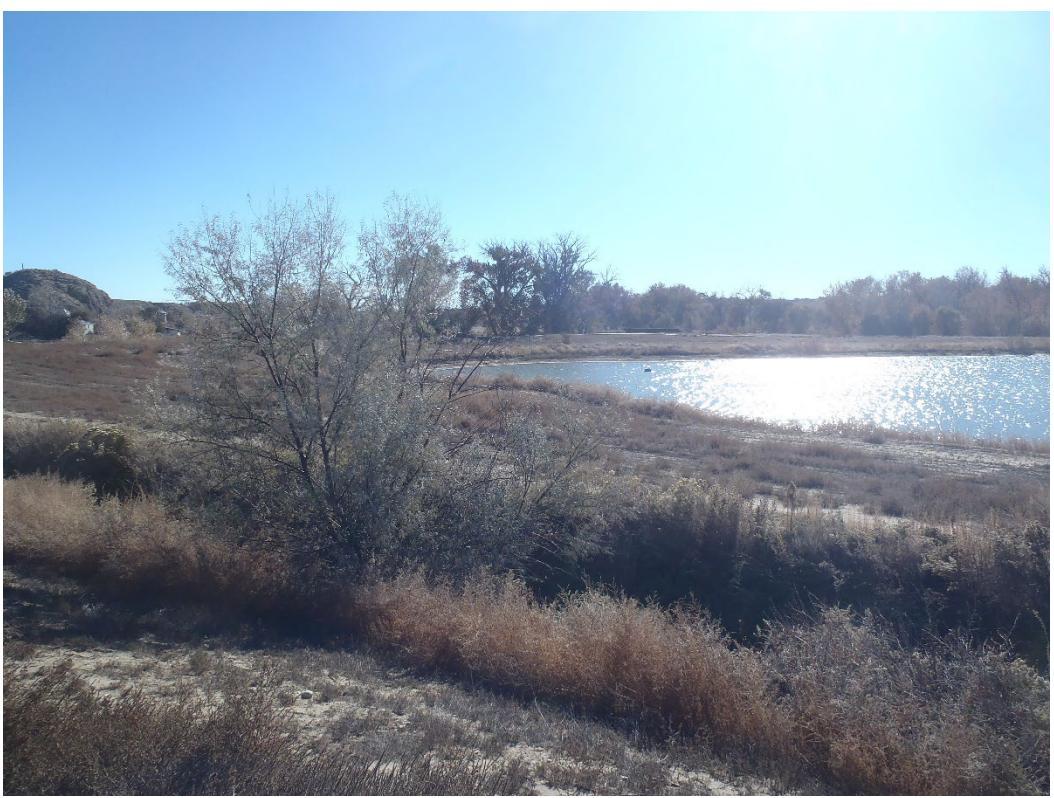
PROBLEM/POSSIBLE VIOLATION: Problem: Both Russian olive and Tamarisk (salt cedar) trees are present within or have volunteered into the permit area and are becoming established. This is a problem for failure to employ weed control methods for a state listed noxious weed species within the permitted area, and to reduce the spread of weeds to nearby areas as required by Section 3.1.10 (6) of the rule.

Photo 5. One of several Russian olive trees along Phase 1 pond perimeter ditch (north side).

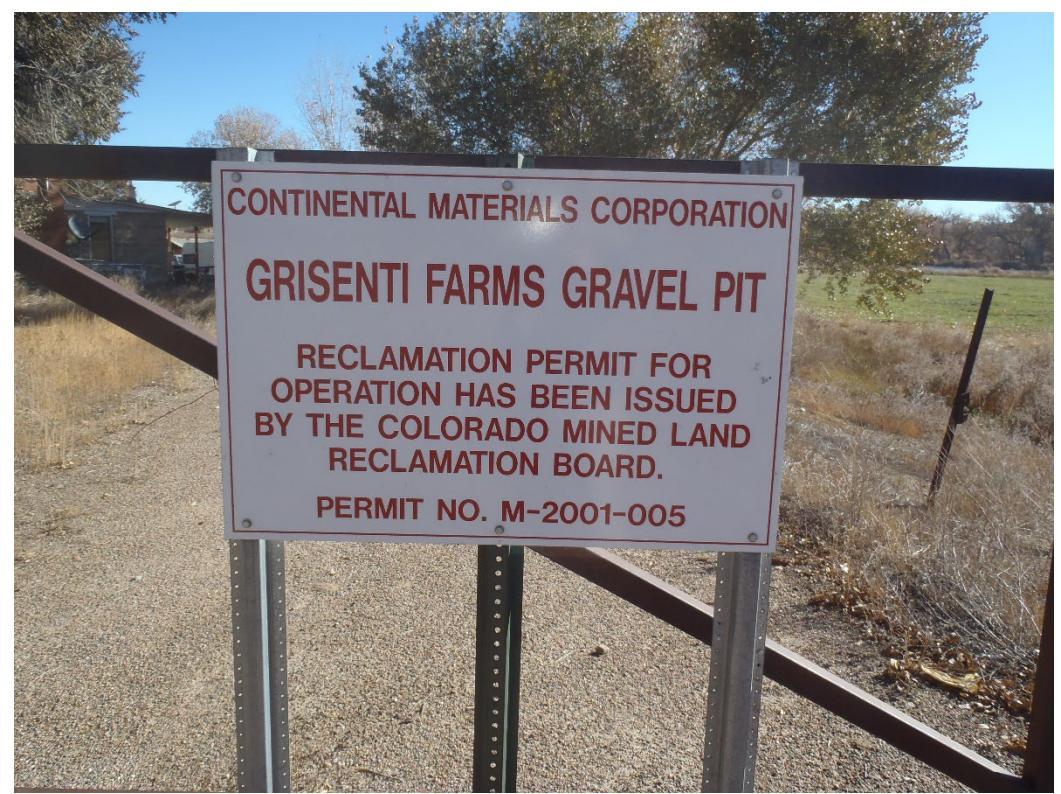
Signs and Markers: The permit sign was properly posted (see Photo 6).

Photo 6. Permit sign at entrance off Hwy 115 (SO will require name change to Riverbend Industries).

CORRECTIVE ACTIONS: Submit a Succession of Operator application by the Corrective Action Due Date. **CORRECTIVE ACTION DUE DATE:** 12/08/23
