MINERALS PROGRAM INSPECTION REPORT PHONE: (303) 866-3567

MINE NAME:		MINE/PROSPECTING ID#:	MINERAL:	COUNTY:
Well Field Pit		M-1984-154	Sand and gravel	Prowers
INSPECTION TYPE:		WEATHER: Clear	INSP. DATE:	INSP. TIME:
Monitoring			March 13, 2024	09:00
OPERATOR:		OPERATOR REPRESENTATIVE:	TYPE OF OPERATION:	
City of Lamar		Patrick Mason	110c - Construction Limited Impact	
REASON FOR INSPECTION:		BOND CALCULATION TYPE:	BOND AMOUNT:	
Normal I&E Program		None	\$0.00	
DATE OF COMPLAINT:		POST INSP. CONTACTS:	JOINT INSP. AGENCY:	
NA		None	None	
INSPECTOR(S):	INSPECTOR'S SIGNATURE:		SIGNATURE DATE:	
Zach Trujillo			March 26, 2024	
	38736

This was a normal monitoring inspection of the Well Field Pit, M-1984-154, conducted by Zach Trujillo of the Colorado Division of Reclamation, Mining and Safety (Division). Mr. Patrick Mason representing the Operator, City of Lamar, during the inspection. The Well Field Pit is a 110c operation permitted for 9.9 acres. The site is located approximately 3-1/2 miles southeast of Lamar, CO in Prowers County, on municipally-owned land. Access to the site is from the west off Co Rd 9 5/10. Weather during the inspection was clear with dry ground conditions and a

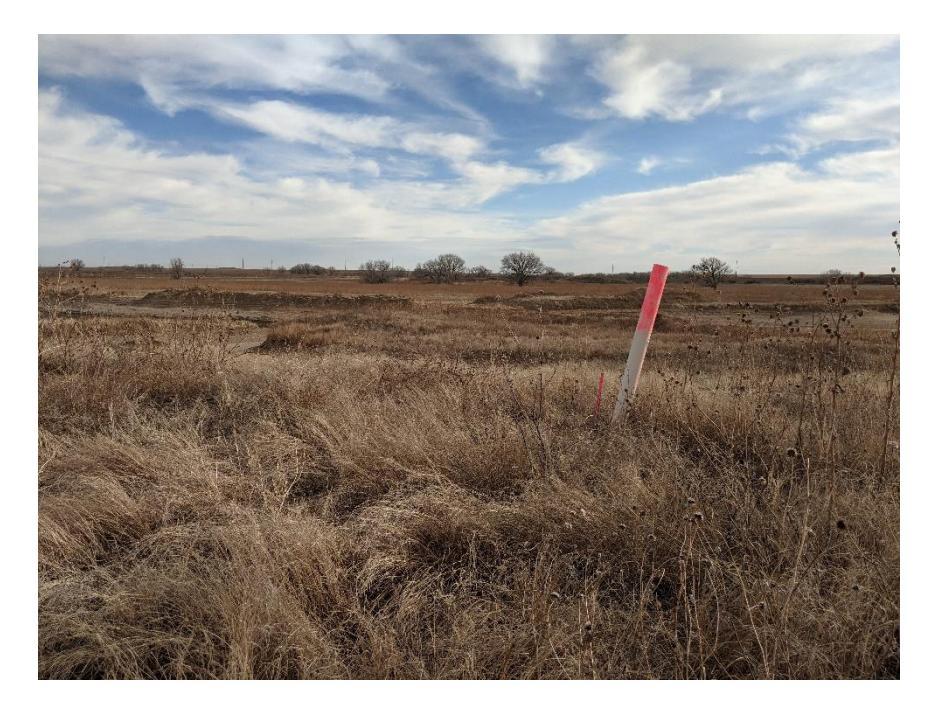
A mine identification sign was located at the entrance to the site. Permit boundary markers were also observed as poles with pink painted tips. All markers were visible from one another which clearly delineated the boundary.

Permit boundary marker.

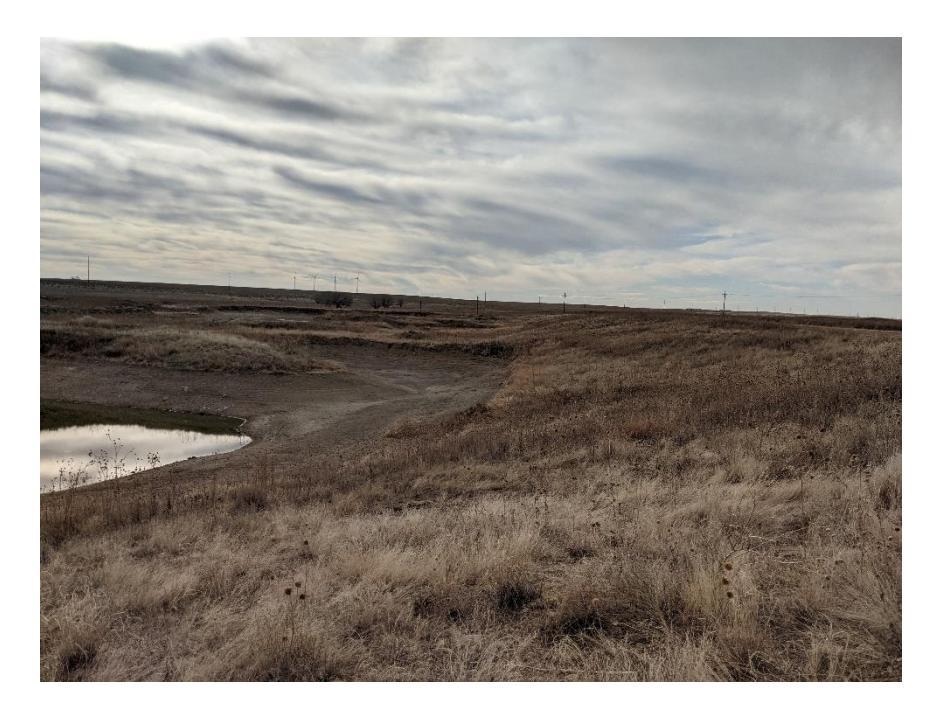
Only a portion of the recharge pond is within the permit boundary, consisting mainly of its western shoreline. Based on previous inspection reports, two sections of the western pond bank were redisturbed by the operation to repair erosion gullies that had developed in these areas. These areas were inspected and showed good vegetation establishment and blended well into the adjacent areas. All embankments and reclaimed areas have been graded with gradual slopes of 3H:1V or less. No additional major erosional features were observed along the reclaimed embankments of the pond or along other portions of the site.

Repaired pond bank looking south.

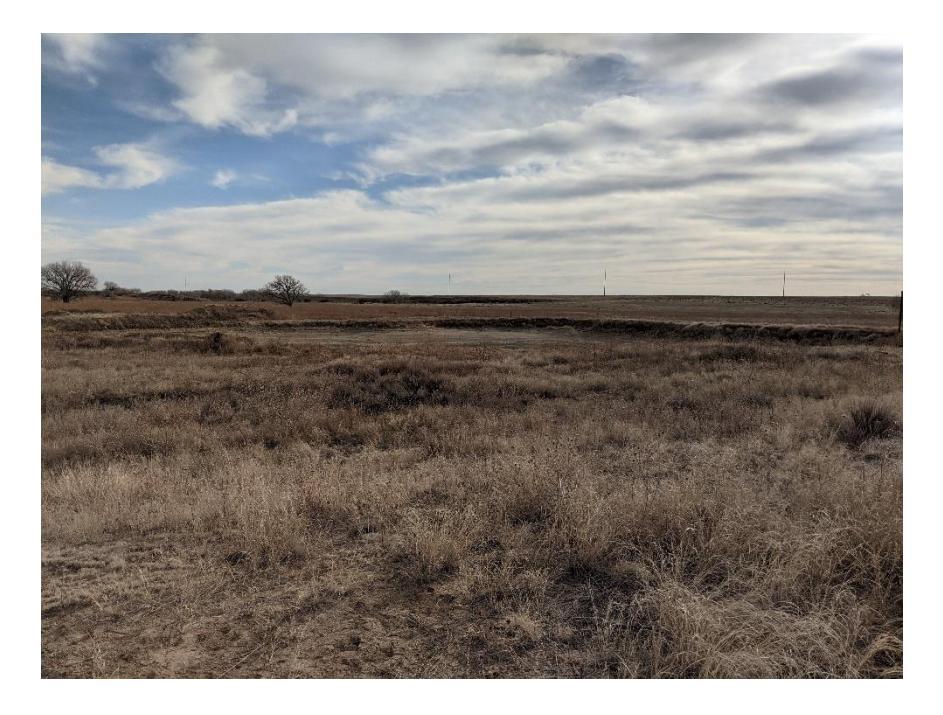
Vegetation throughout the site was well established up to the water line elevation of the pond. The Division's previous inspection noted noxious weeds on site, most notably Tamarisk trees along the pond embankment. Tamarisk trees were not observed as well as other noxious weeds were not encountered during the inspection. While no noxious weeds were observed, given the previous documentation in the Division's reports, it is recommended that the Operator continue to monitor and enact the approved weed management plan as necessary. This will help ensure compliance with requirements for site release and termination of jurisdiction.

Reclamation looking east from existing road.

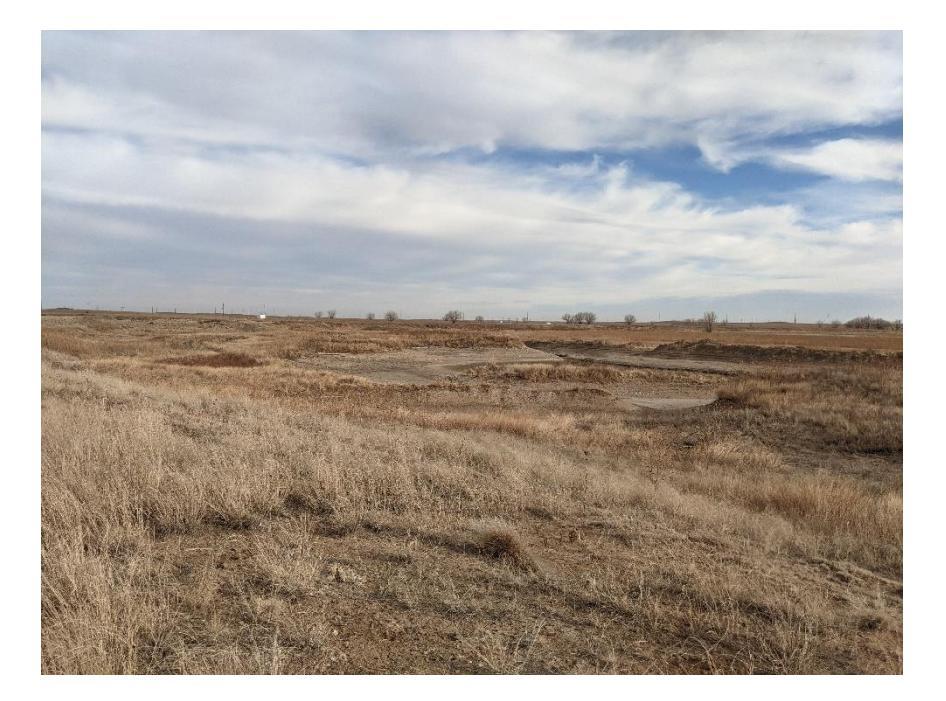
Reclamation along southern end of the pit looking north.

The Operator and Division discussed the potential for termination of jurisdiction based upon the results from the reclamation. While reclamation appears to have been completed with vegetation establishment, the Operator will need to request a full and final release per Rule 4.17 with the attached form.
