# Environment, Inc.

May 28, 2024

RE: Tamrock Gravel LLC. - Shot Rock Pit Permit # M-2012-023 (AM1) - Adequacy Review

On behalf of our client Tamrock Gravel LLC., I will respond to your April 23, 2024, adequacy review letter, as needed, in the order and number format presented in that document.

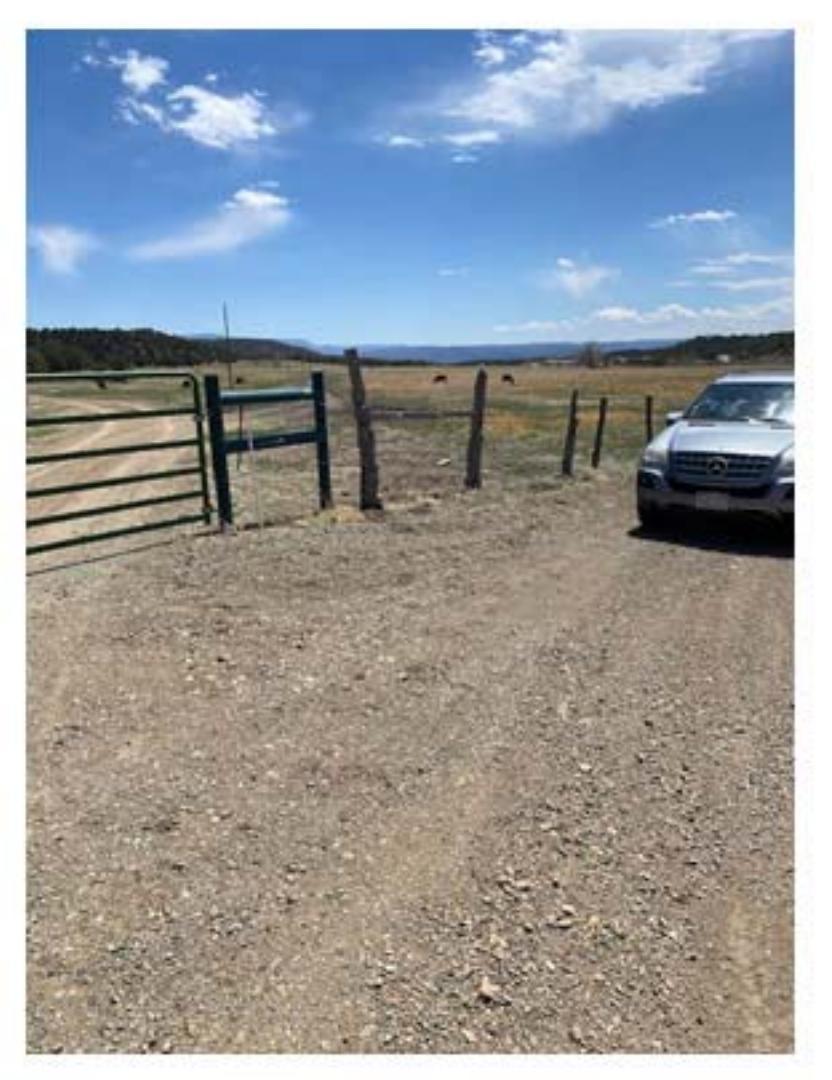
CORNER R7 - PHOTO DATE 4/23/2024

The coordinates for corner R7 contained a typo error where I forgot one of the numbers in the Latitude. The Map has been corrected and the new numbers for that corner are 37.192095 N, 104.659737 W. I have also attached 2 Photos showing the corner was properly marked. Note Tami Tamburelli took the pictures and the car in the photo is approximately where you parked during the recent inspection.
