MINERALS PROGRAM INSPECTION REPORT PHONE: (303) 866-3567

MINE NAME:	MINE/PROSPECTING ID#:	MINERAL:	COUNTY:
Pinon Mine	M-1997-094	Stone	Pueblo
INSPECTION TYPE:	WEATHER:	INSP. DATE:	INSP. TIME:
Monitoring	Clear	December 5, 2024	12:45
OPERATOR:	OPERATOR REPRESENTATIVE:	TYPE OF OPERAT	FION:
Siloam Stone, Inc.	Mr. Matthew Mueller	110c - Construction	Limited Impact
REASON FOR INSPECTION:	BOND CALCULATION TYPE:	BOND AMOUNT:	
Normal I&E Program	Complete Bond	\$8,300.00	
DATE OF COMPLAINT:	POST INSP. CONTACTS:	JOINT INSP. AGE	NCY:
NA	None	None	
INSPECTOR(S):	INSPECTOR'S SIGNATURE:	SIGNATURE DAT	Е:
Jocelyn Carter	1 DAL	January 6, 2025	
Ursula Armstrong	Courth		
-

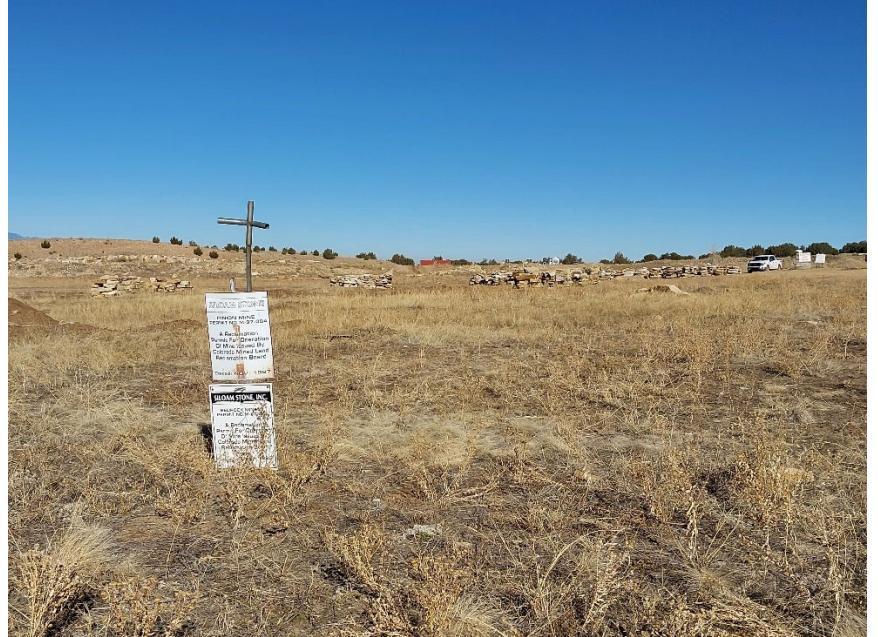
Photo #1: Mine sign at the entrance of the site, the upper sign seen on this post is for this permit.

There is a sign at the entrance of the mine site in accordance with Rule 3.1.12(1). Markers were not verified during the inspection.

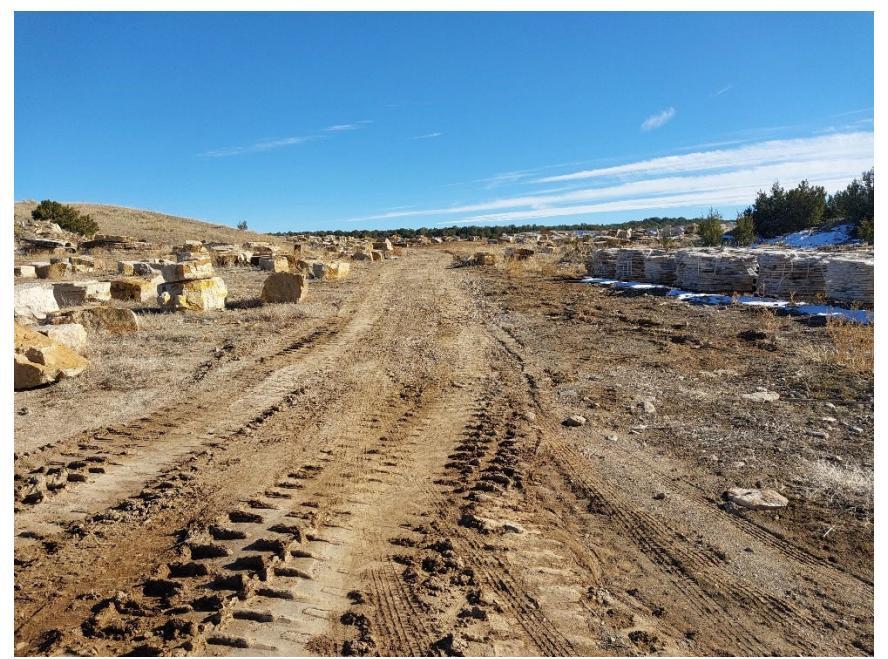
Photo #2: View of the northern section of the permit area on the road, looking to the southeast. Product material is stored on either side of the road, palletized material is stored on the southwest side.

There was no mining activity occurring on the permit at the time of the inspection. Mining on the west side of the permitted area is complete, according to Mr. Mueller. It has been backfilled and graded and is currently being used to store product material. The east side of the permit area has not yet been mined but is expected to be mined in the future. The east side is also being used to store product material, see Photo #2.

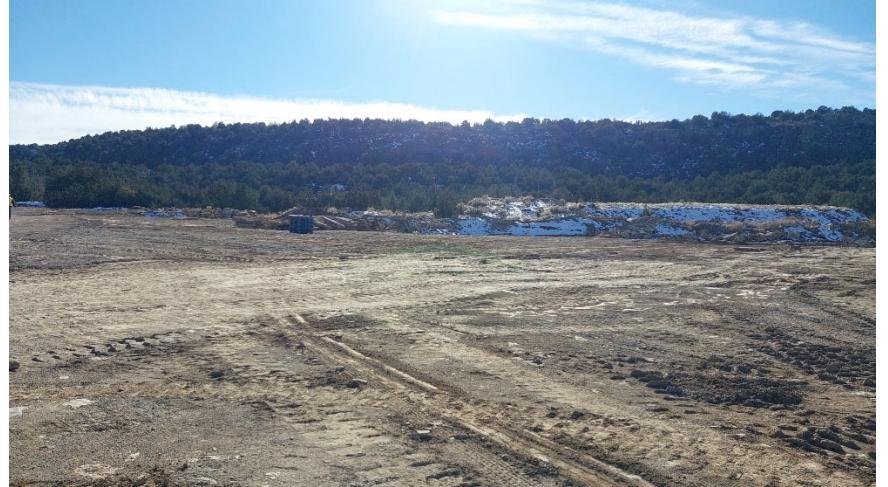
Photo #3: View of the western section of the permit area that has been backfilled and graded, looking to the west-southwest from the road. The topsoil stockpile can be seen covered in snow.

The western portions of the site that have been backfilled and graded appear to be stable and in good condition.

There is one topsoil stockpile that is stored along the western perimeter of this permit site, see Photo #3. However, there are numerous topsoil stockpiles in the vicinity that are kept for the purpose of reclamation of all three permit areas. The topsoil stockpiles for the three mining operations appeared to be well vegetated, stable, and adequate in volume for reclamation purposes.

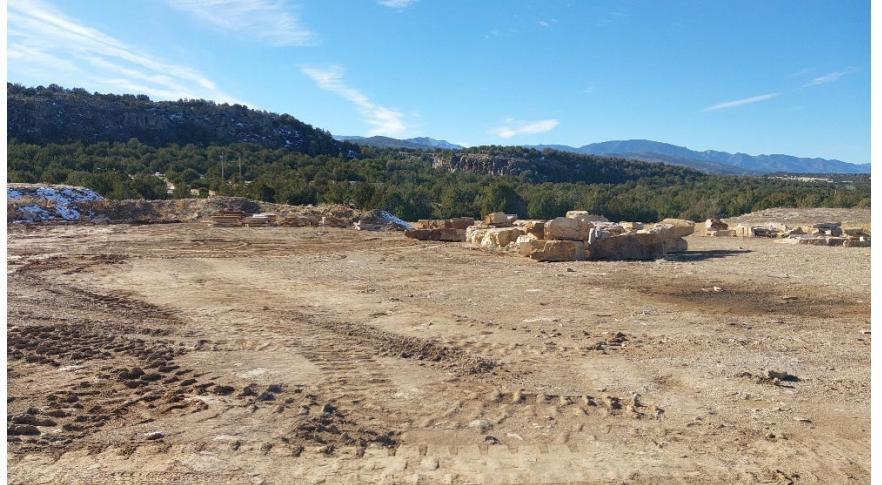
Photo #4: View of the material stored on the northwestern portion of the permit area, looking to the northwest

from the road.

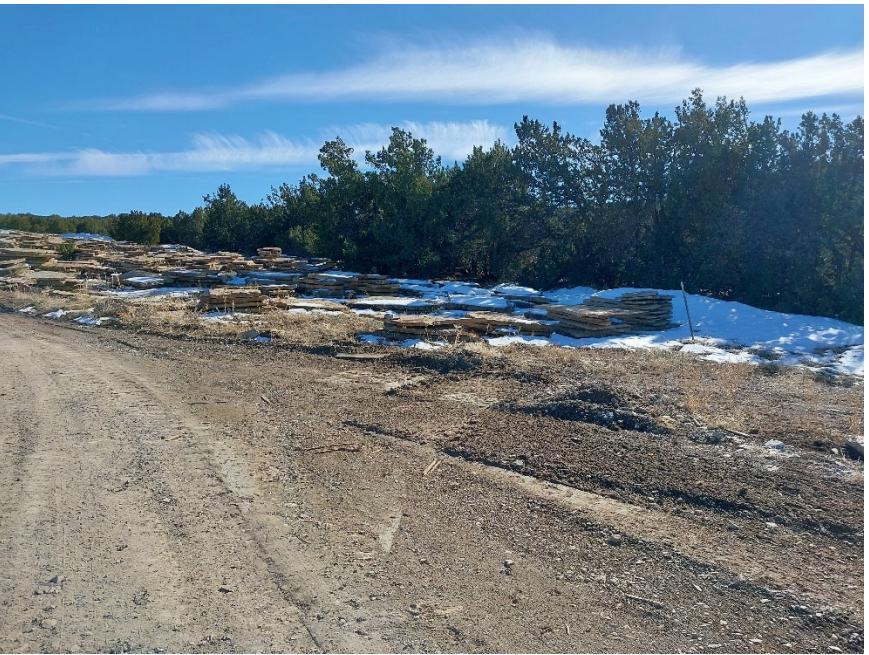
Photo #5: View of palletized product material stored in the southwestern portion of the permit area.

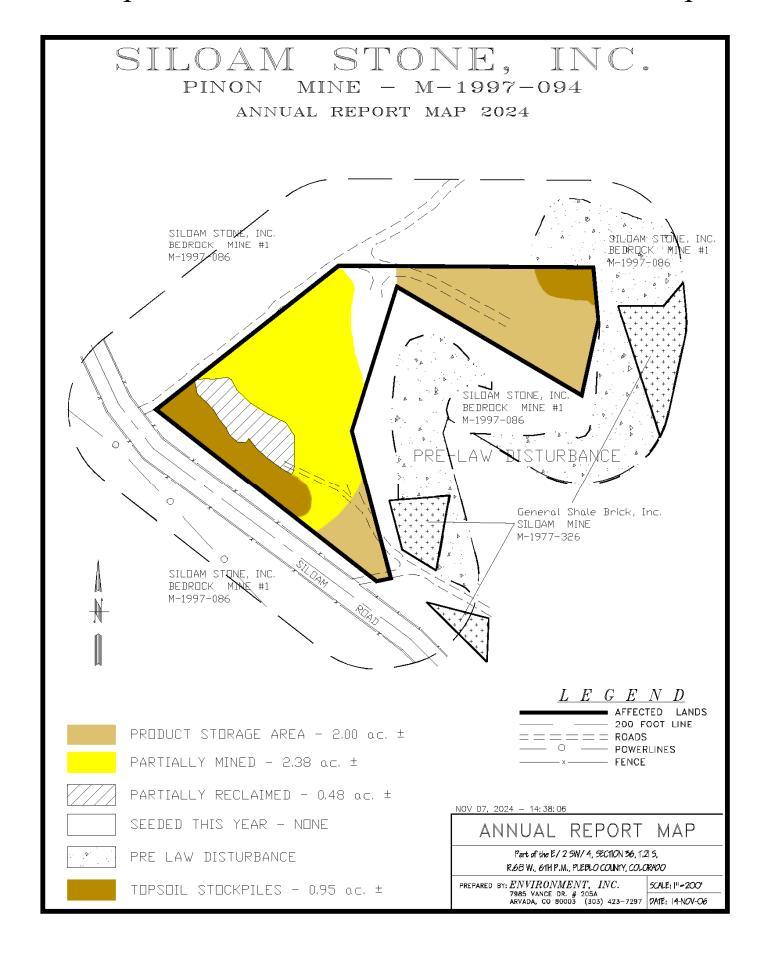
2024 annual map submitted for the Pinion Mine permit.
