MINE NAME:	MINE/PROSPECTING ID#:	MINERAL:	COUNTY:
Weimer One Gravel	M-2001-002	Sand and gravel	Montrose
INSPECTION TYPE:	INSPECTOR(S):	INSP. DATE:	INSP. TIME:
Surety-Related Inspection	G. Russell Means	March 27, 2012	12:30
OPERATOR:	OPERATOR REPRESENTATIVE:	TYPE OF OPERATION:	
West End Gravel Company	None	112c - Construction Regular Operation

INSPECTION TOPIC: Backfilling & Grading

INSPECTION TOPIC: Gen. Compliance With Mine Plan

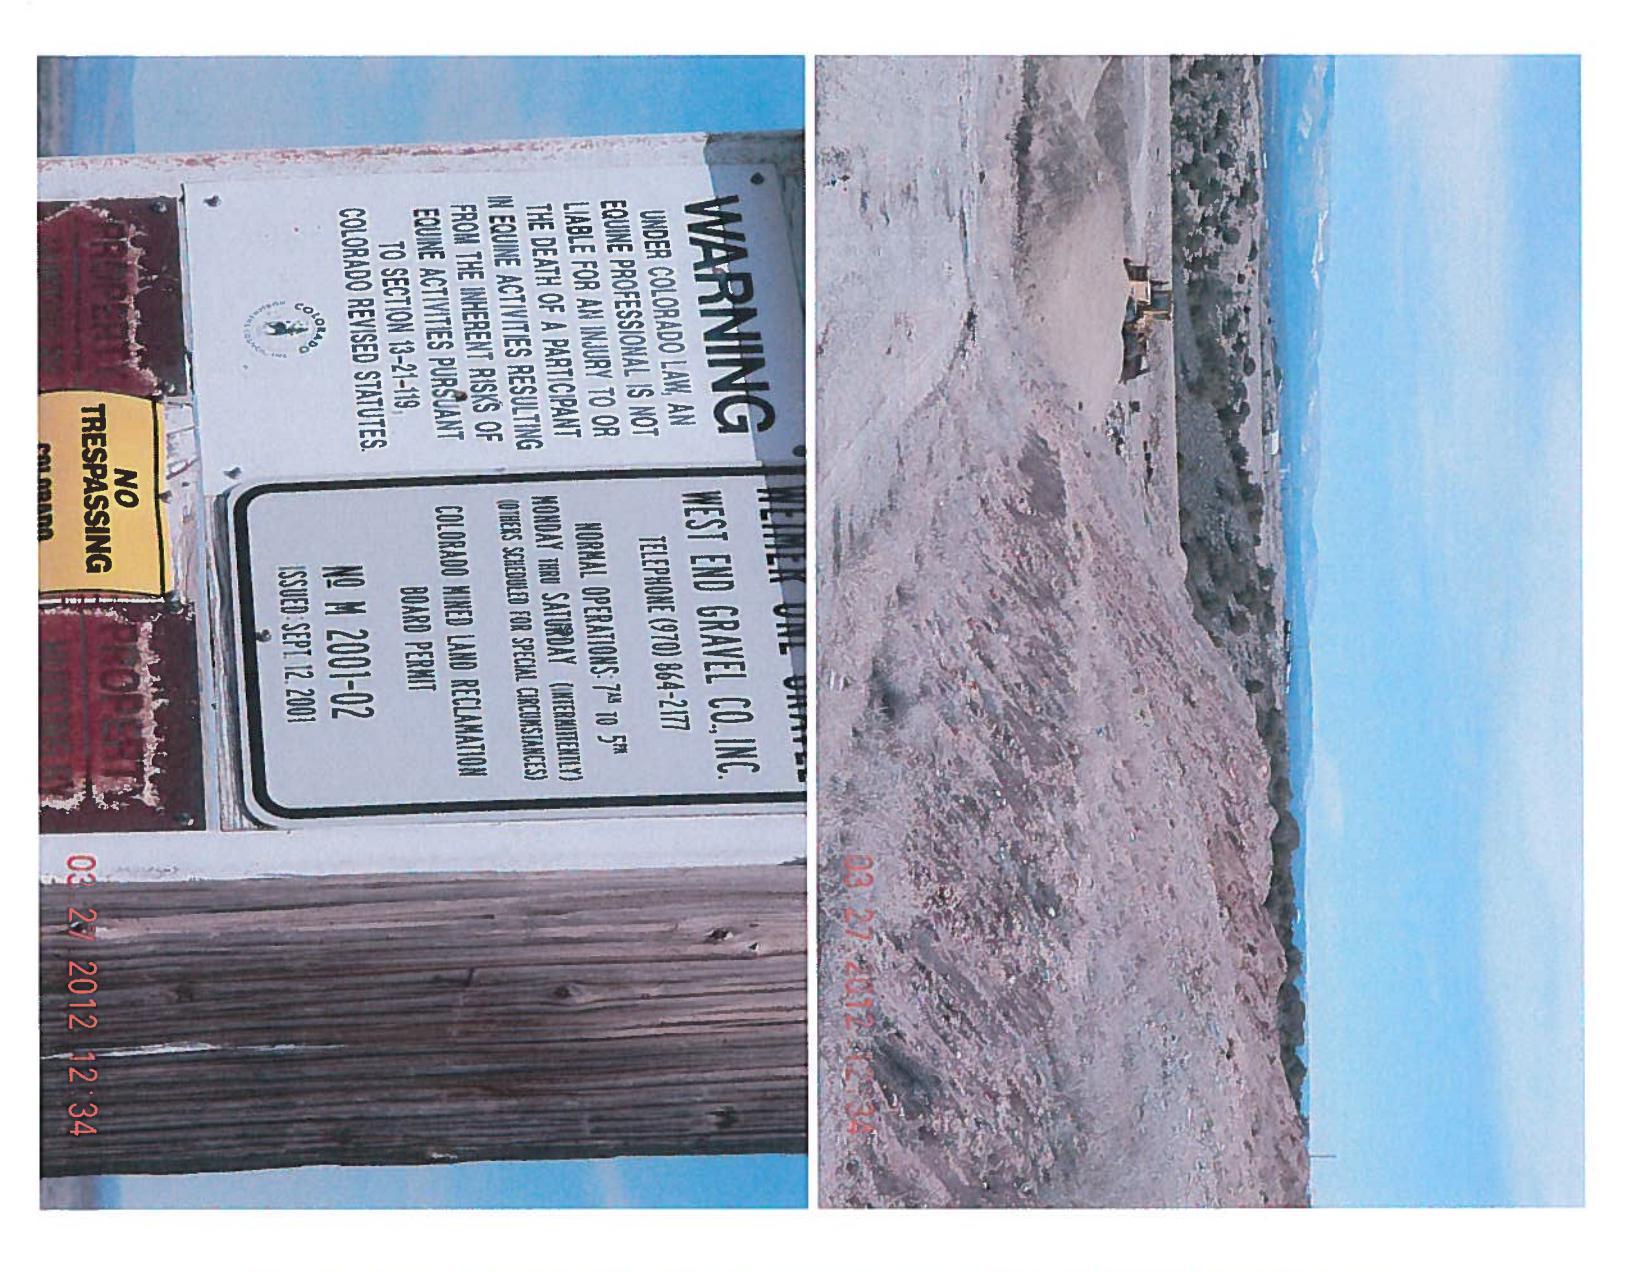
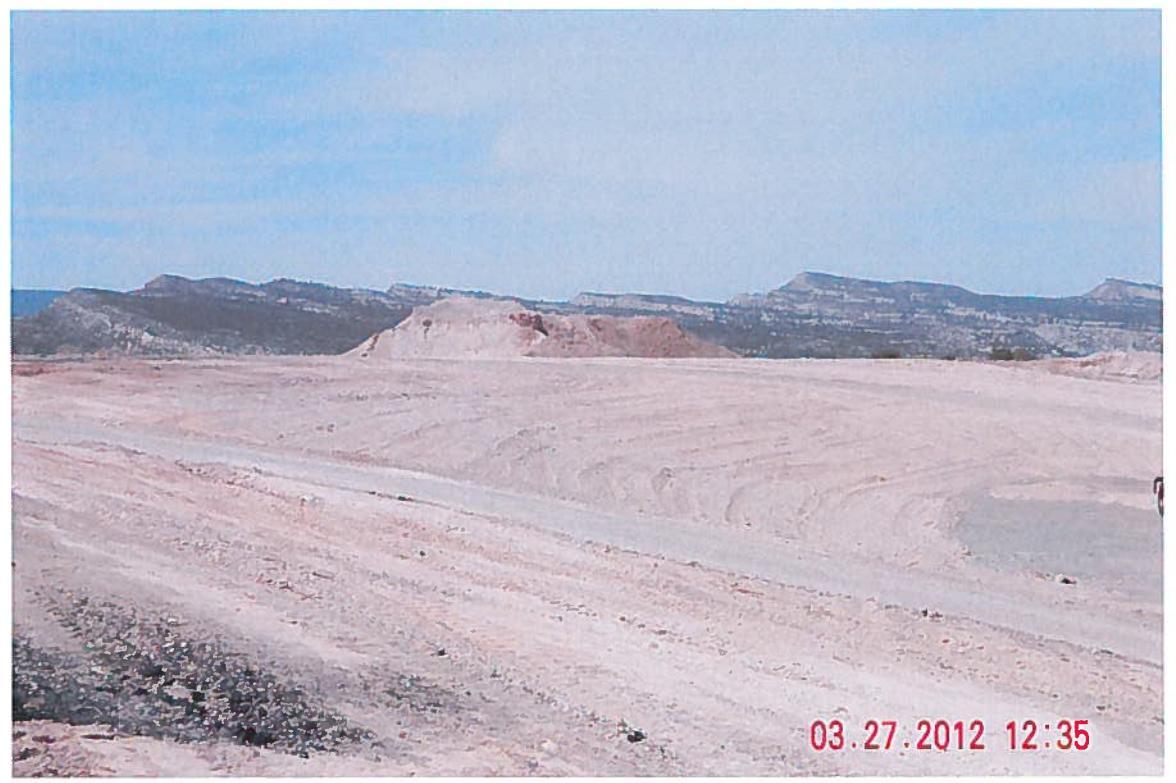
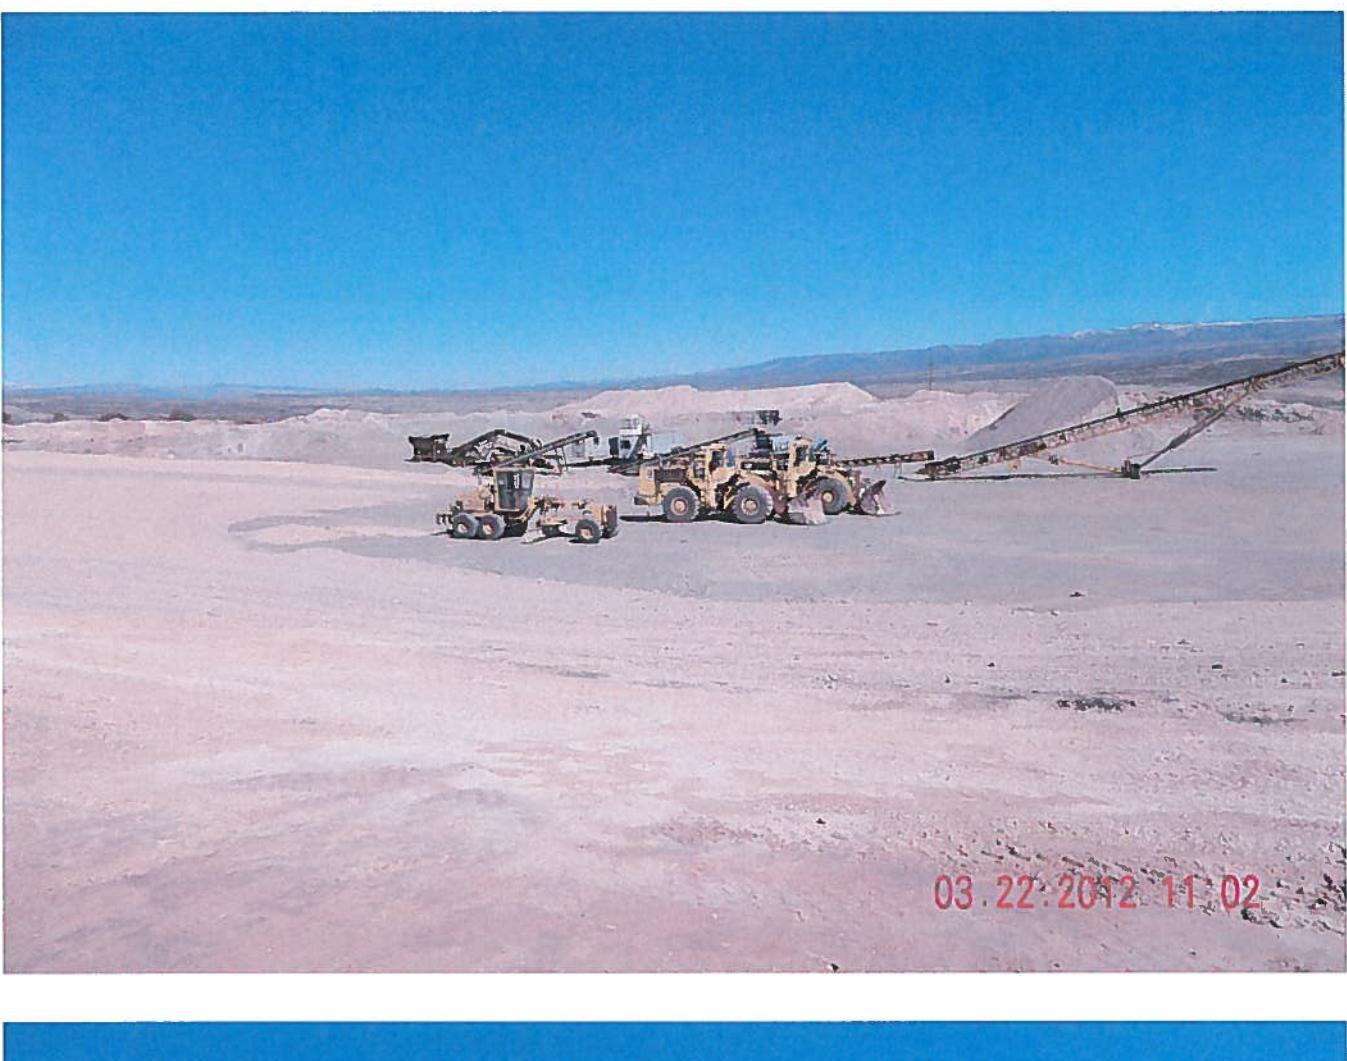
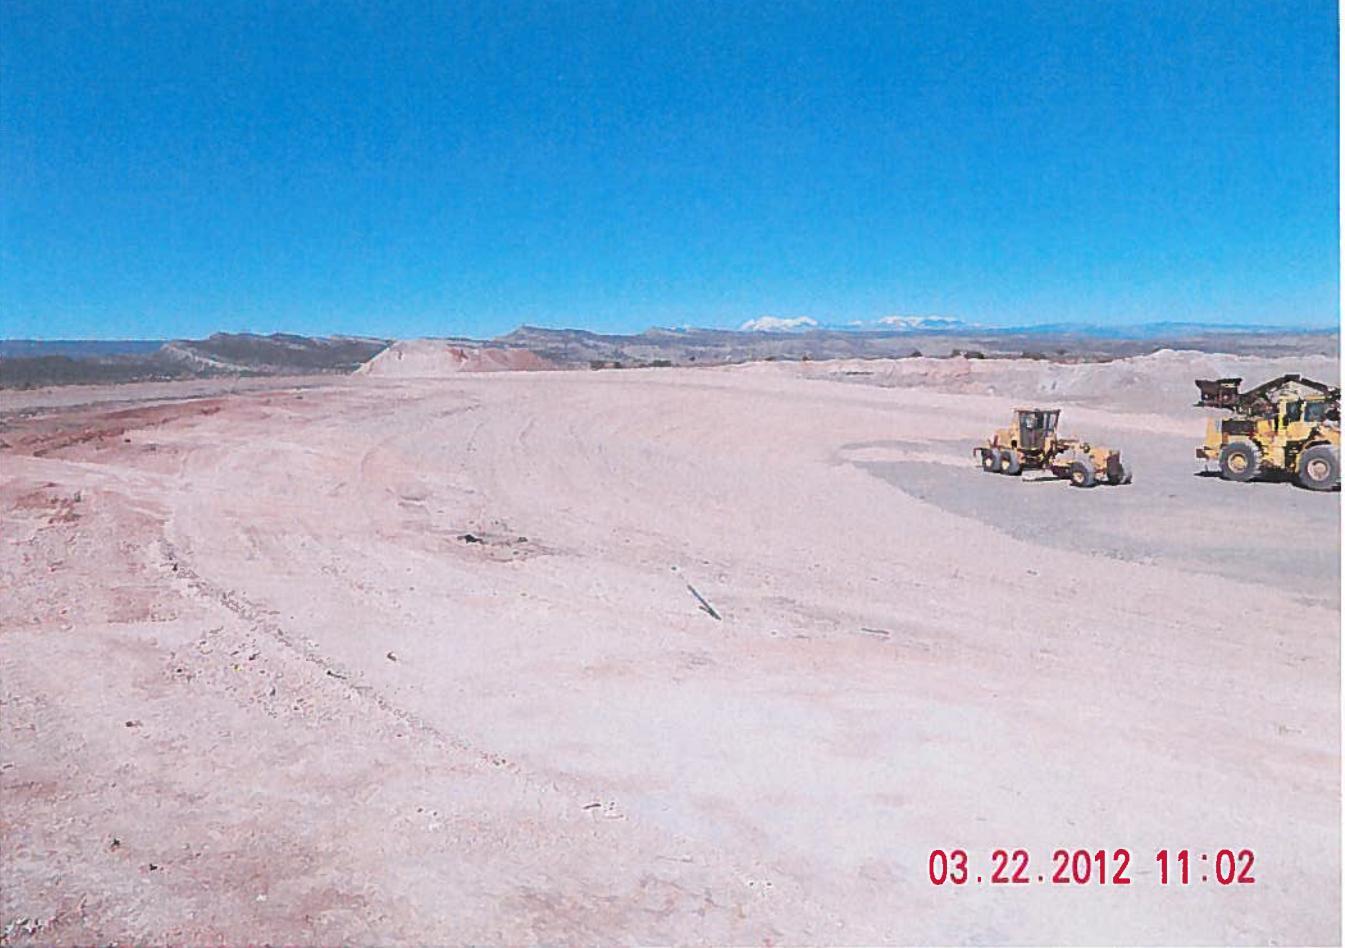
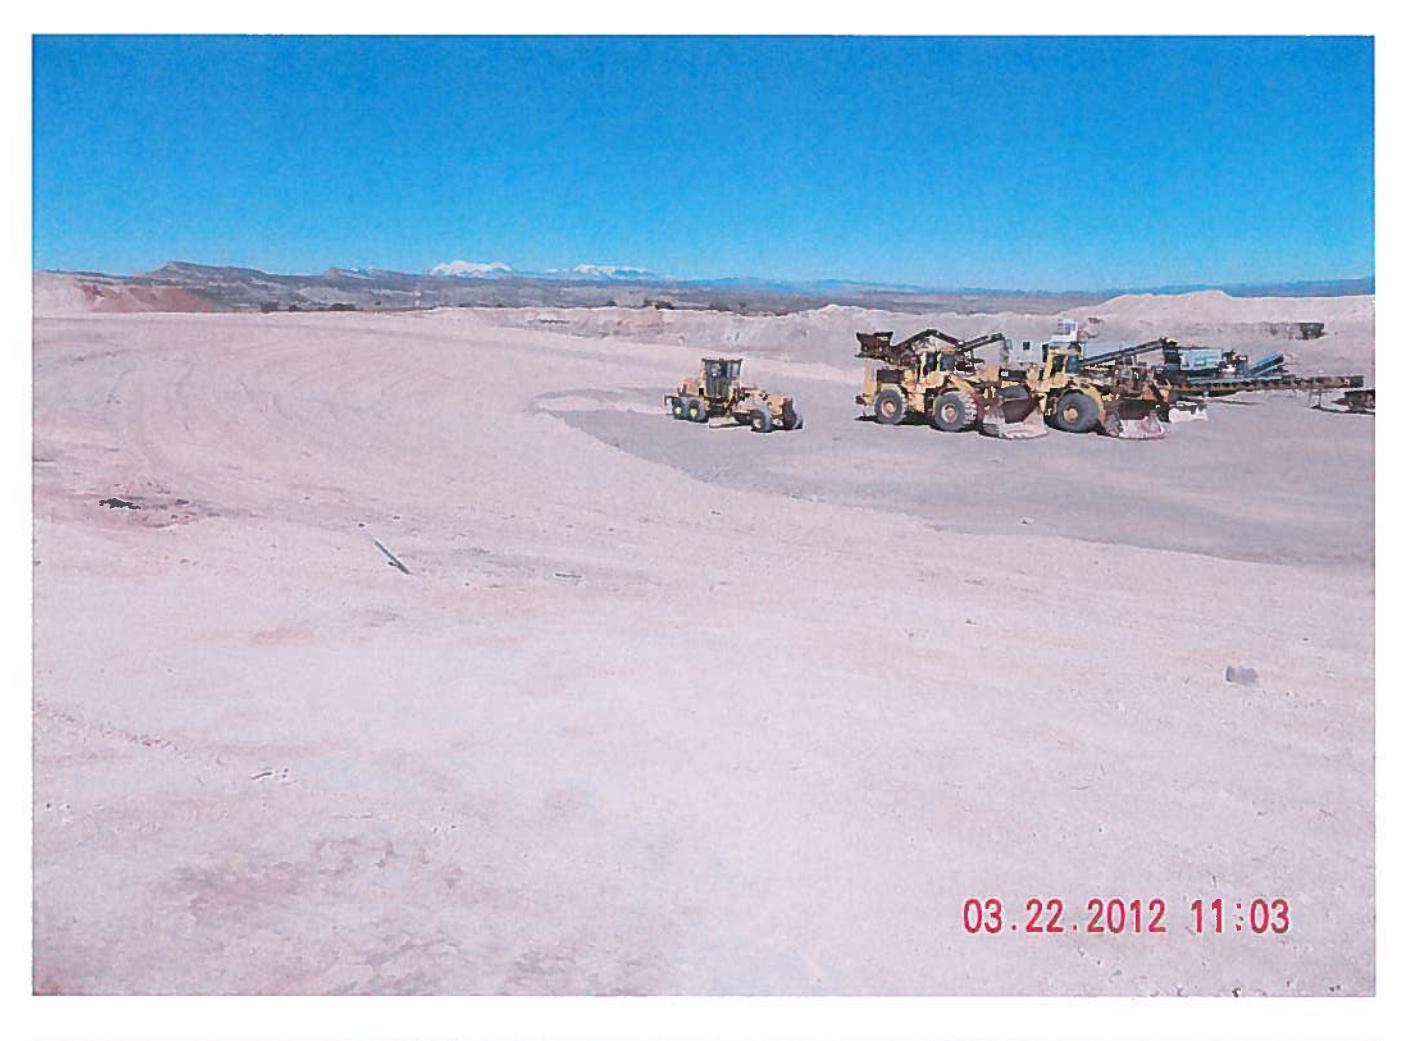
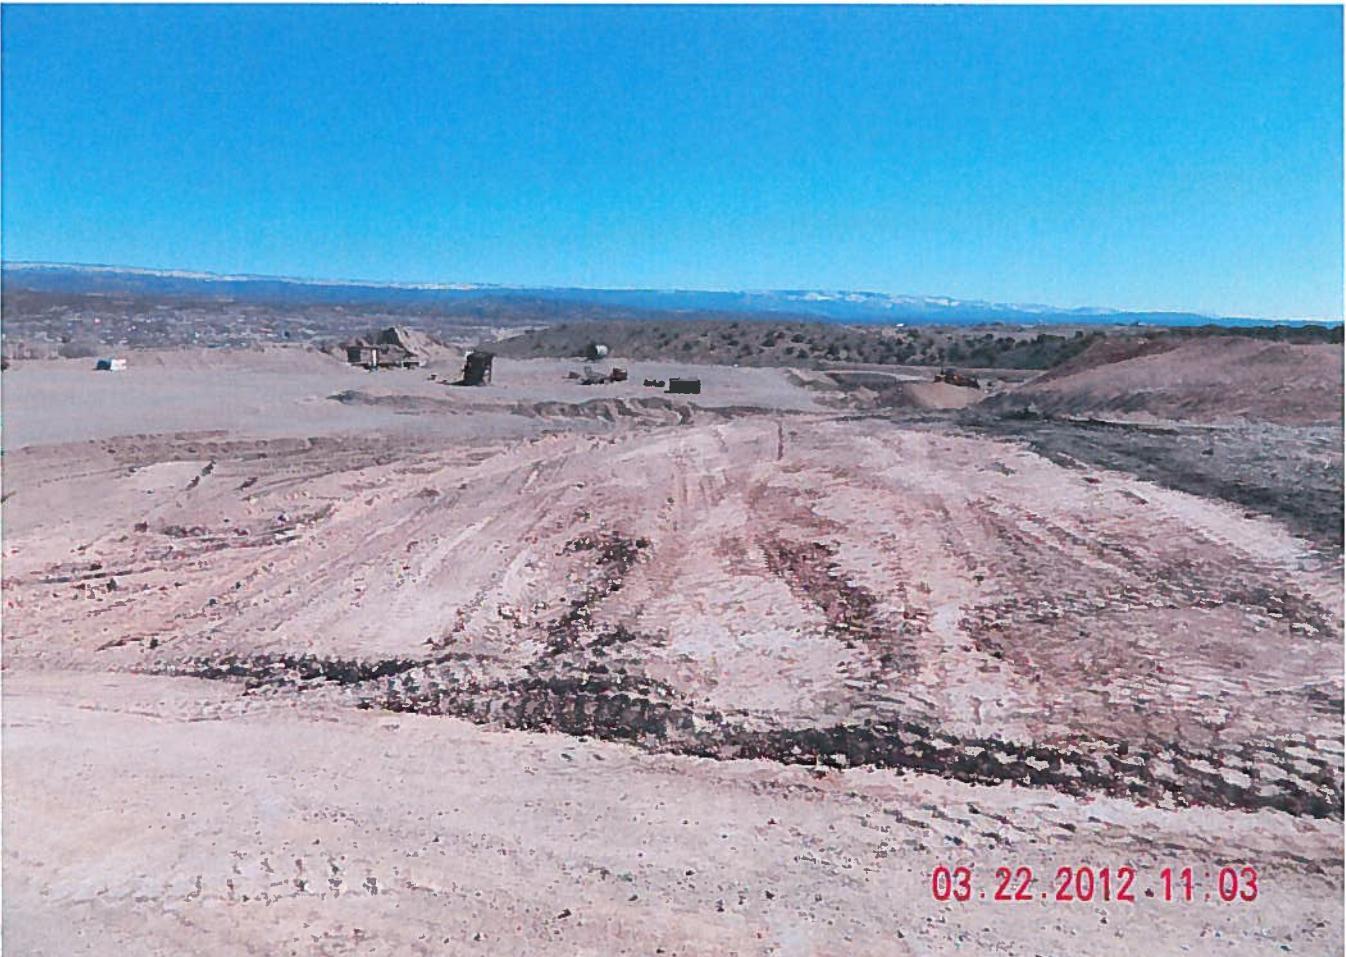
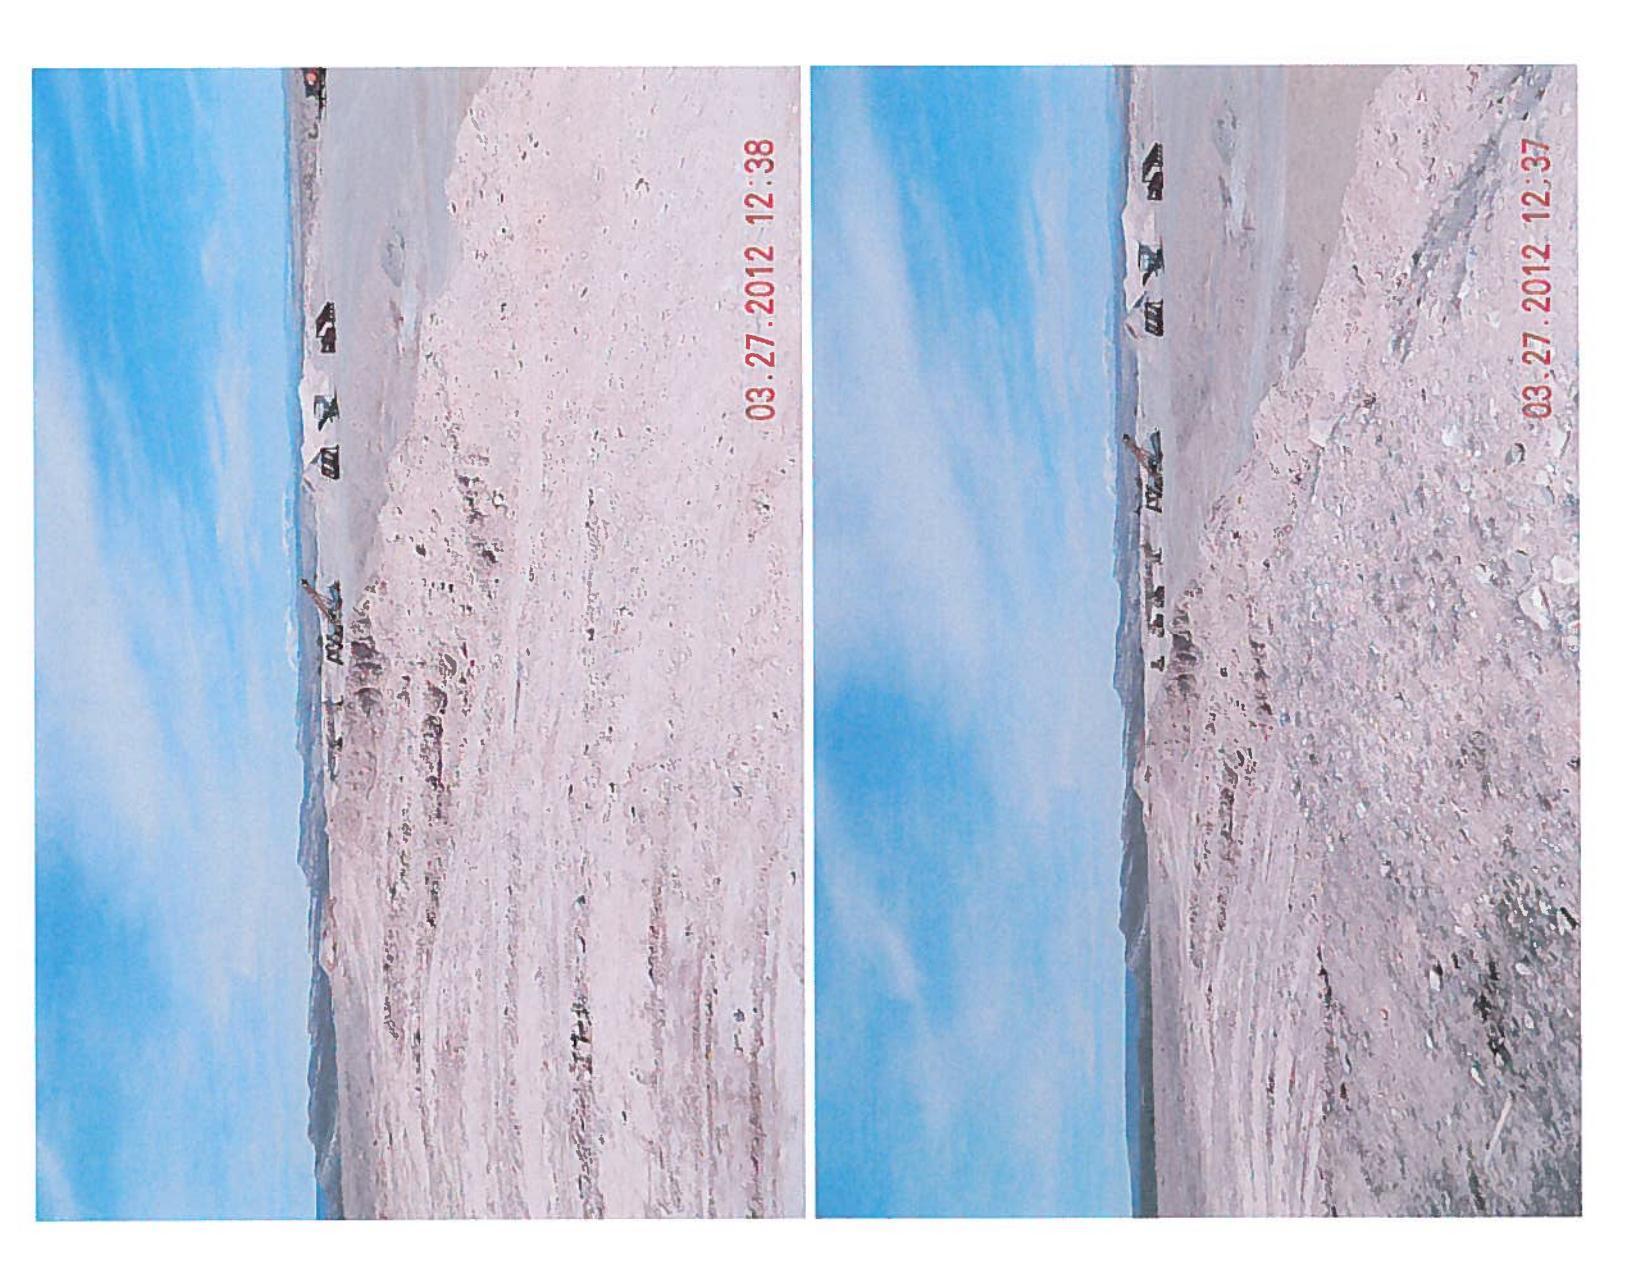
As part of other activities in the area the inspector stopped by the pit to verify the slope reduction was completed. Per the photo-documentation it appears that work on the slopes stopped very shortly after the inspection on March 14, 2012. Approximately half of the 2:1 or steeper slopes are not reclaimed as of this date.

PROBLEM/POSSIBLE VIOLATION: Problem: Operator committed reclamation of slope reduction is incomplete **CORRECTIVE ACTIONS:** Submit photo-documentation of completion of slope reduction on southwest highwall by correction date or submit financial warranty increase as required.

Due to 30 day notice requirements the Division will be sending a Reason to Believe letter out within the next 7 days. The notice is to ensure that if Sutherland Brothers fails to meet the April 18, 2012 deadline for a release request the matter can be heard in May with another possible pending enforcement action.
