MINE NAME:	<b>MINE/PROSPECTING ID#:</b>	MINERAL:	COUNTY:
Wells Pit	M-2006-027	Sand & Gravel	Mesa
INSPECTION TYPE:	INSPECTOR(S):	INSP. DATE:	INSP. TIME:
Monitoring	Travis H. Marshall	March 7, 2012	12:00
OPERATOR:	<b>OPERATOR REPRESENTATIVE:</b>	TYPE OF OPERATION:	
Dirt Merchant	Brian Wells	110c - Construction Limited Impact	
<b>REASON FOR INSPECTION:</b>	BOND CALCULATION TYPE:	BOND AMOUNT:	
Normal I&E Program	Complete Bond	\$9,804.00	
DATE OF COMPLAINT:	POST INSP. CONTACTS:	JOINT INSP. AGENCY:

This inspection was conducted as part of the normal monitoring program established by the Colorado Division of Reclamation, Mining and Safety (Division). The Wells Pit is located approximately 4 miles east of Delta, Colorado off of 1800 Road. The site is an 8.5 acre 110c operation that is currently active.

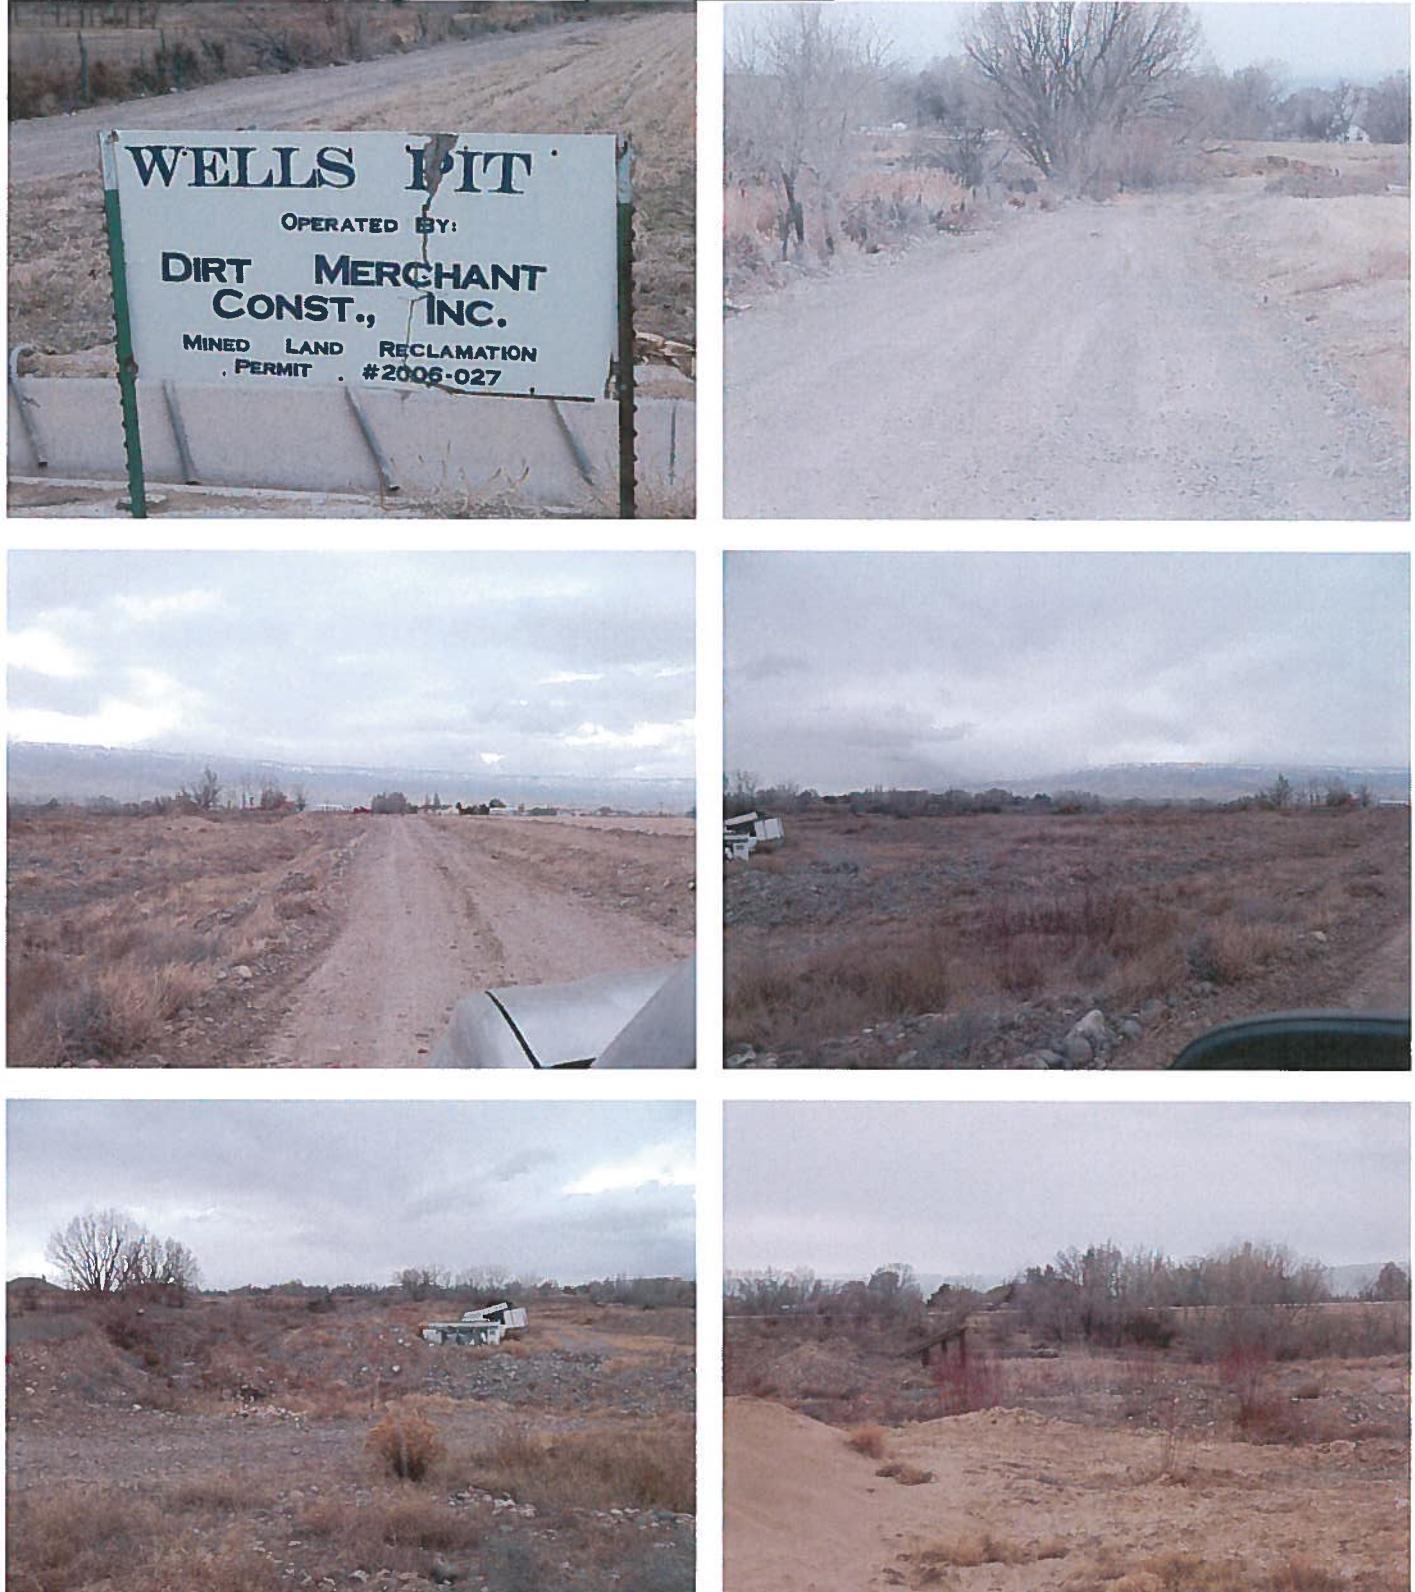
## **PHOTOGRAPHS**

Material excavating equipment and material processing equipment was observed in the permit area.

A noxious and/or problematic weed infestation was observed within the affected area. The infestation, if not controlled, will most likely hinder and/or delay successful reclamation of this site and contribute to off-site spreading and establishment of these weeds. The approved weed control plan is either not being implemented or is not effective in its current application. Please indicate what measures will be taken to improve weed control and, if appropriate, submit a technical revision to incorporate these measures into the permit. Weed infestation is noted as a problem. Significant progress toward control of on-site weeds must be demonstrated within three years to avoid potential Board action.

**PROBLEM/POSSIBLE VIOLATION:** Problem: There are state-listed noxious weeds present on site. This is a problem for failure to employ weed control methods for state listed noxious weed species within the permitted area, and to reduce the spread of weeds to nearby areas as required by Section 3.1.10 (6) of the rule. **CORRECTIVE ACTIONS:** Implement approved weed control plan and provide proof to the Division that this has been done. If a weed control plan is not already in place, the operator shall develop a weed control and management plan in accordance with Section 3.1.10 (6) of the Rule. This plan should be developed in consultation with the county extension agency, or weed control district office and should include specific control measures to be applied, a schedule for when control measures will be applied and a post-treatment monitoring plan. This weed control plan shall be submitted to the Division as a Technical Revision to the approved plan with the appropriate Technical Revision fee of \$216.00 by the corrective action date. **CORRECTIVE ACTION DUE DATE:** 5/15/12
