The Division of Reclamation, Mining and Safety has conducted an inspection of the mining operation noted below. This report documents observations concerning compliance with the terms of the permit and applicable rules and regulations of the Mined Land Reclamation Board.

MINE NAME:	MINE/PROSPECTING ID#:	MINERAL:	COUNTY:
Incas Mine	M-1986-076	Gold and silver	La Plata
INSPECTION TYPE:	INSPECTOR(S):	INSP. DATE:	INSP. TIME:
Monitoring	Kate A. Pickford	November 8, 2012	10:00
OPERATOR:	OPERATOR REPRESENTATIVE:	TYPE OF OPERATION:	
DGMC	Scott Martin	110d - Designated Limited Impact	
REASON FOR INSPECTION:	BOND CALCULATION TYPE:	BOND AMOUNT:	
Normal I&E Program	Complete Bond	\$18,033.00	
DATE OF COMPLAINT:	POST INSP. CONTACTS:	JOINT INSP. AGENCY:	
NA	None /	None	
WEATHER:	INSPECTOR'S SIGNATURE:	SIGNATURE DATE:	
Clear	Say Mill	November 21, 2012

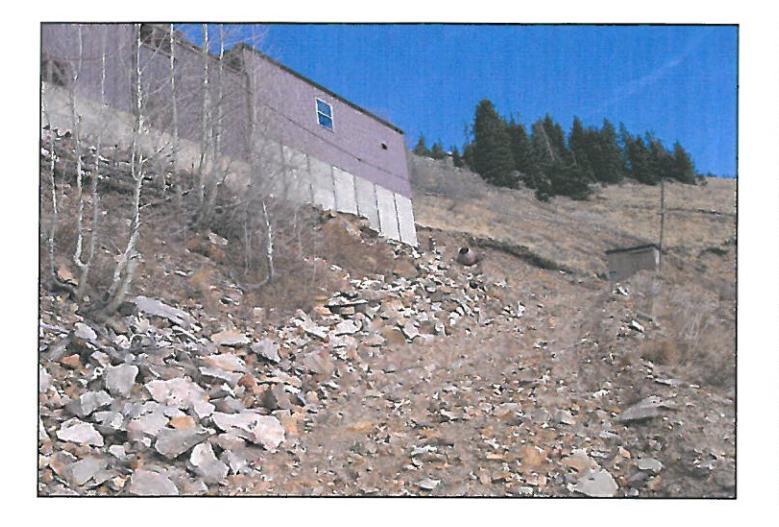
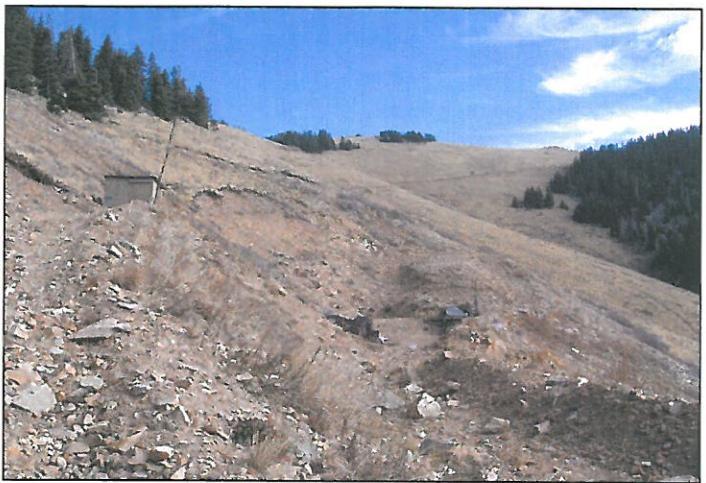
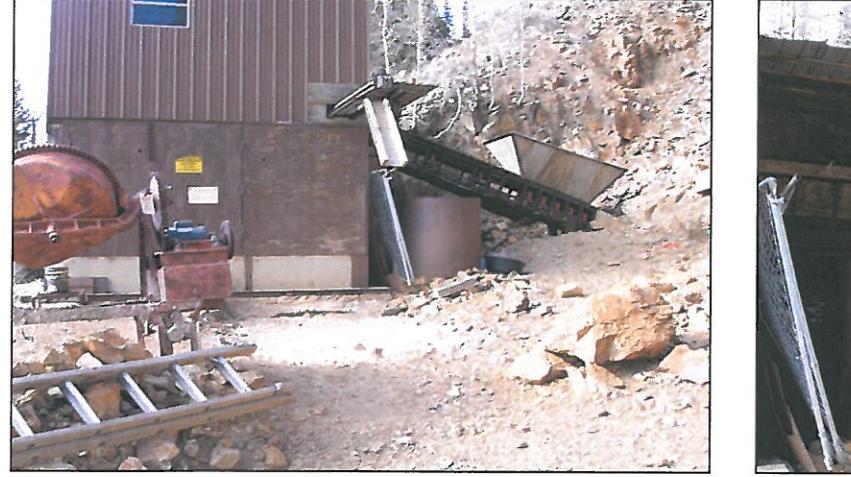
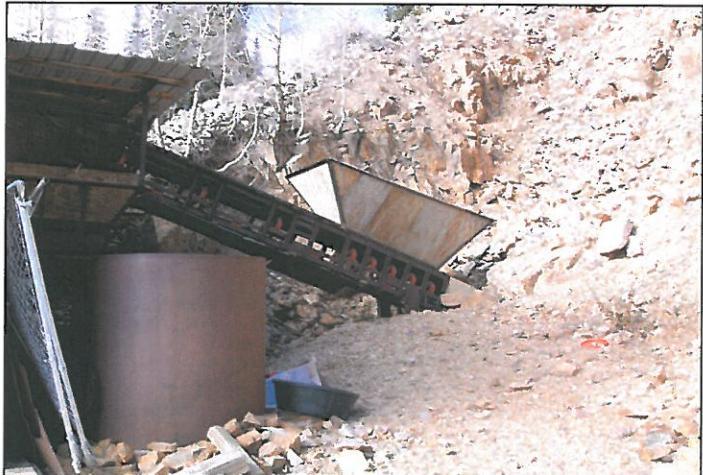
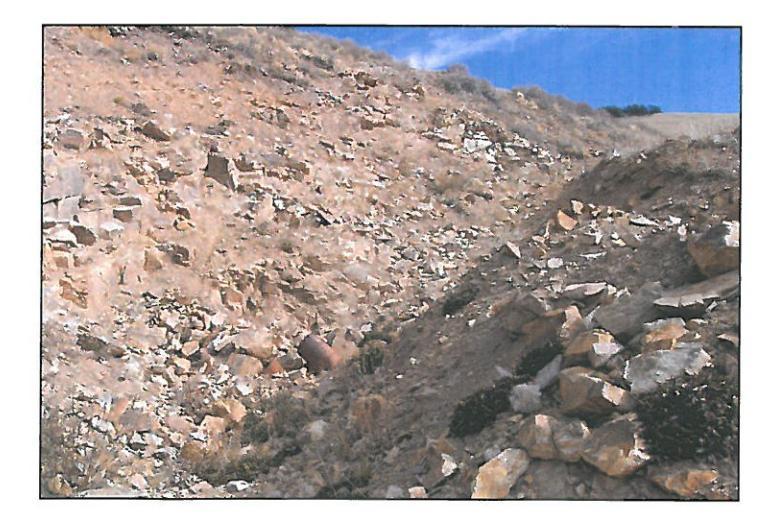
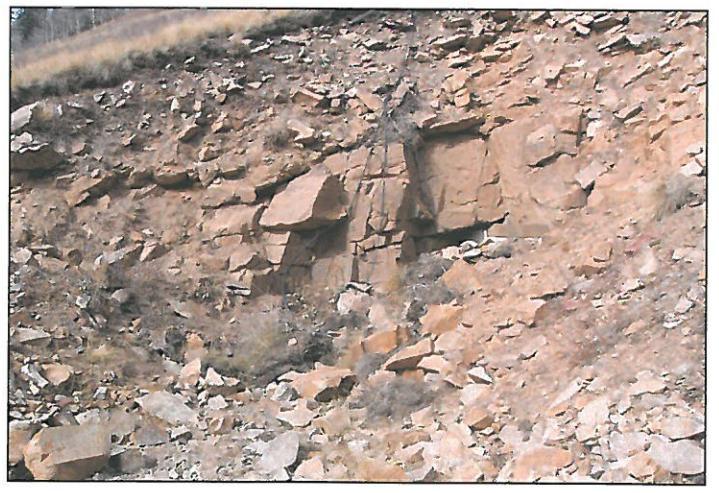
PHOTOGRAPHS

The condition of the site has changed little since the previous inspection. The mill could not be accessed due to the company representative not have a key for the lock on the door, but there is no indication that the mill has been operated in the recent past.

The portal is mostly blocked by rock that has sloughed off from the rock face about it. Water samples were collected by the operator representative at the time of the inspection from the portal and from the river at the bridge crossing.
