Crystal River at Riverfront Park Restoration and Efficiency Project Roaring Fork Conservancy

Water Plan Grant Application

March 2022 Board Meeting

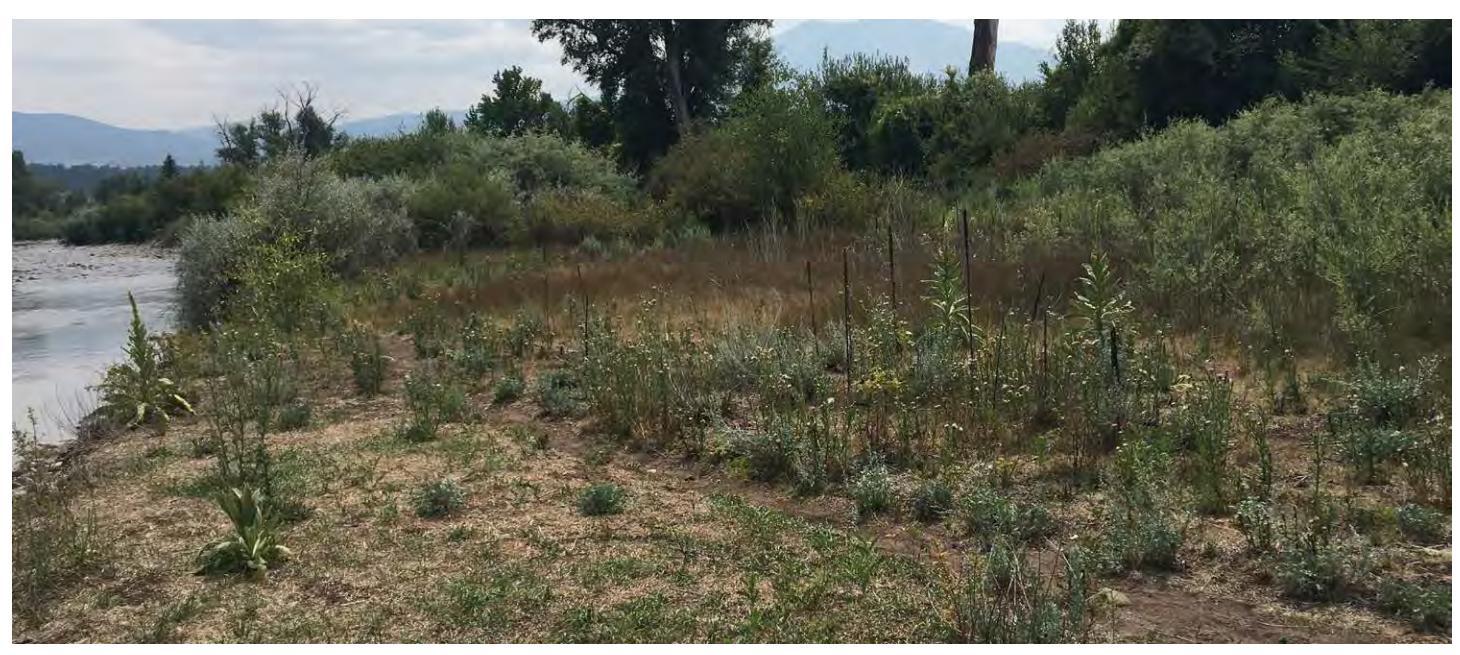
Image 4–1 This image demonstrates highly degraded ecologic conditions near the river on the left side of the photograph. This is an area recommended for riparian creation. Near the center of the photo, healthy forbes indicate an intact wetland which could be enhanced.

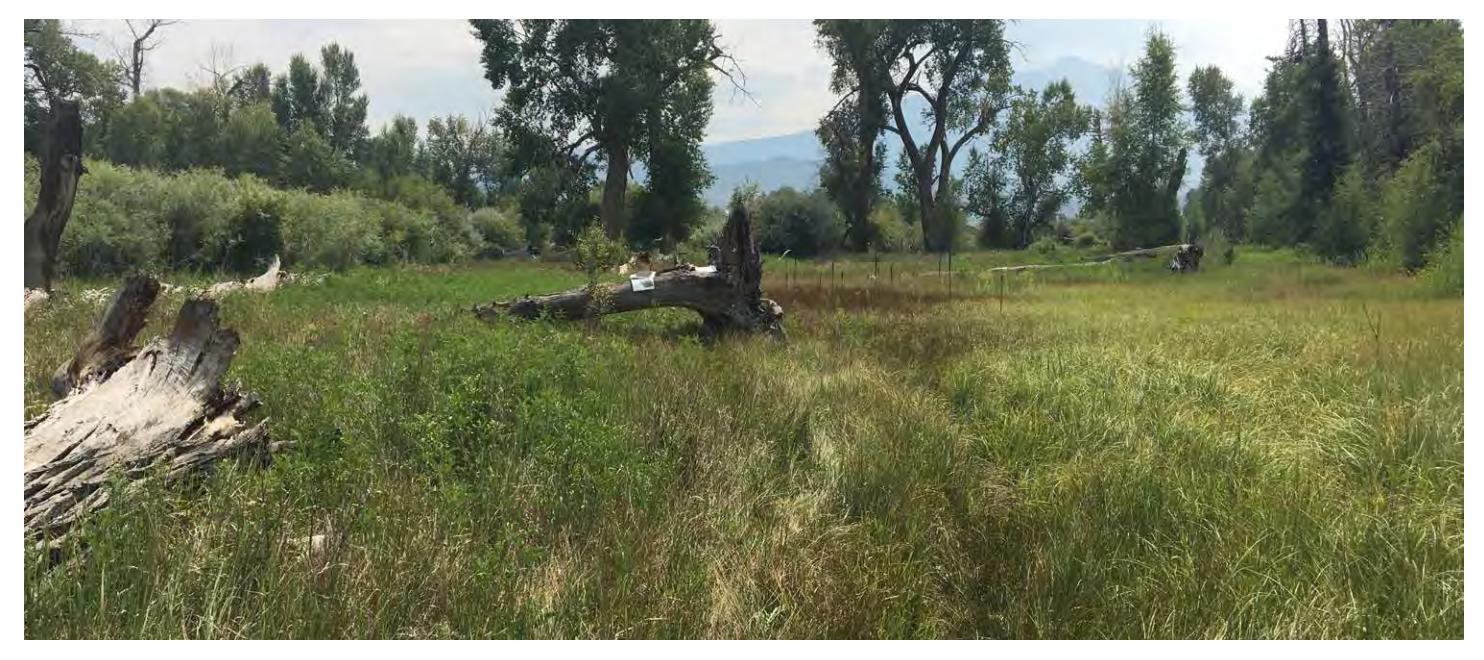
Image 4–2 A high quality wetland can be seen on the right side of the image. This area would be recommended for wetland preservation. On the left side of the image, closer to the Crystal River there is an area recommended for wetland creation

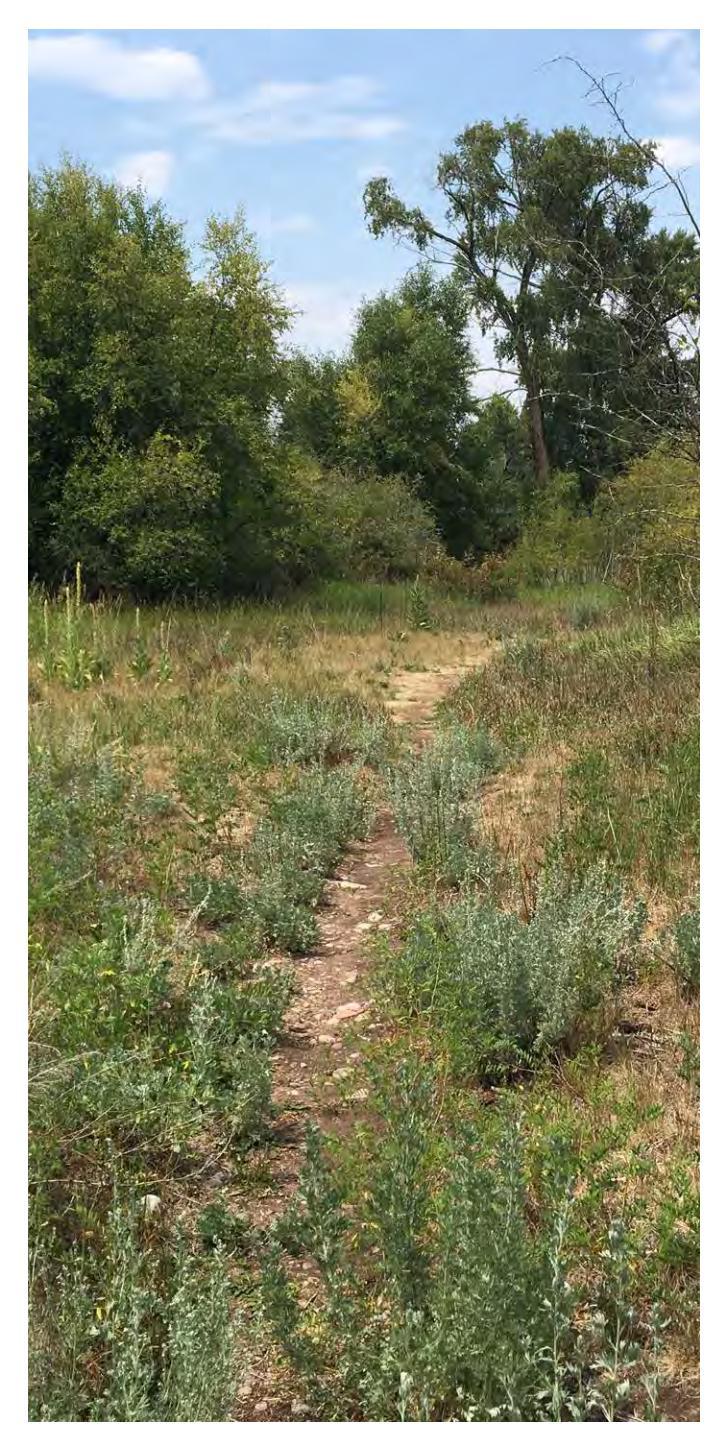
Image 4–3 This location of the assessment area has mature trees and shrubs suitable for riparian preservation. The herbaceous ground cover is mostly noxious weeds making it a candidate for riparian creation

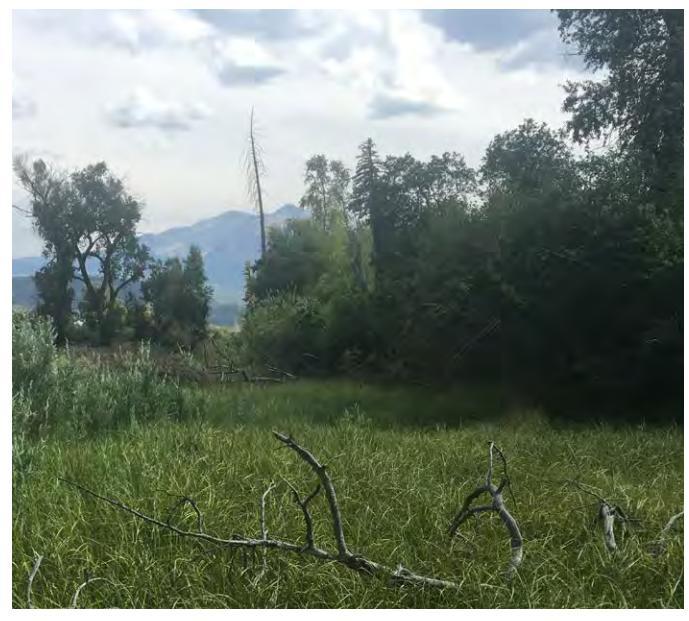
Image 4-4 An example of healthy PER wetlands and riparian shrublands. Both areas are recommended for preservation

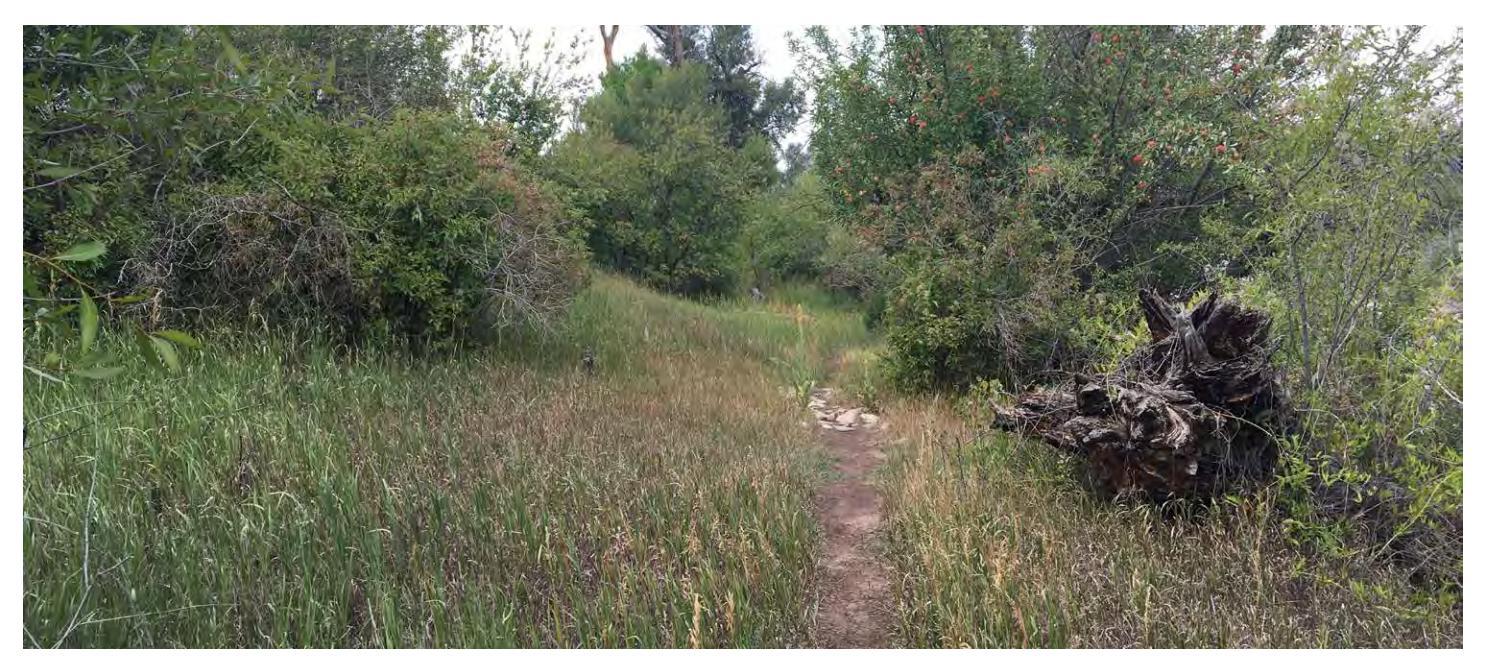
Image 4–5 The shrubs in this image are in good health and these woody vegetated zones are recommended for preservation. The wide swaths of brome in the foreground of the photograph are an opportunity for riparian enhancement.

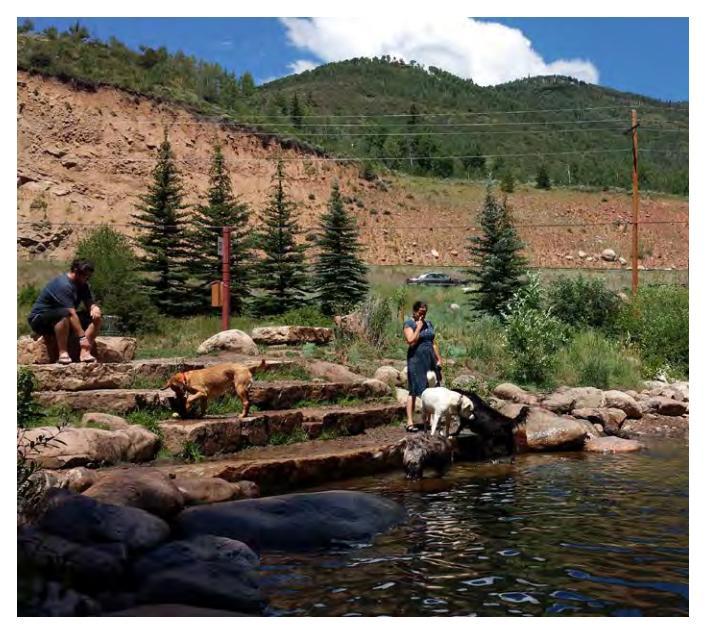
Image 4-6 An example of a bank repaired with boulders and steps

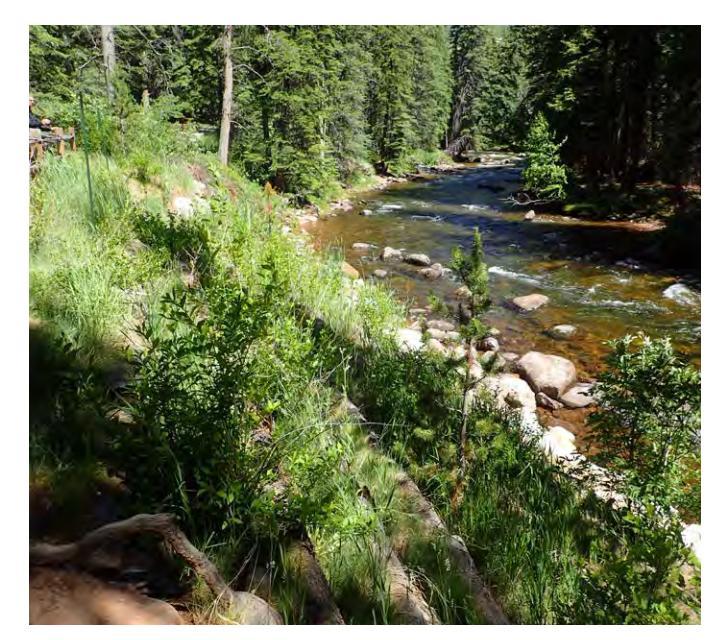
Image 4-7 An example of a bank repaired with vegetation

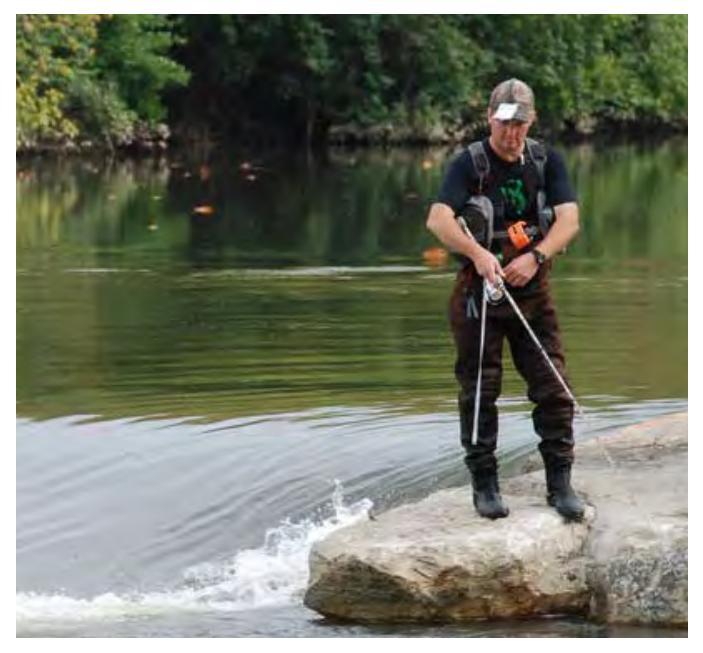
Image 5-12 Example of a durable surface used for river access, helping to prevent erosion, fisheries health and bank destabilization
places on the site that help create a unique narrative. The project team recommends ongoing collaboration to create the educational and interpretive programming. In conjunction with the interpretive elements, an outdoor classroom area is a is a key recommendation of this report.

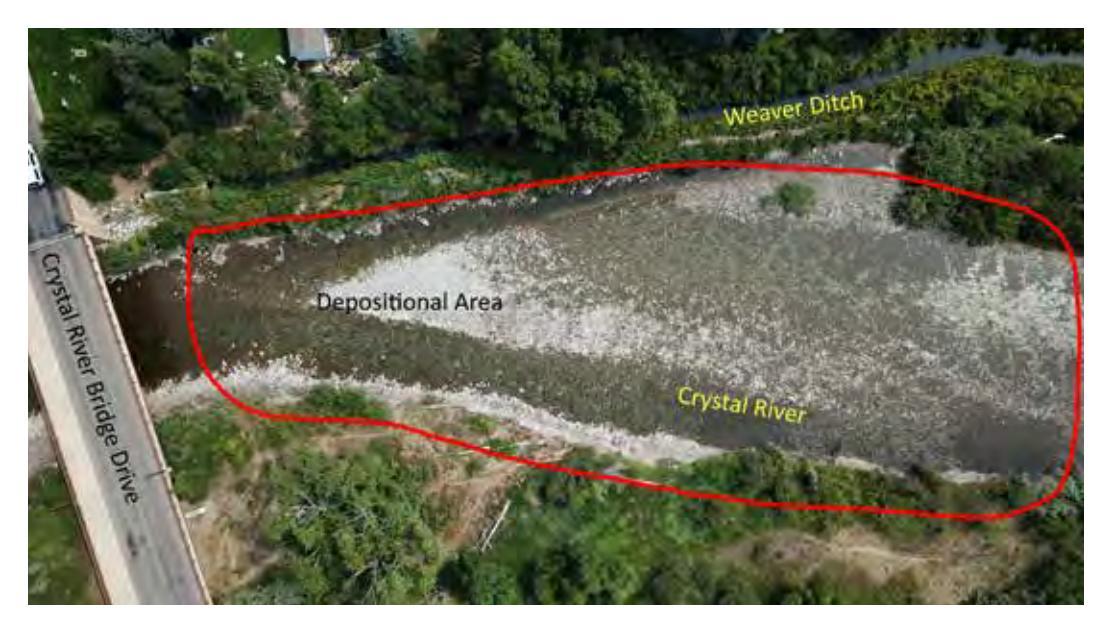
Image 3-2 Alluvium deposition area

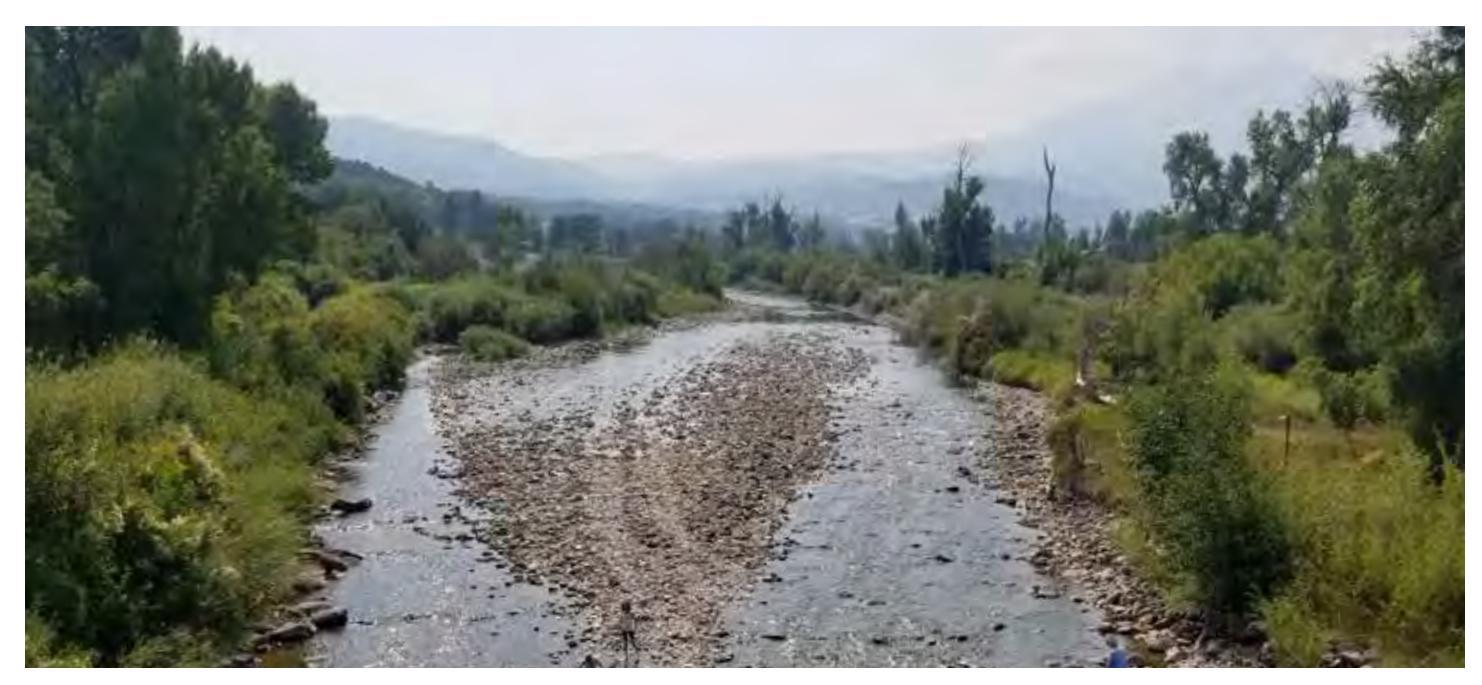
Image 3-7 The wide shallow course of the river through the project area seasonally limits fish habitat and angling potential

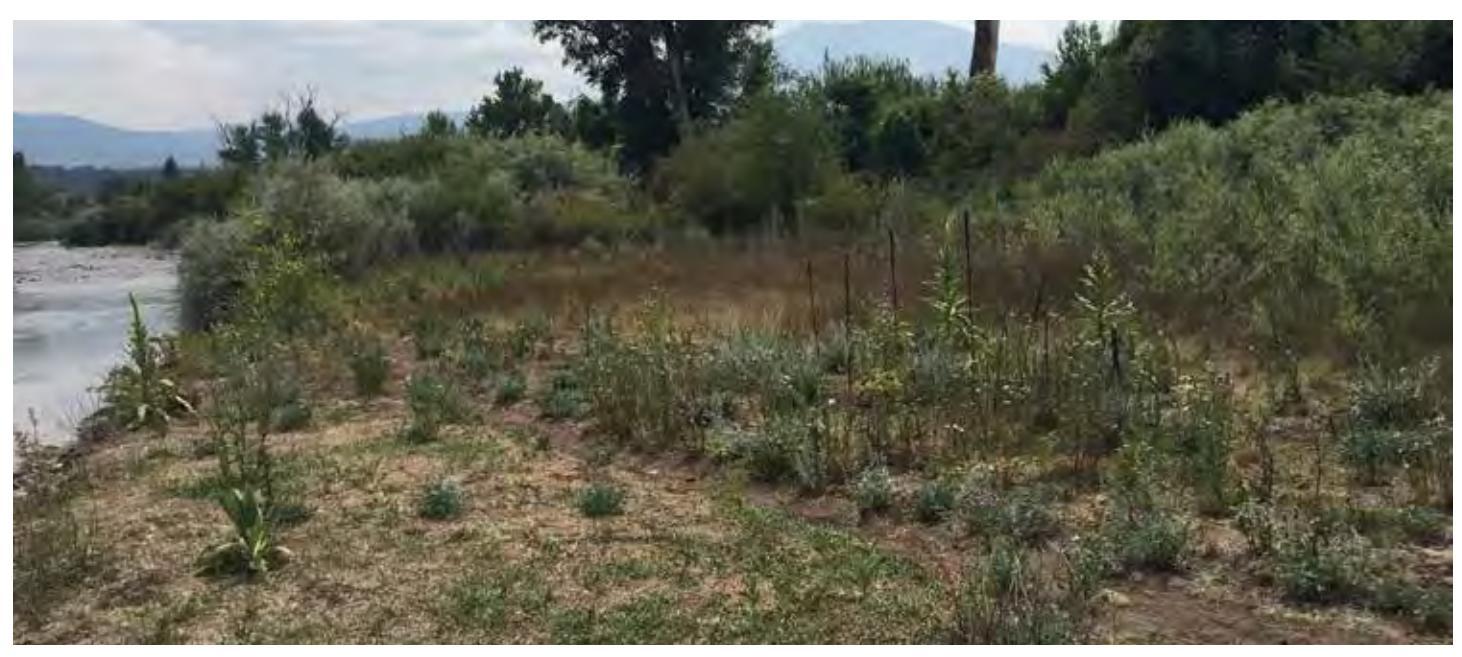
Image 4–1 This image demonstrates highly degraded ecologic conditions near the river on the left side of the photograph. This is an area recommended for riparian creation. Near the center of the photo, healthy forbes indicate an intact wetland which could be enhanced.

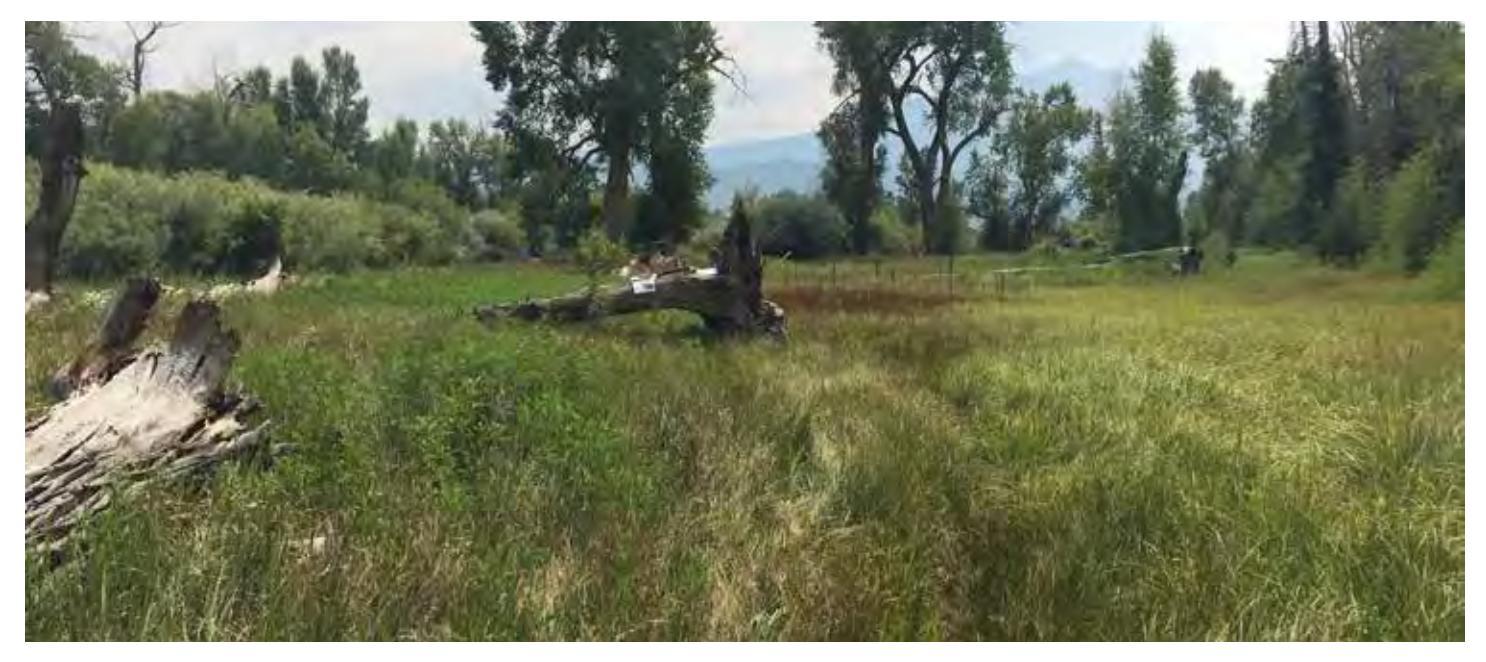
Image 4-2 A high quality wetland can be seen on the right side of the image. This area would be recommended for wetland preservation. On the left side of the image, closer to the Crystal River there is an area recommended for wetland creation

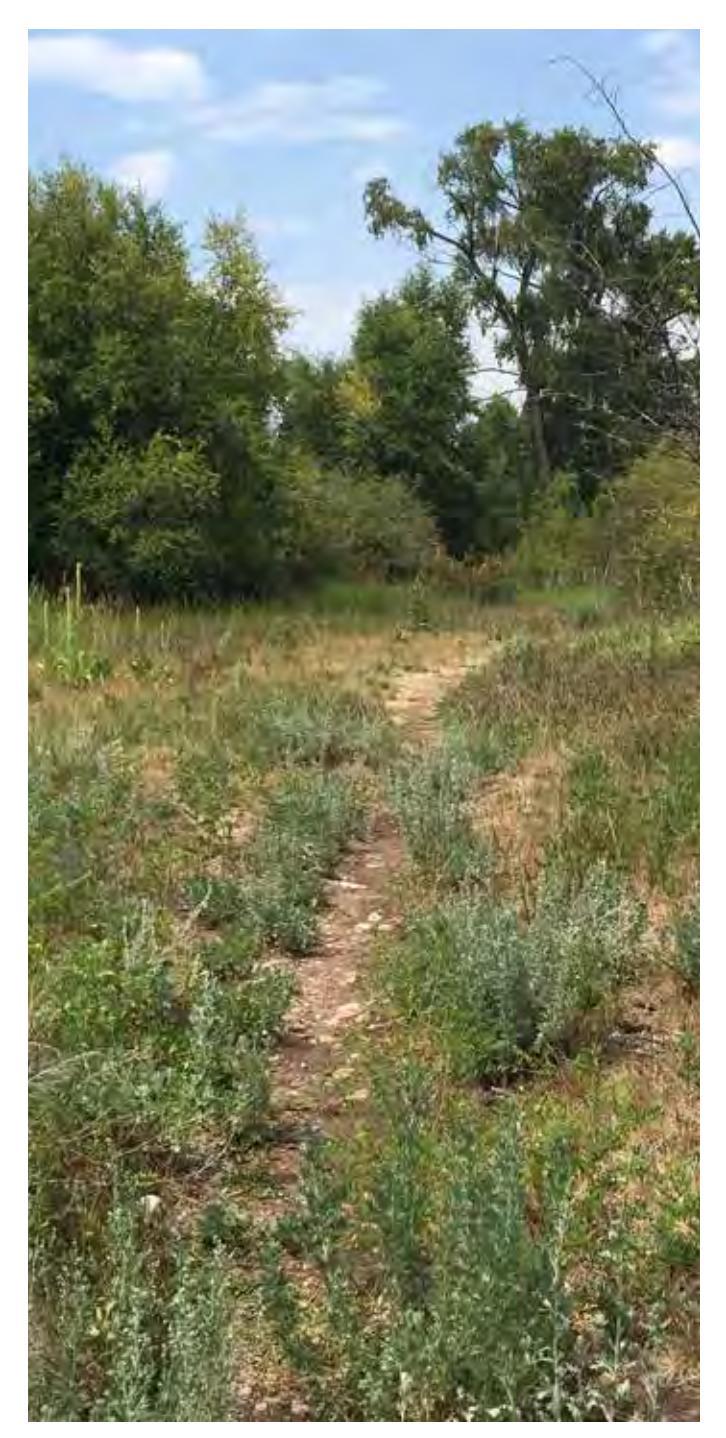
Image 4–3 This location of the assessment area has mature trees and shrubs suitable for riparian preservation. The herbaceous ground cover is mostly noxious weeds making it a candidate for riparian creation

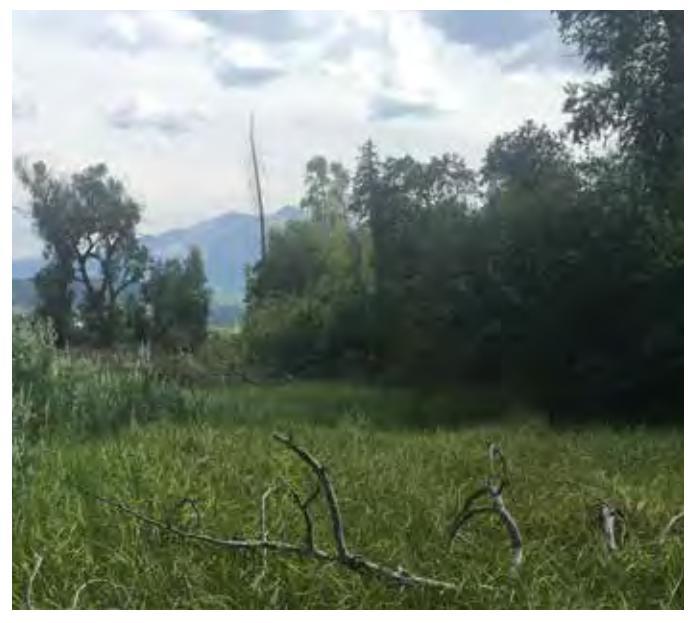
Image 4-4 An example of healthy PER wetlands and riparian shrublands. Both areas are recommended for preservation

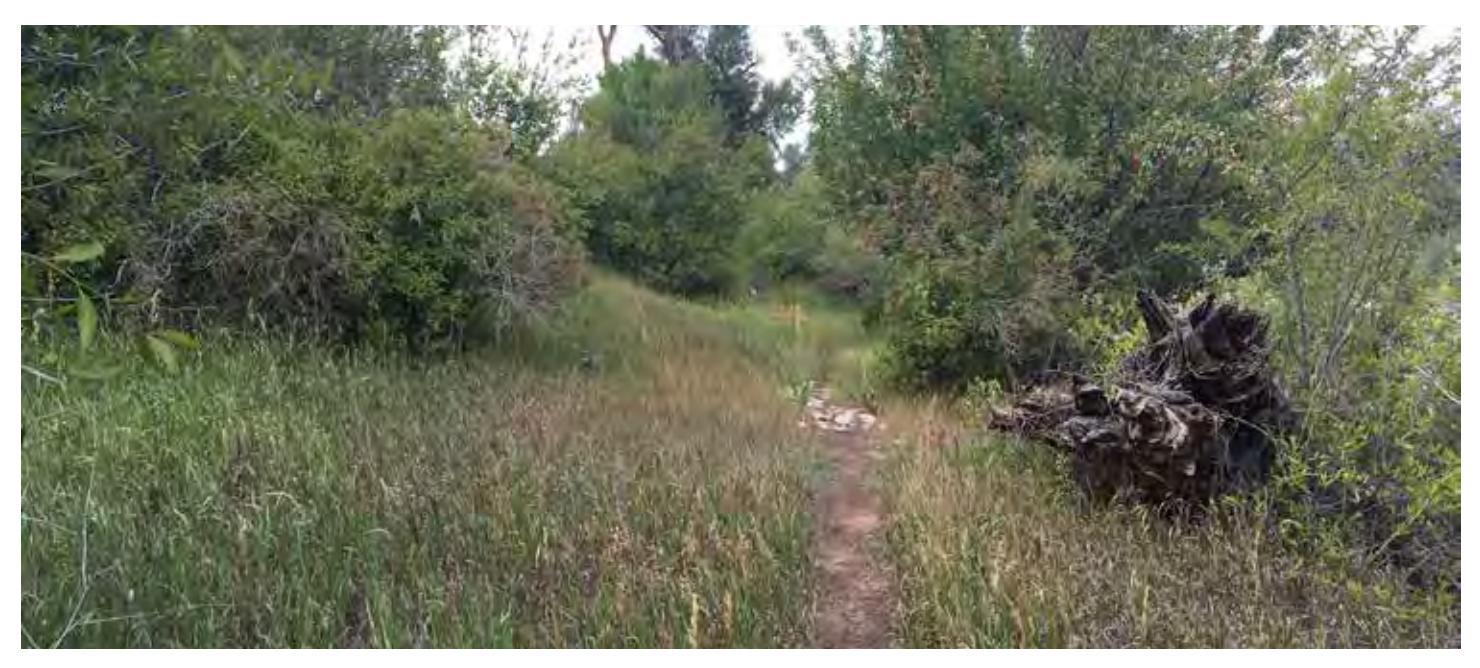
Image 4–5 The shrubs in this image are in good health and these woody vegetated zones are recommended for preservation. The wide swaths of brome in the foreground of the photograph are an opportunity for riparian enhancement.

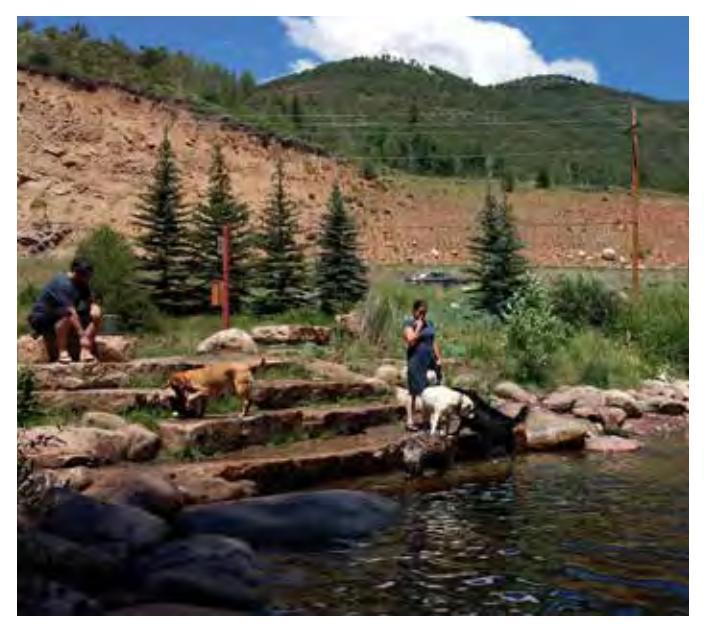
Image 4-6 An example of a bank repaired with boulders and steps

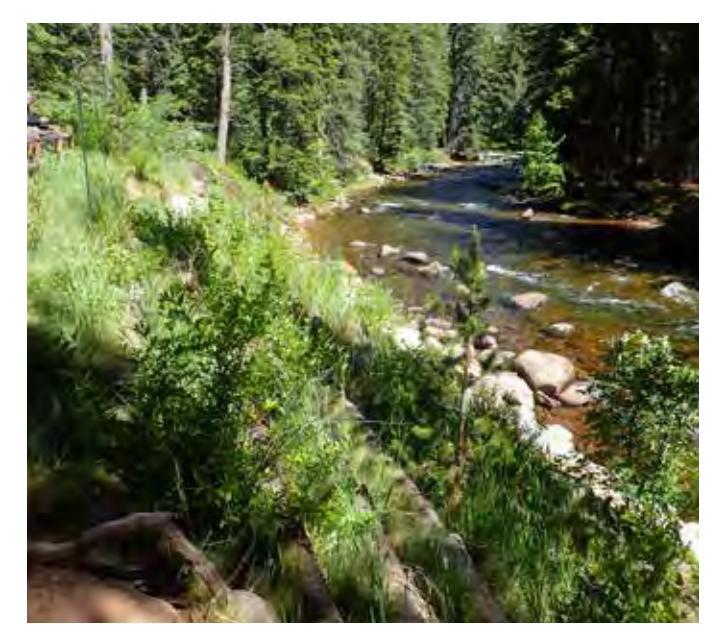
Image 4-7 An example of a bank repaired with vegetation

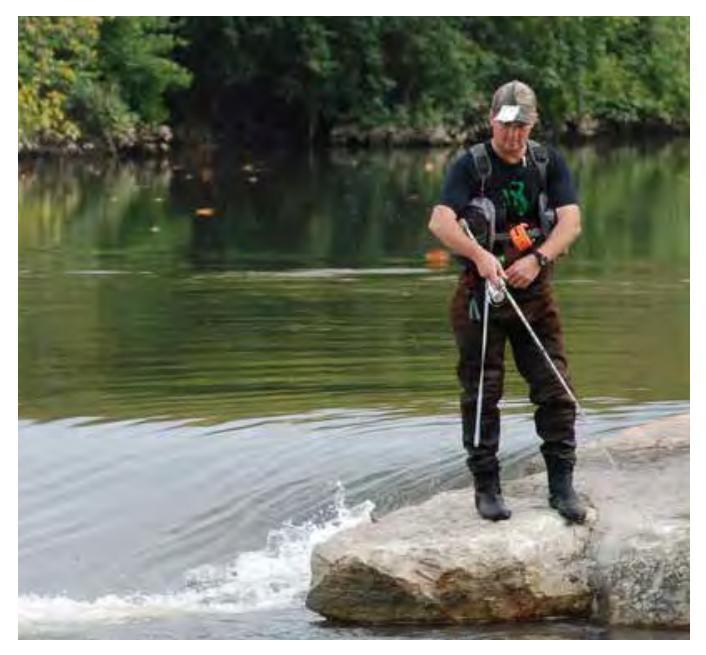
Image 5-12 Example of a durable surface used for river access, helping to prevent erosion, fisheries health and bank destabilization

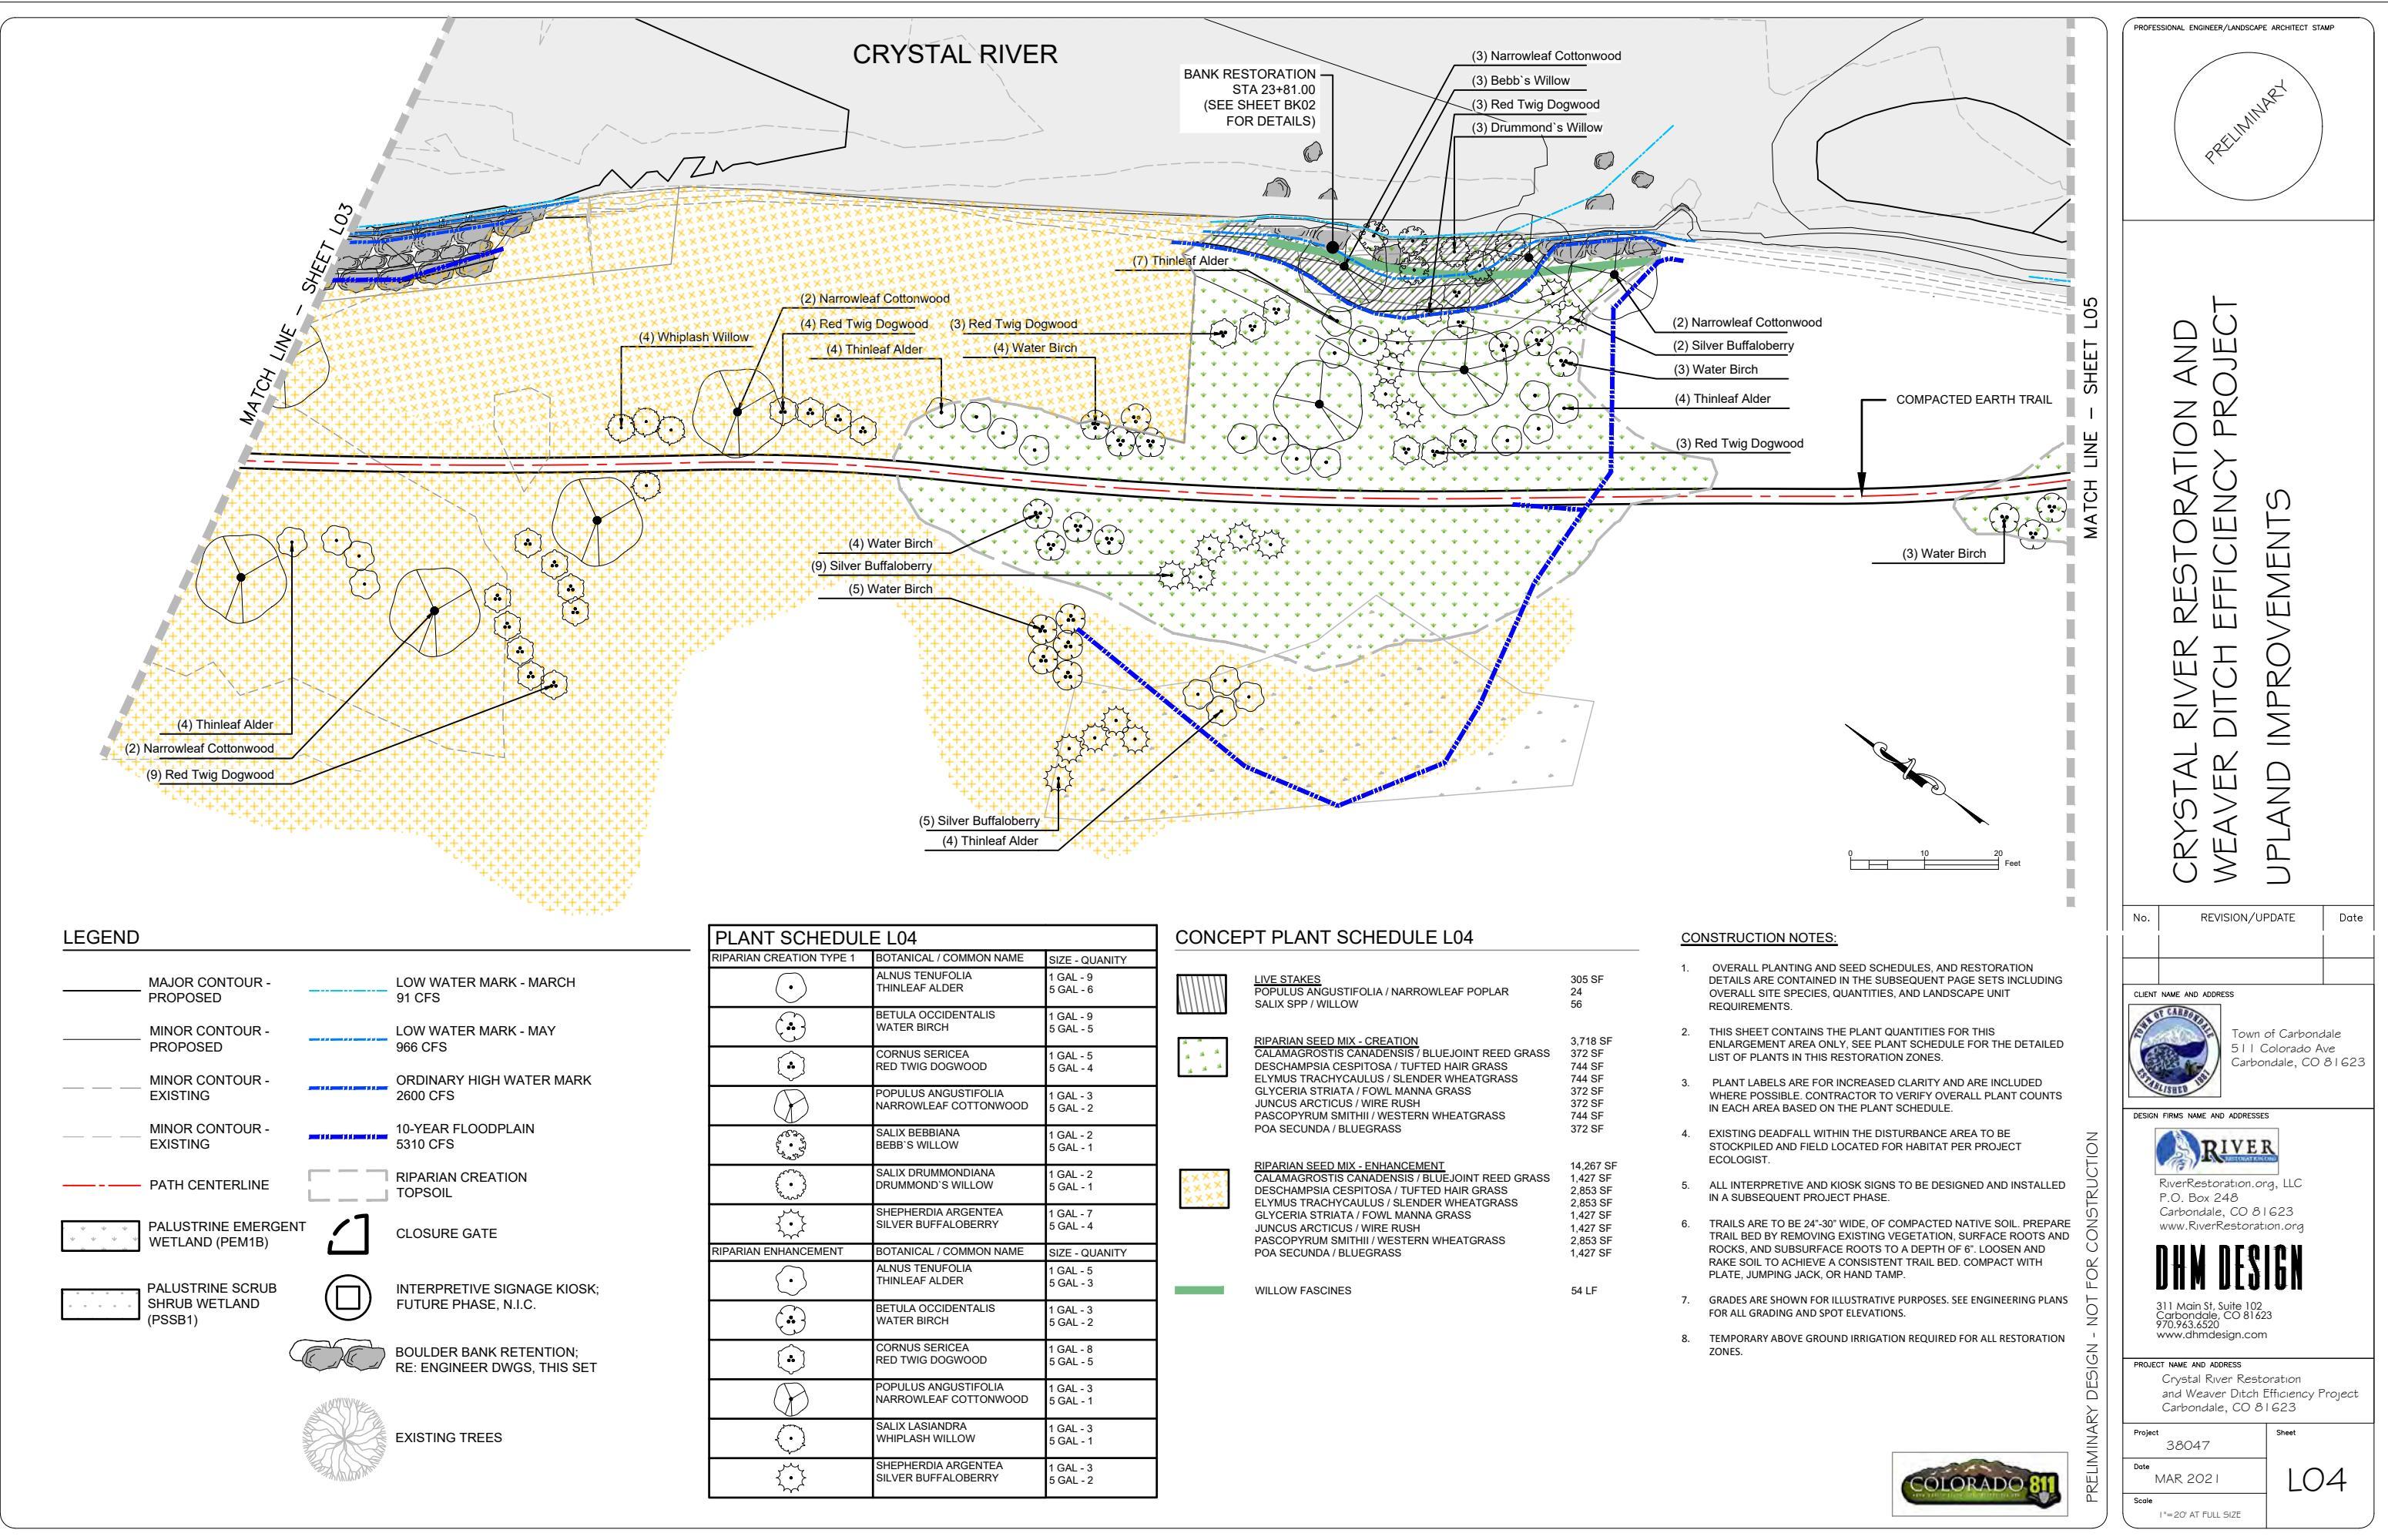
N	MAJOR CONTOUR - PROPOSED		LOW WATER MARK - MARCH 91 CFS
P	MINOR CONTOUR - PROPOSED		LOW WATER MARK - MAY 966 CFS
F	MINOR CONTOUR - EXISTING		ORDINARY HIGH WATER MARK 2600 CFS
P	MINOR CONTOUR - EXISTING	anna i fanns i fanns i fan anna	10-YEAR FLOODPLAIN 5310 CFS
F	PATH CENTERLINE		RIPARIAN CREATION TOPSOIL
• • • • F • • • • • V	PALUSTRINE EMERGEN WETLAND (PEM1B)		CLOSURE GATE
F S ((PALUSTRINE SCRUB SHRUB WETLAND PSSB1)		INTERPRETIVE SIGNAGE KIOSK; FUTURE PHASE, N.I.C.
	(BOULDER BANK RETENTION; RE: ENGINEER DWGS, THIS SET
			EXISTING TREES

$\langle \rangle$	<u>LIVE STAKES</u> POPULUS ANGUSTIFOLIA / NARROWLEAF POPLAR SALIX SPP / WILLOW	305 SF 24 56
*	RIPARIAN SEED MIX - CREATION CALAMAGROSTIS CANADENSIS / BLUEJOINT REED GRASS DESCHAMPSIA CESPITOSA / TUFTED HAIR GRASS ELYMUS TRACHYCAULUS / SLENDER WHEATGRASS GLYCERIA STRIATA / FOWL MANNA GRASS JUNCUS ARCTICUS / WIRE RUSH PASCOPYRUM SMITHII / WESTERN WHEATGRASS POA SECUNDA / BLUEGRASS	3,718 SF 372 SF 744 SF 744 SF 372 SF 372 SF 744 SF 372 SF
20X X	RIPARIAN SEED MIX - ENHANCEMENT CALAMAGROSTIS CANADENSIS / BLUEJOINT REED GRASS DESCHAMPSIA CESPITOSA / TUFTED HAIR GRASS ELYMUS TRACHYCAULUS / SLENDER WHEATGRASS GLYCERIA STRIATA / FOWL MANNA GRASS JUNCUS ARCTICUS / WIRE RUSH PASCOPYRUM SMITHILI / WESTERN WHEATGRASS POA SECUNDA / BLUEGRASS	14,267 SF 1,427 SF 2,853 SF 2,853 SF 1,427 SF 1,427 SF 2,853 SF 1,427 SF
	WILLOW FASCINES	54 LF

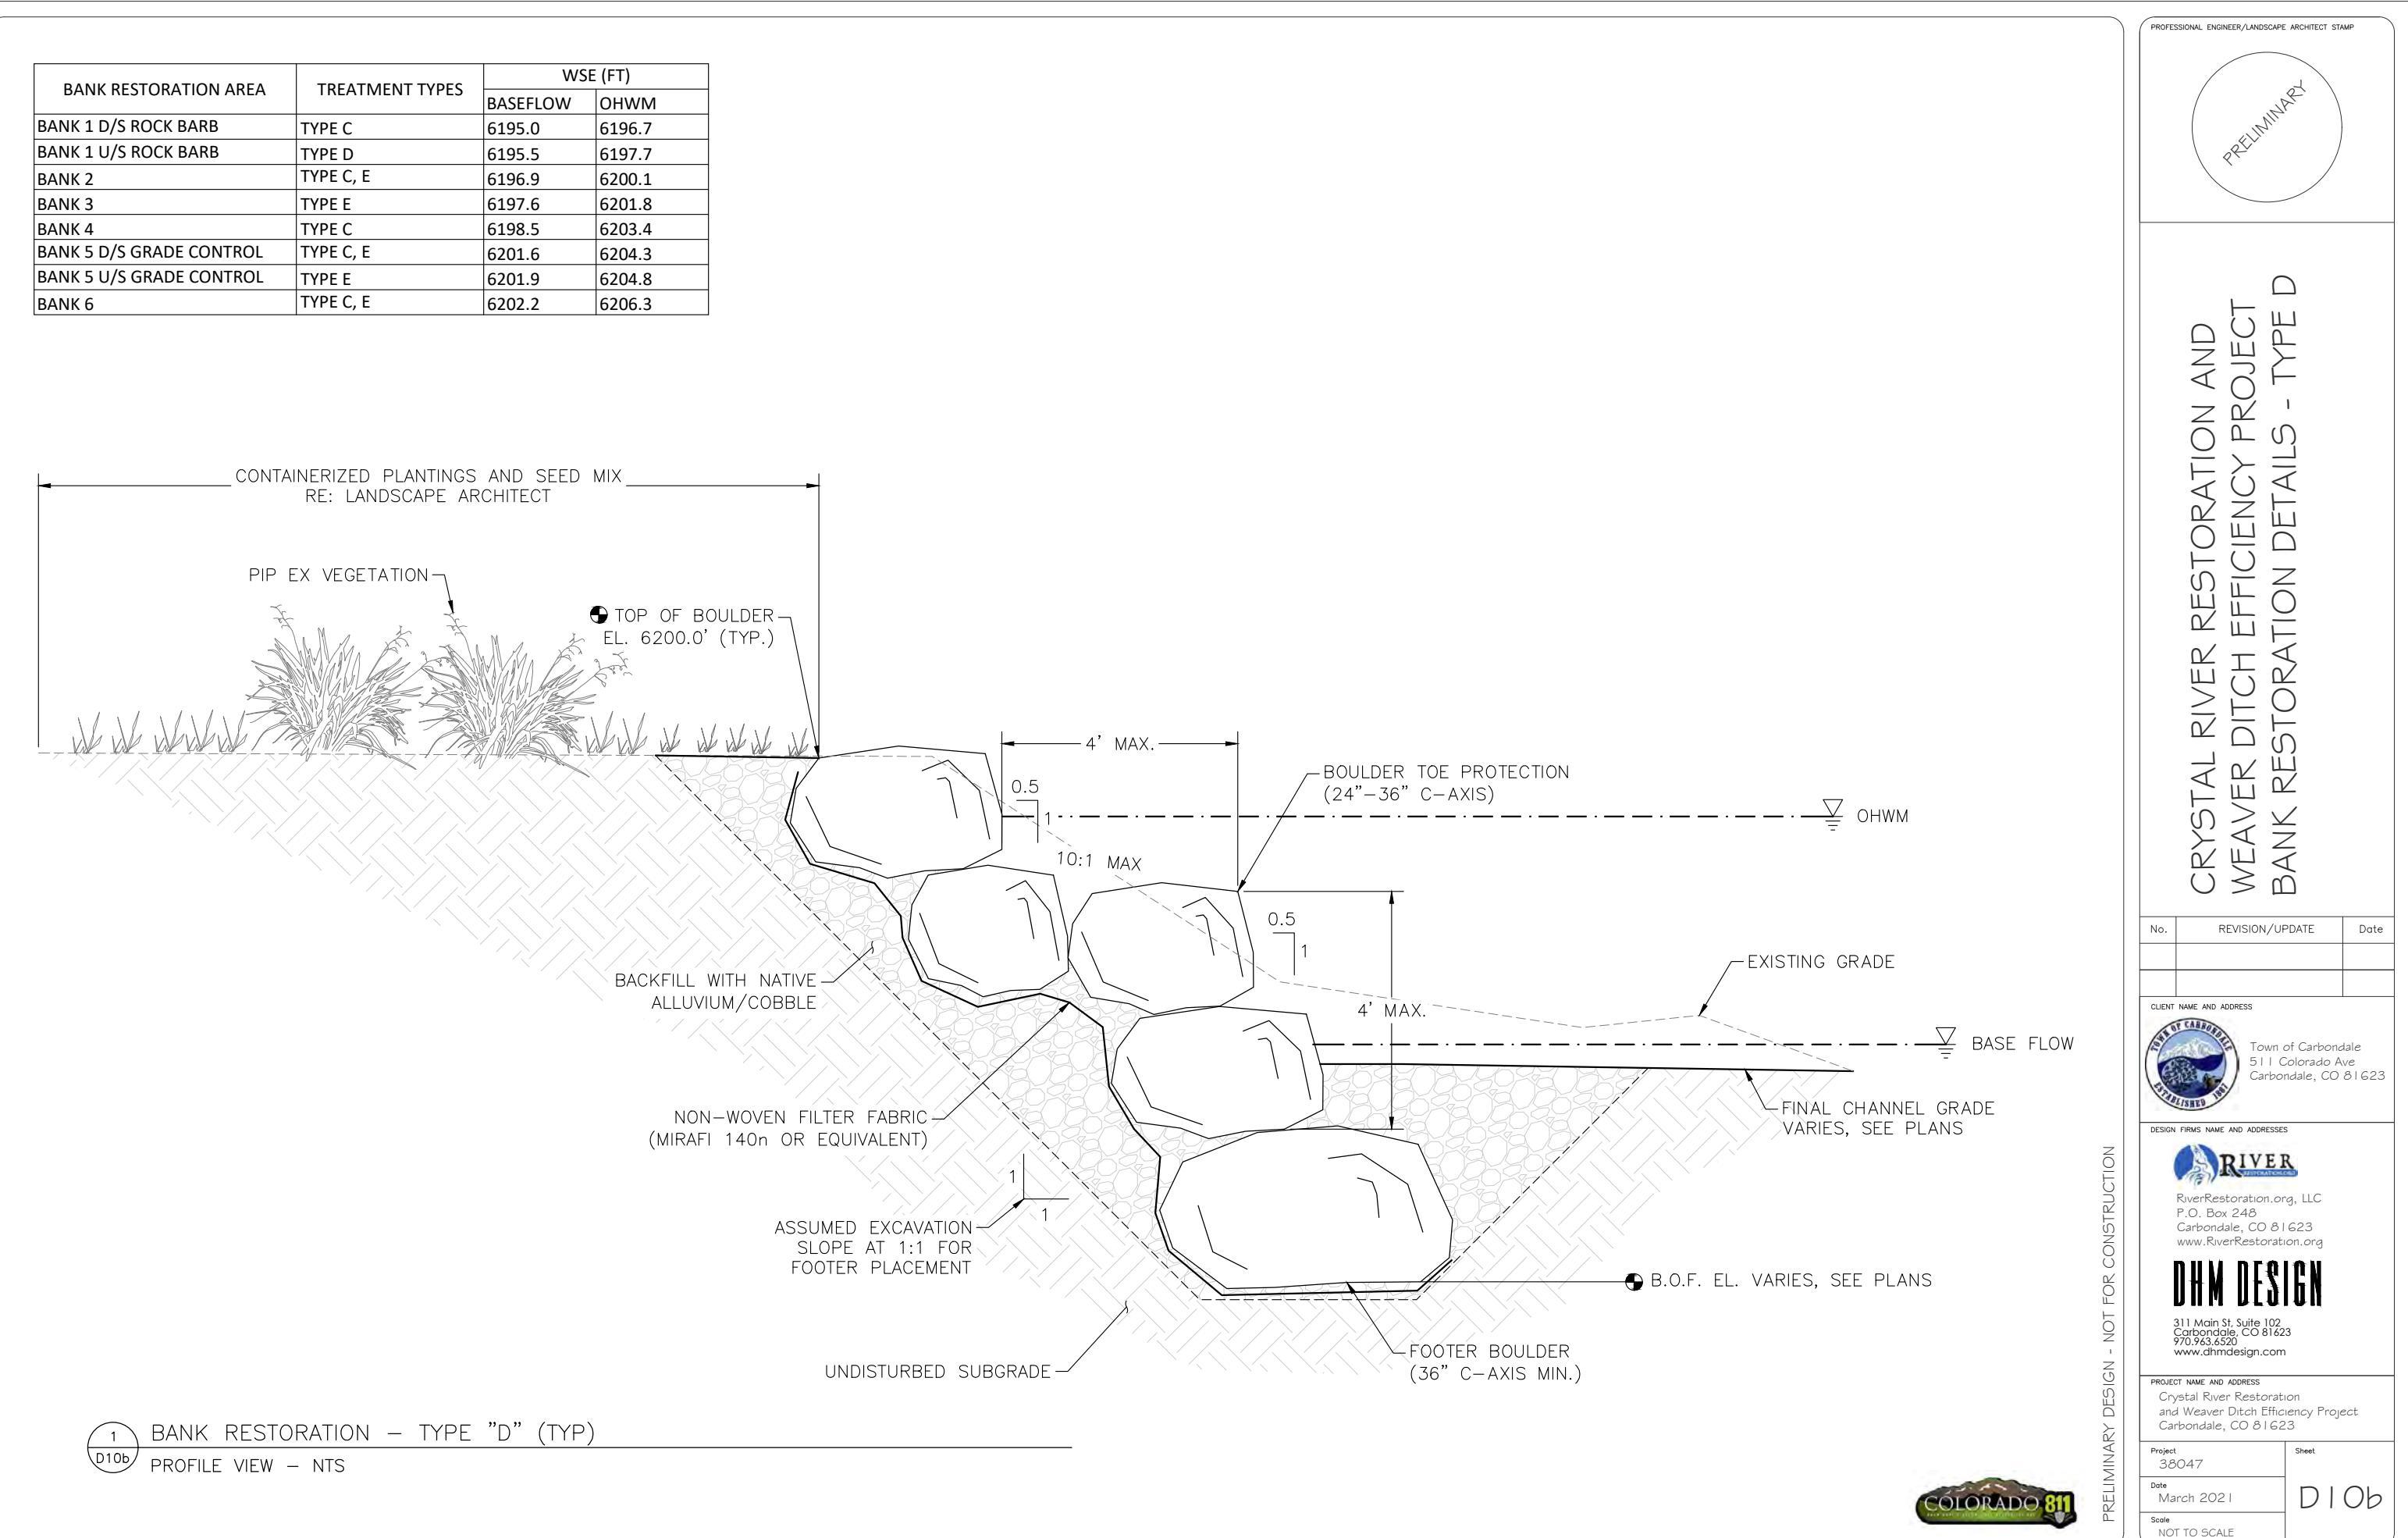
BANK RESTORATION AREA	TREATMENT TYPES	WSE (FT)		
		BASEFLOW	ОНШМ	
BANK 1 D/S ROCK BARB	TYPE C	6195.0	6196.7	
BANK 1 U/S ROCK BARB	TYPE D	6195.5	6197.7	
BANK 2	TYPE C, E	6196.9	6200.1	
BANK 3	TYPE E	6197.6	6201.8	
BANK 4	TYPE C	6198.5	6203.4	
BANK 5 D/S GRADE CONTROL	TYPE C, E	6201.6	6204.3	
BANK 5 U/S GRADE CONTROL	TYPE E	6201.9	6204.8	
BANK 6	TYPE C, E	6202.2	6206.3

- COARSE BIODEGRADABLE WOVEN COIR 700 OR EQUIVALENT. ECB SHALL BE ANCHORED AND MODIFIED FOR PLANTINGS PER LANDSCAPE ARCHITECT DIRECTION. SEE SHEET D11.
- RE: LANDSCAPE ARCHITECT. TO THE IN THESE ZONES POST-SEEDING.
