Crystal River at Riverfront Park Restoration and Efficiency Project Roaring Fork Conservancy

Water Plan Grant Application

March 2022 Board Meeting

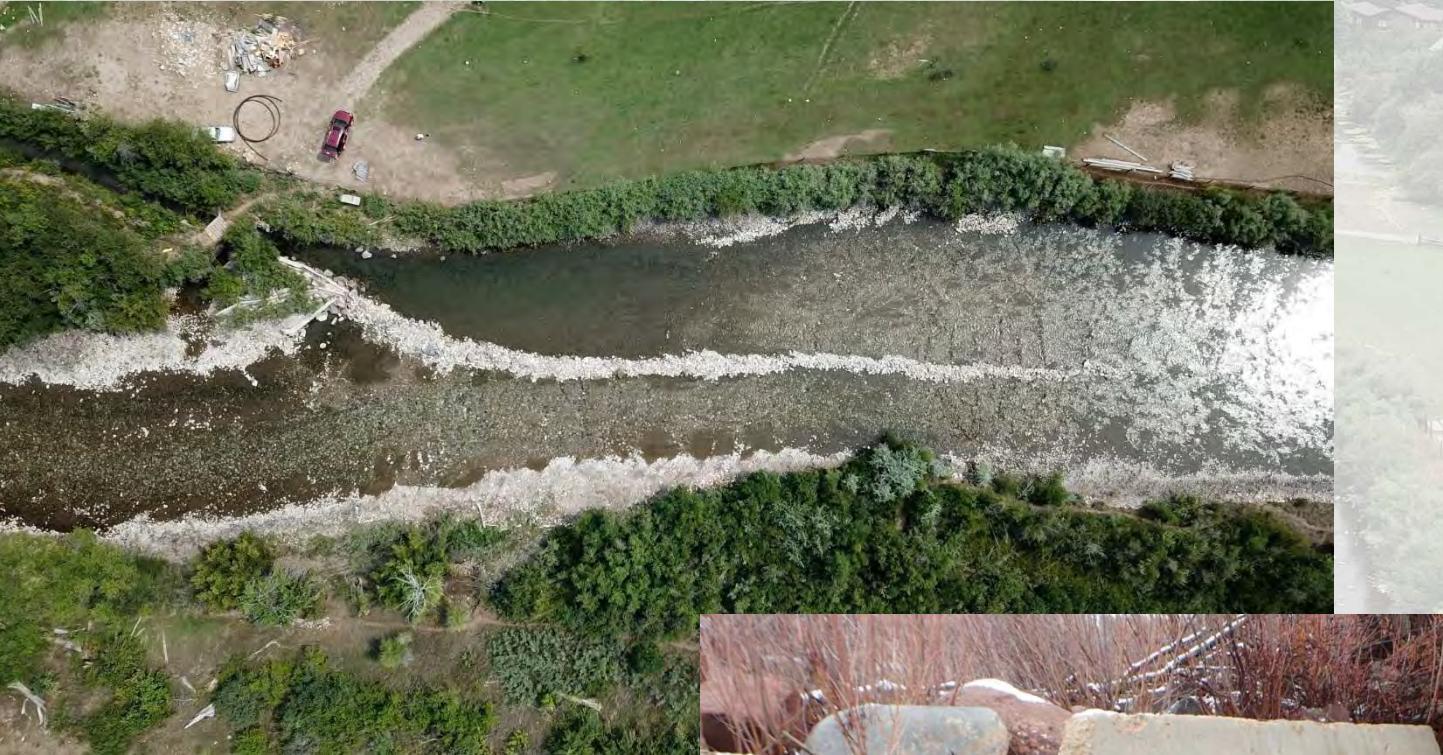
Above - Weaver Diversion requires annual channel disturbance for push up dam. *Right* – headgate entrance with degrading concrete traffic barrier.
