This report is the summary document for work efforts on the identification and collection of various documents and parameters of 14 whitewater courses constructed in the State of Colorado.

# TABLE OF CONTENTS

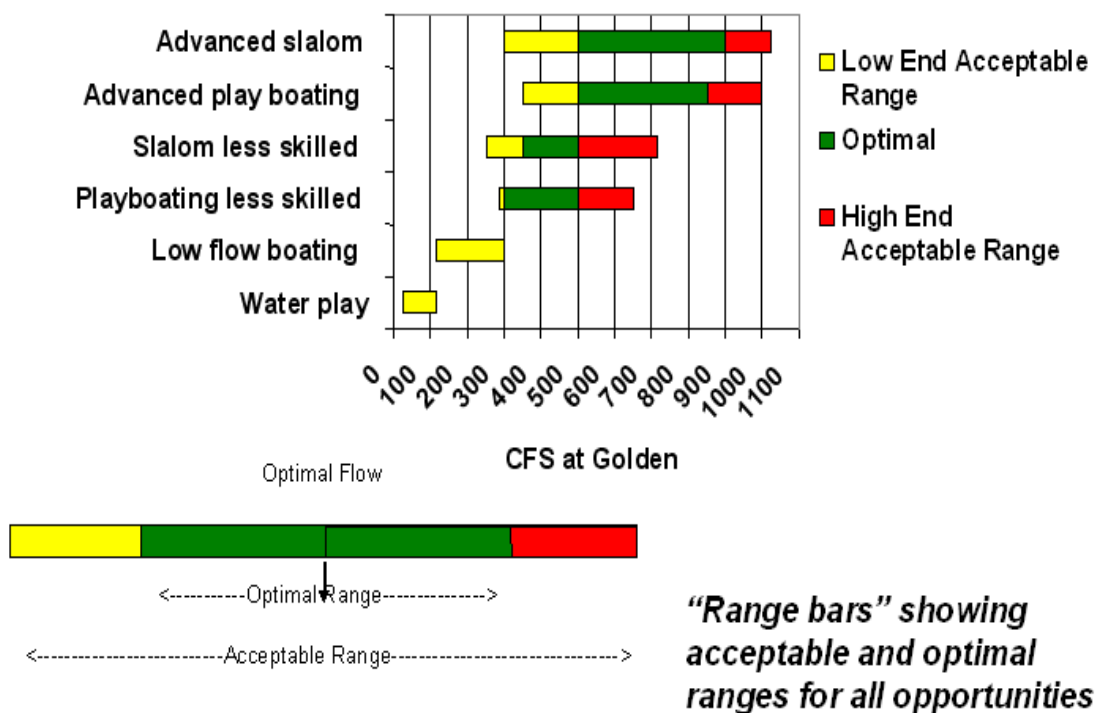
### *Flow needs for the whitewater park in Golden, Colorado. (Shelby)*

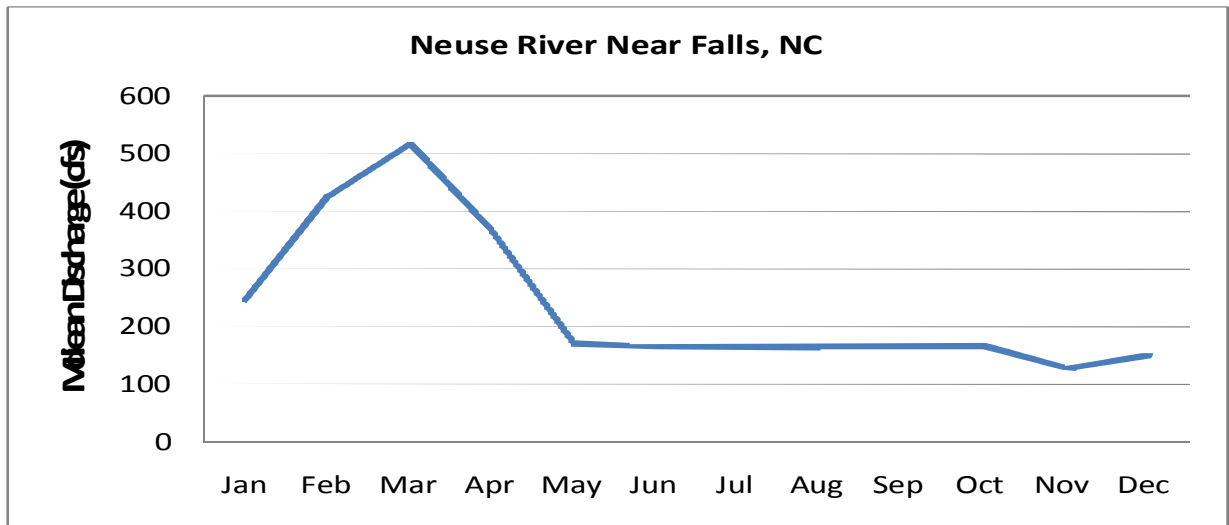
**Hydrograph of a seasonal eastern river with boatable flows only in the winter and early spring.**

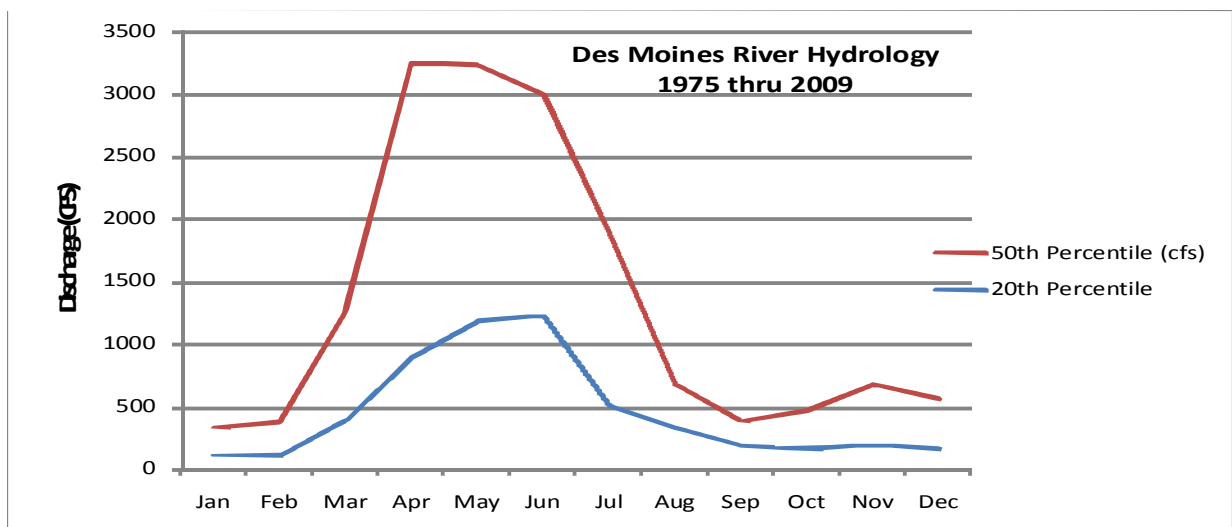
**Hydrograph of a mid-western river with boatable flows most of the year with lower flows occurring only during the winter.**

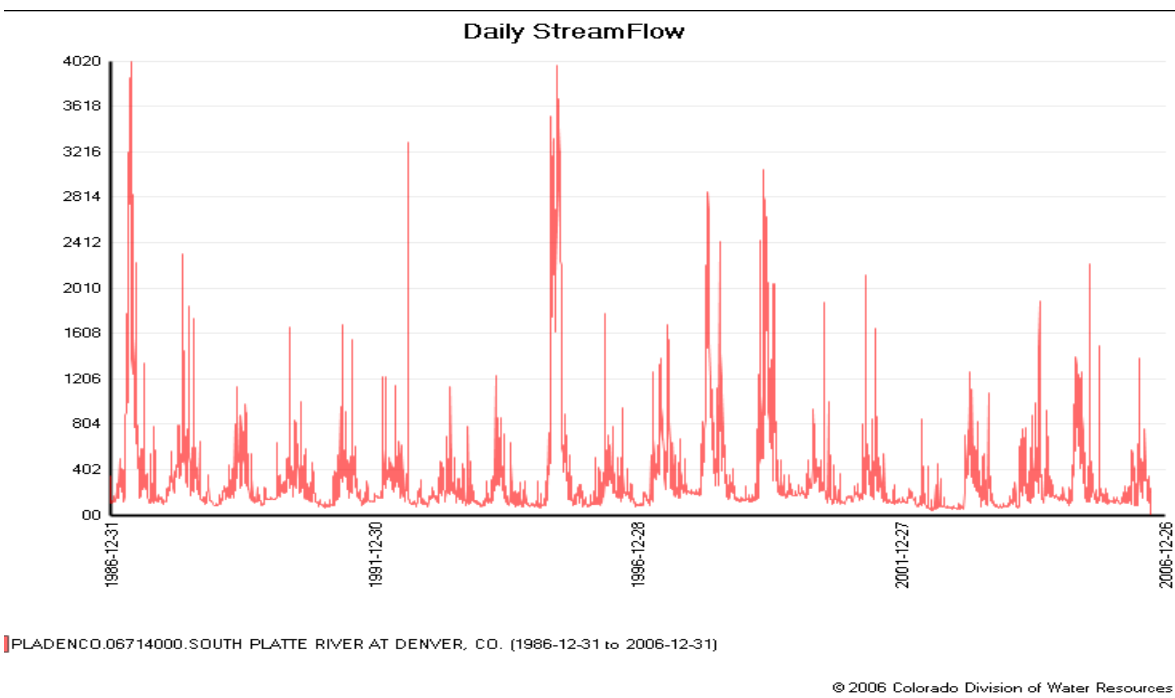
20 Years of Record, note that this gage includes flows from Cherry Creek.

Note: Only a fraction of the flow in the Platte River is diverted through the whitewater course. The remainder flows over the dam, through a gate, or into the diversion.

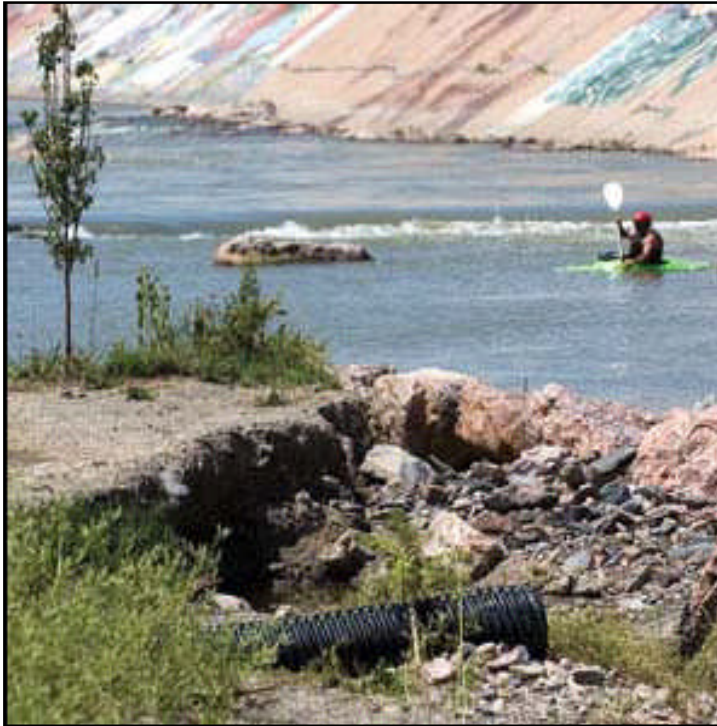
*A drainage pipe for storm water lies exposed along the shore of the Arkansas River in the Pueblo whitewater park Friday. Recent high flows through the park have caused some damage to the river in the area.*

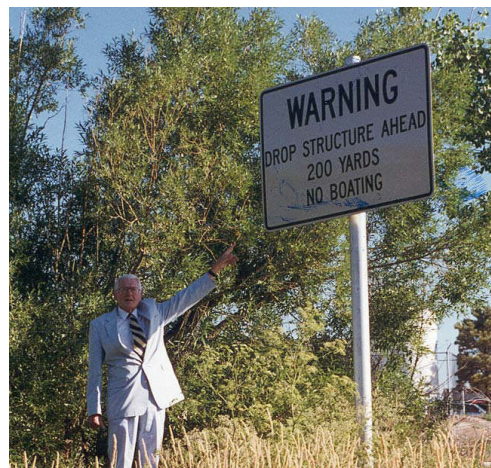
*Photograph HS-18—Warning signs can be used to help achieve public boating safety, but signs cannot in themselves serve as a substitute for an appropriate standard of care in the design of a reasonable grade control structures on a boatable waterway.*
