Colorado Water Conservation Board - Fish and Wildlife Grant

COALITION FOR THE UPPER SOUTH PLATTE

Final Report PO # OE PDA 1200000003 October 7, 2011

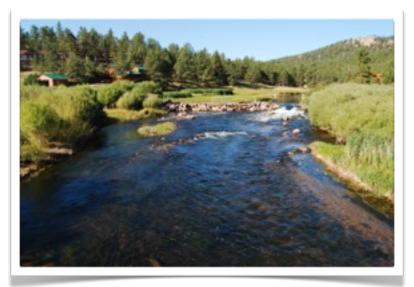
Looking up-stream at Sportsman's dam prior to construction

structure from the mainstem of the South Platte. The community initially built a small rock structure to increase stage in order to run water to the pond, but due to sediment deposition, they continued increasing the height over the years until they had a full dam across the river. The dam was not engineered, and is perpendicular to the channel, so it has continued to accumulate and deposit ever-larger quantities of

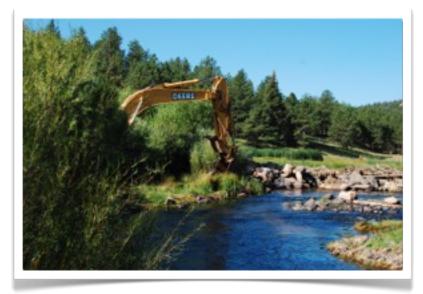
Beginning to remove the dam and redevelop the diversion

Work began on the project on August 30th, with equipment mobilization and collection of rocks and trees from the Sportsman's property. Denver Water and Aurora Water took flows down beginning September 1st to a low enough level for work to begin in the stream. The first order of business was to remove the existing dam and redevelop a new diversion structure that served the Sportsman's needs while meeting ecological goals. For me (CUSP Executive Director, Carol Ekarius) this was one of the most special days of my career. To actually see a problematic dam removed and a new diversion developed that met the owner's needs, yet allowed free fish passage and proper hydrologic function, was a really a great feeling. The sediment field that had built up behind was stabilized with large wood, and is being revegetated.

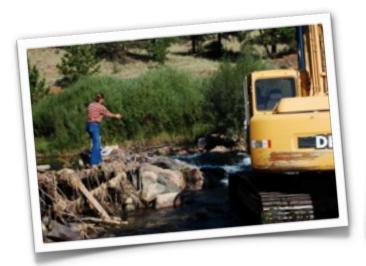
Jeff Crane, of Crane Associates, and Pete Gallagher, of Fin-Up Habitat Consultants, were joint design contractors for this project. Here, Crane directs the equipment operator from Chaparral Construction in beginning to remove the dam.

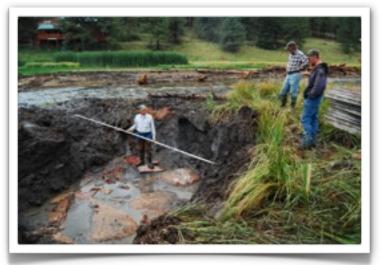
Prepping the hole for the new diversion structure. (Jeff Crane checking elevations in the hole, Pete Gallagher at left on bank, and Justin Jameson of Chaparral at right.)

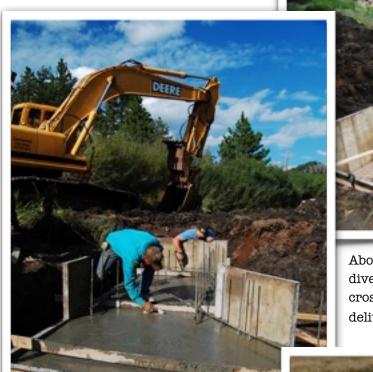
Above and left: forming and pouring the new diversion. Finished diversion, fed by a double cross weir (below), which is designed to be able to deliver water in all flow regimes.

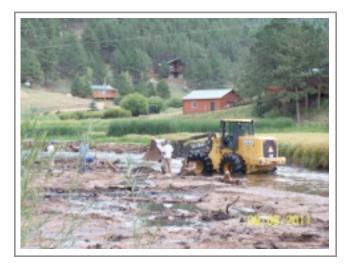
Narrowing the stream back up just above the dam site, where it had over-widened over decades and threatened the road. On left, filling, on right replanted with sedge and willows.

By mid-September the diversion area work was complete, and work began in ernest on the river restoration and riparian habitat work through the Sportsman's portion of the river, and on the first 1,500 feet of river upstream from the dam (the rest of Happy Meadows will be completed in 2012). Restoration treatments were designed based on both WARSSS and Hec-Raz models for this portion of the river. Treatments were installed to reduce the width of the channel and increase the depth, and include j-hook veins and cross-weirs, as well as habitat trees. Several islands were removed or were redeveloped into small peninsulas with backwater pools for habitat.

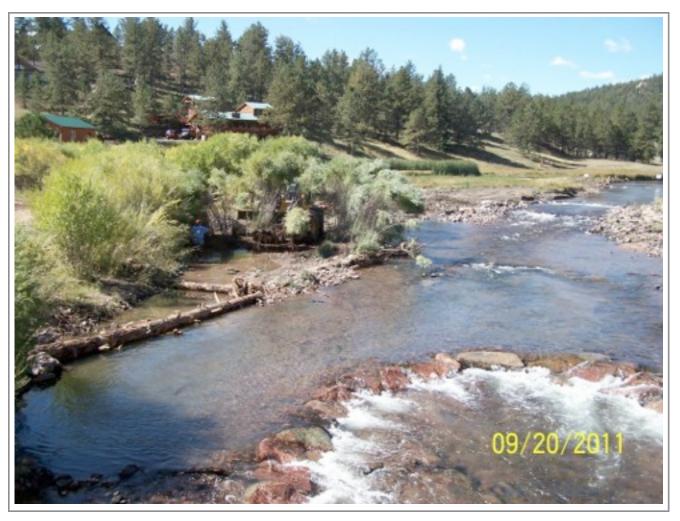
Looking upstream, where the dam once blocked the river. The cross-weir in the foreground guides the thalweg into the middle of the area as the water flows under a bridge.
