# INUNDATION MAPPING REPORT

## **TERRACE DAM AND RESERVOIR**

WATER DIVISION 3, WATER DISTRICT 21  
CONEJOS COUNTY, COLORADO  
DAMID: 210102

**INUNDATION MAPPING REPORT  
FOR  
TERRACE DAM AND RESERVOIR**

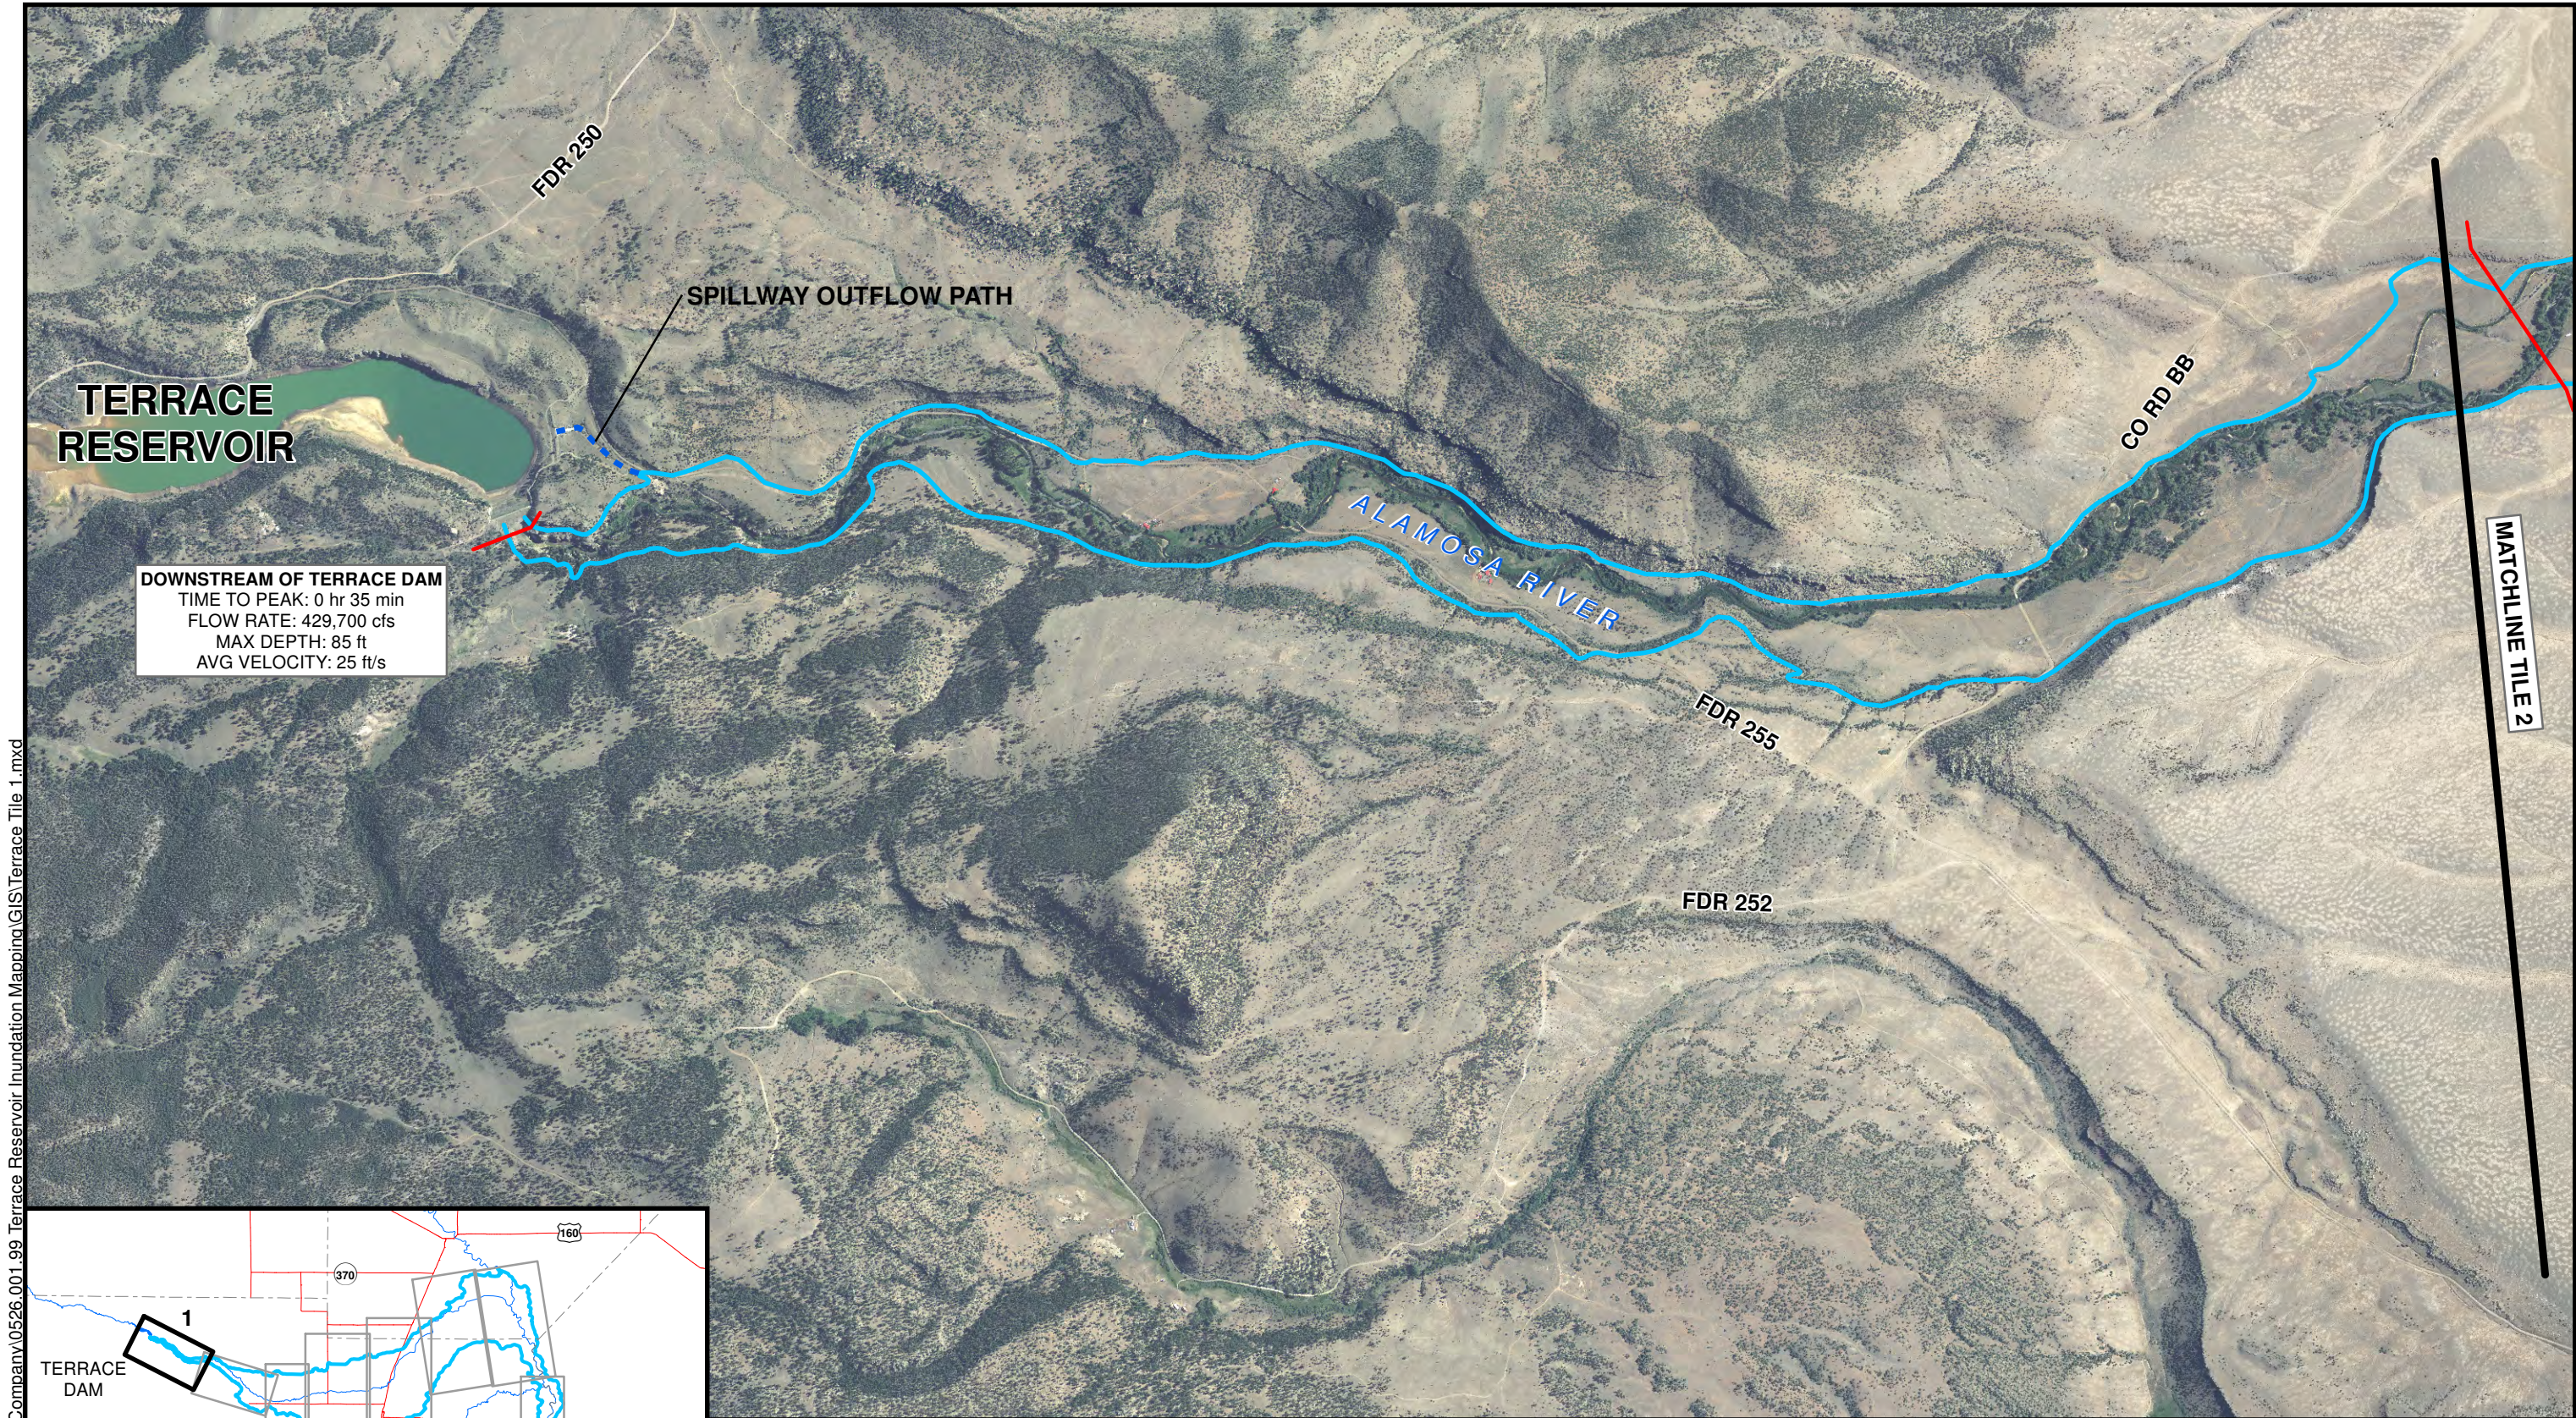
**DOWNSTREAM OF TERRACE DAM**  
TIME TO PEAK: 0 hr 35 min  
FLOW RATE: 429,700 cfs  
MAX DEPTH: 85 ft  
AVG VELOCITY: 25 ft/s

A clear-day failure of Terrace Dam with the water surface at the emergency spillway crest will result in a peak outflow of approximately 429,700 cfs. The time it takes to achieve this peak outflow will be 35 minutes from the onset of the breach. From the dam the flood wave will travel southeast for about 6 miles along the Alamosa River through a deep canyon where the average channel flow depth will be about 60 feet, and the channel velocity will reach up to 53 feet per second. The structures and roads located within the canyon are expected to be significantly overtopped due to a clear-day breach of Terrace Dam.
