Final Report – Dated January, 2017
Sullivan Ditch Repair – Cliff Piping
Pursuant to Notice to Proceed – WSRF Grant – POGGI 2017-516 – Sullivan
Ditch Repair in the SW Basin
Funding Source Southwest Basin Funds

Task 1 – North Cliff Repair

Task 2 – South Cliff Repair

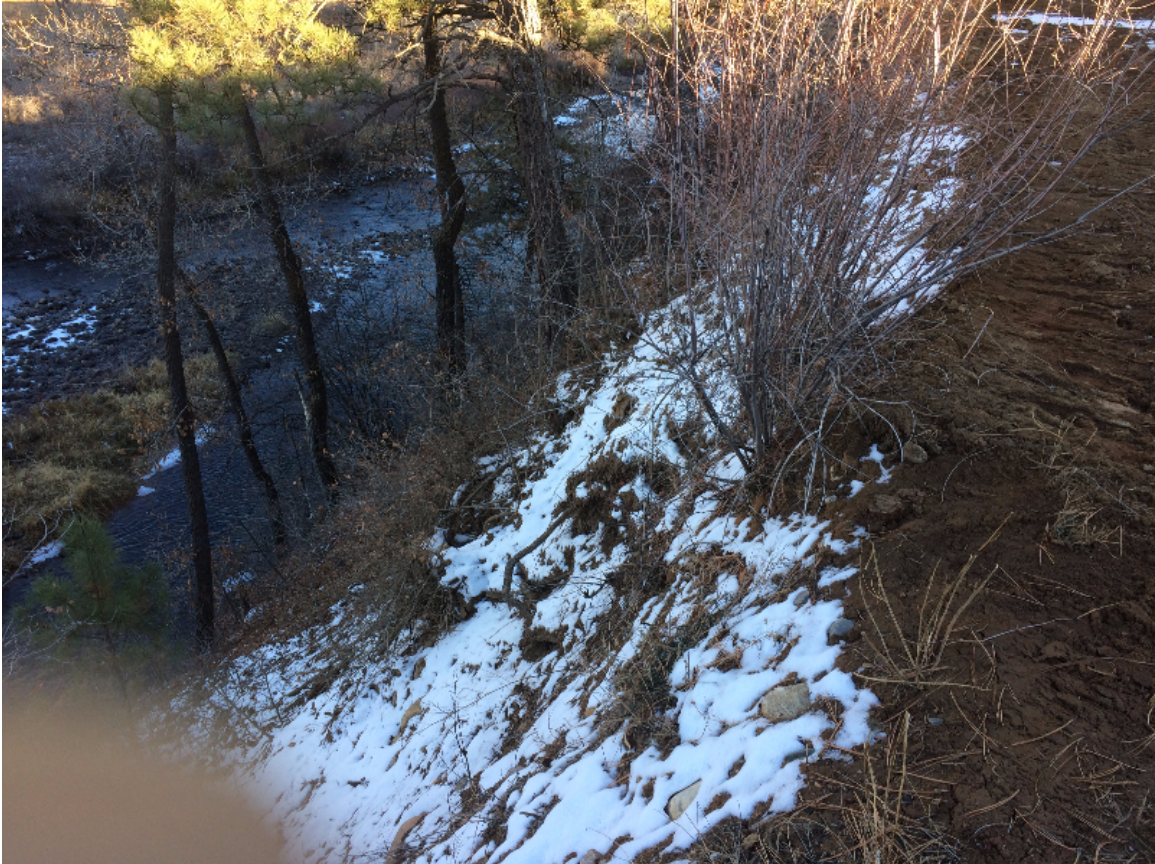
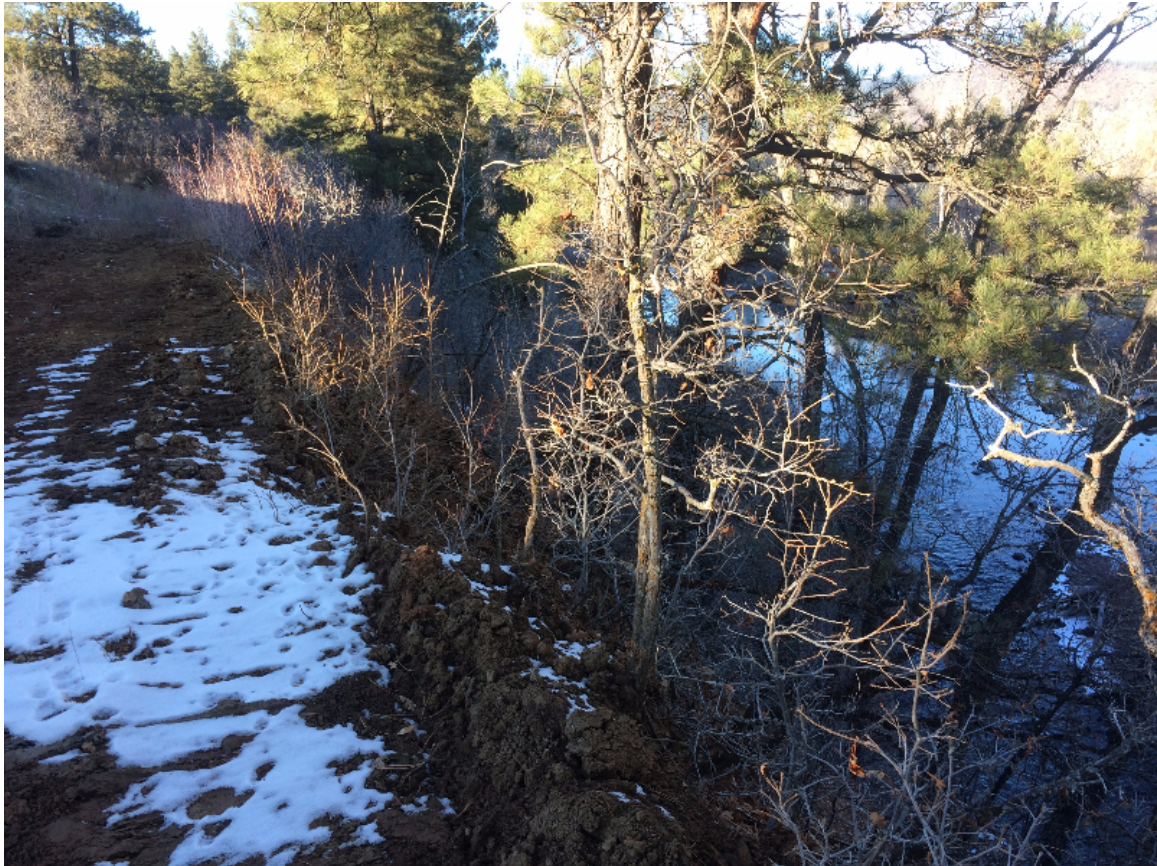
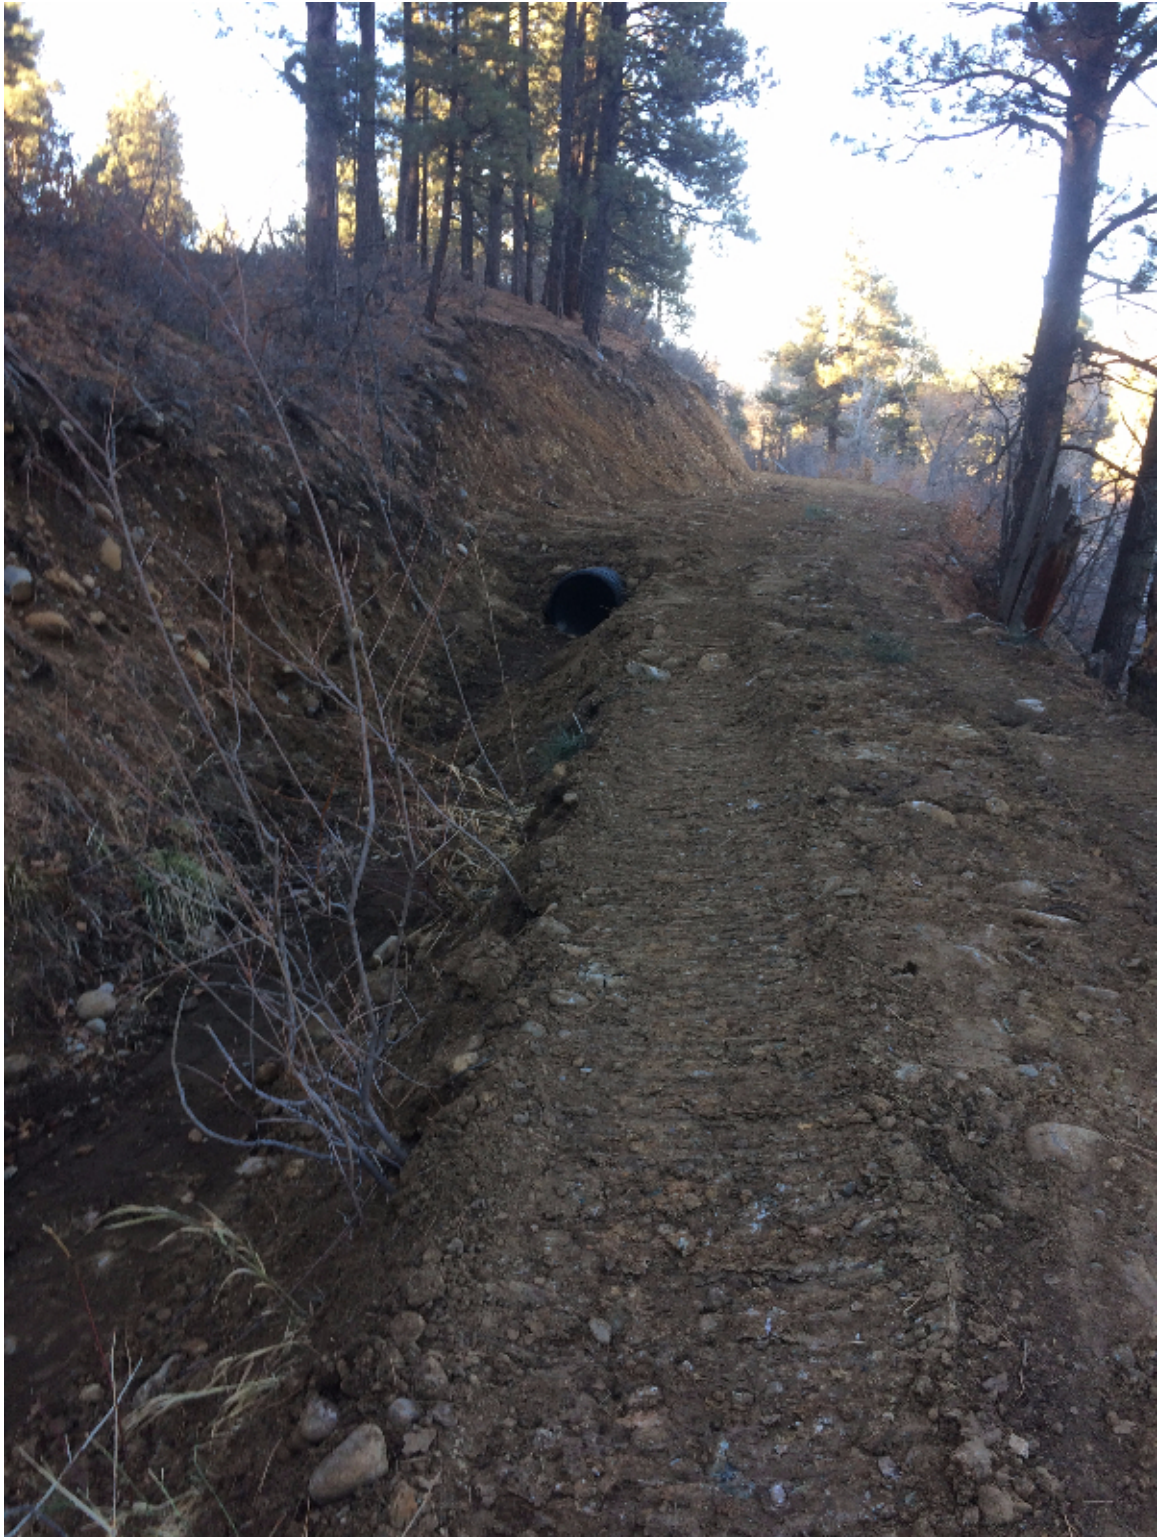
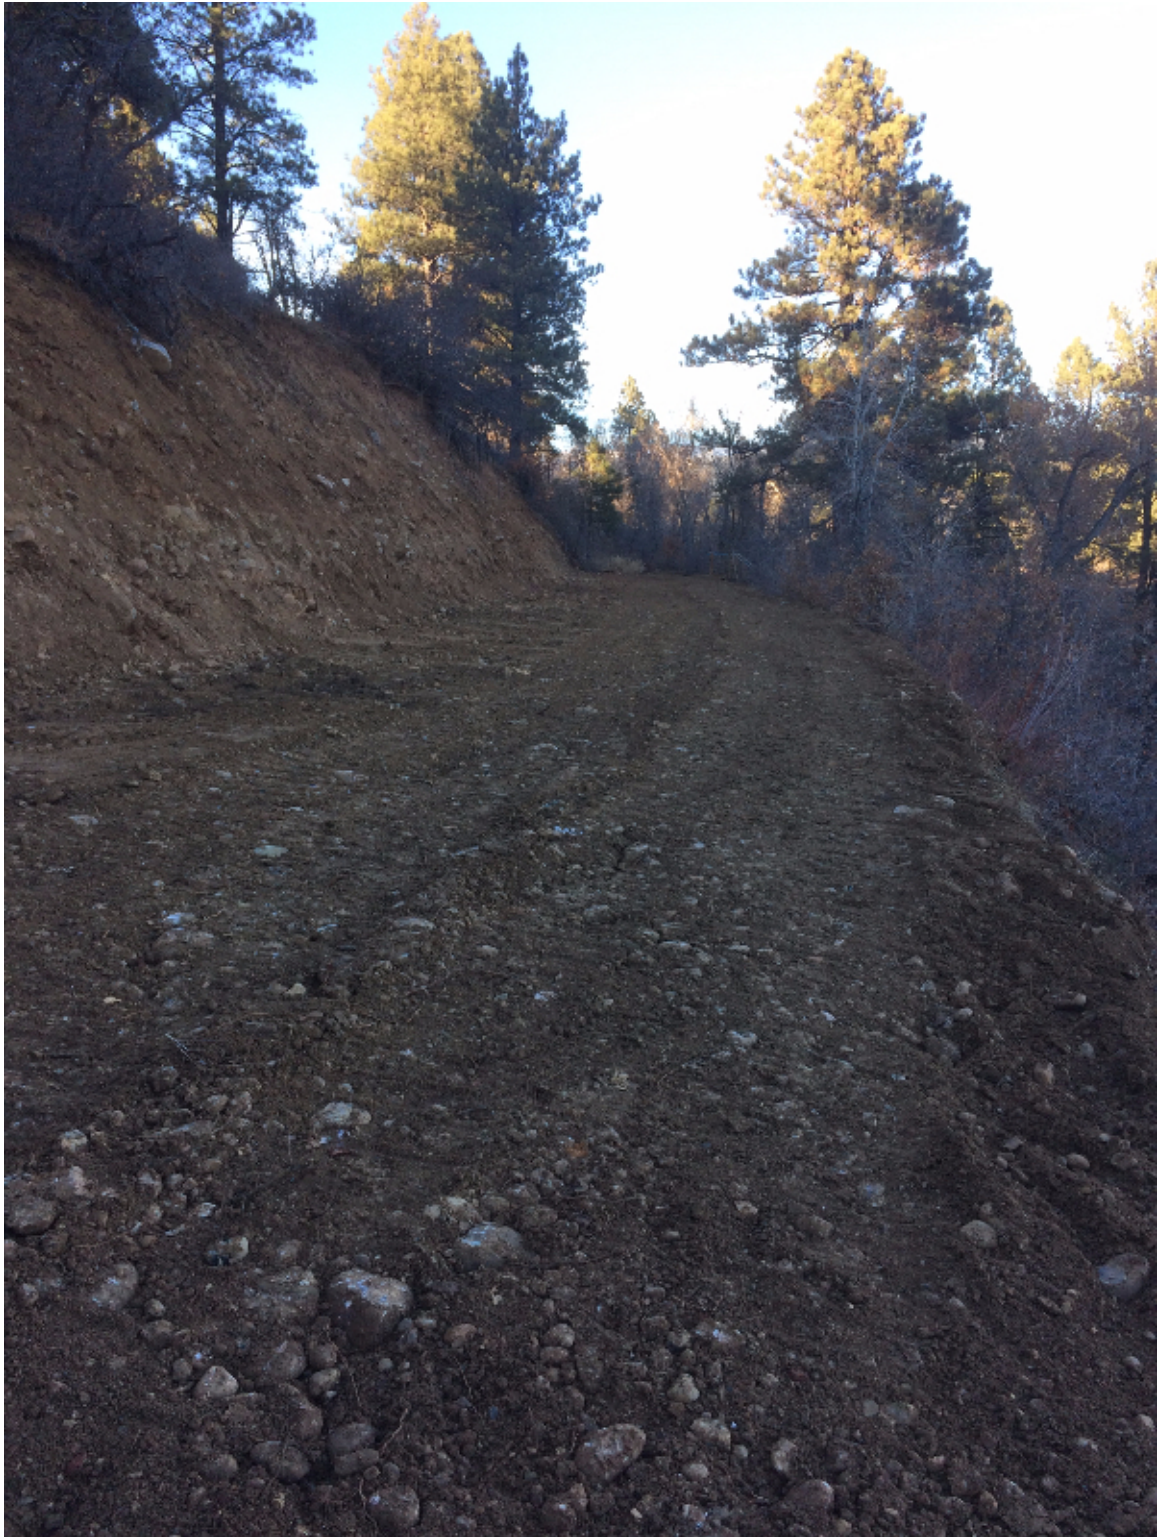
The Ditch Company installed 300' of 3' in diameter piping. Rock fill was used to improve the berm and pipe base as well as the pipe entrance and exit. The site has not yet been reseeded and will be reseeded in the spring.

The Ditch Company purchased the pipe and mobilized the construction area for the northern cliff area designated in the grant proposal.

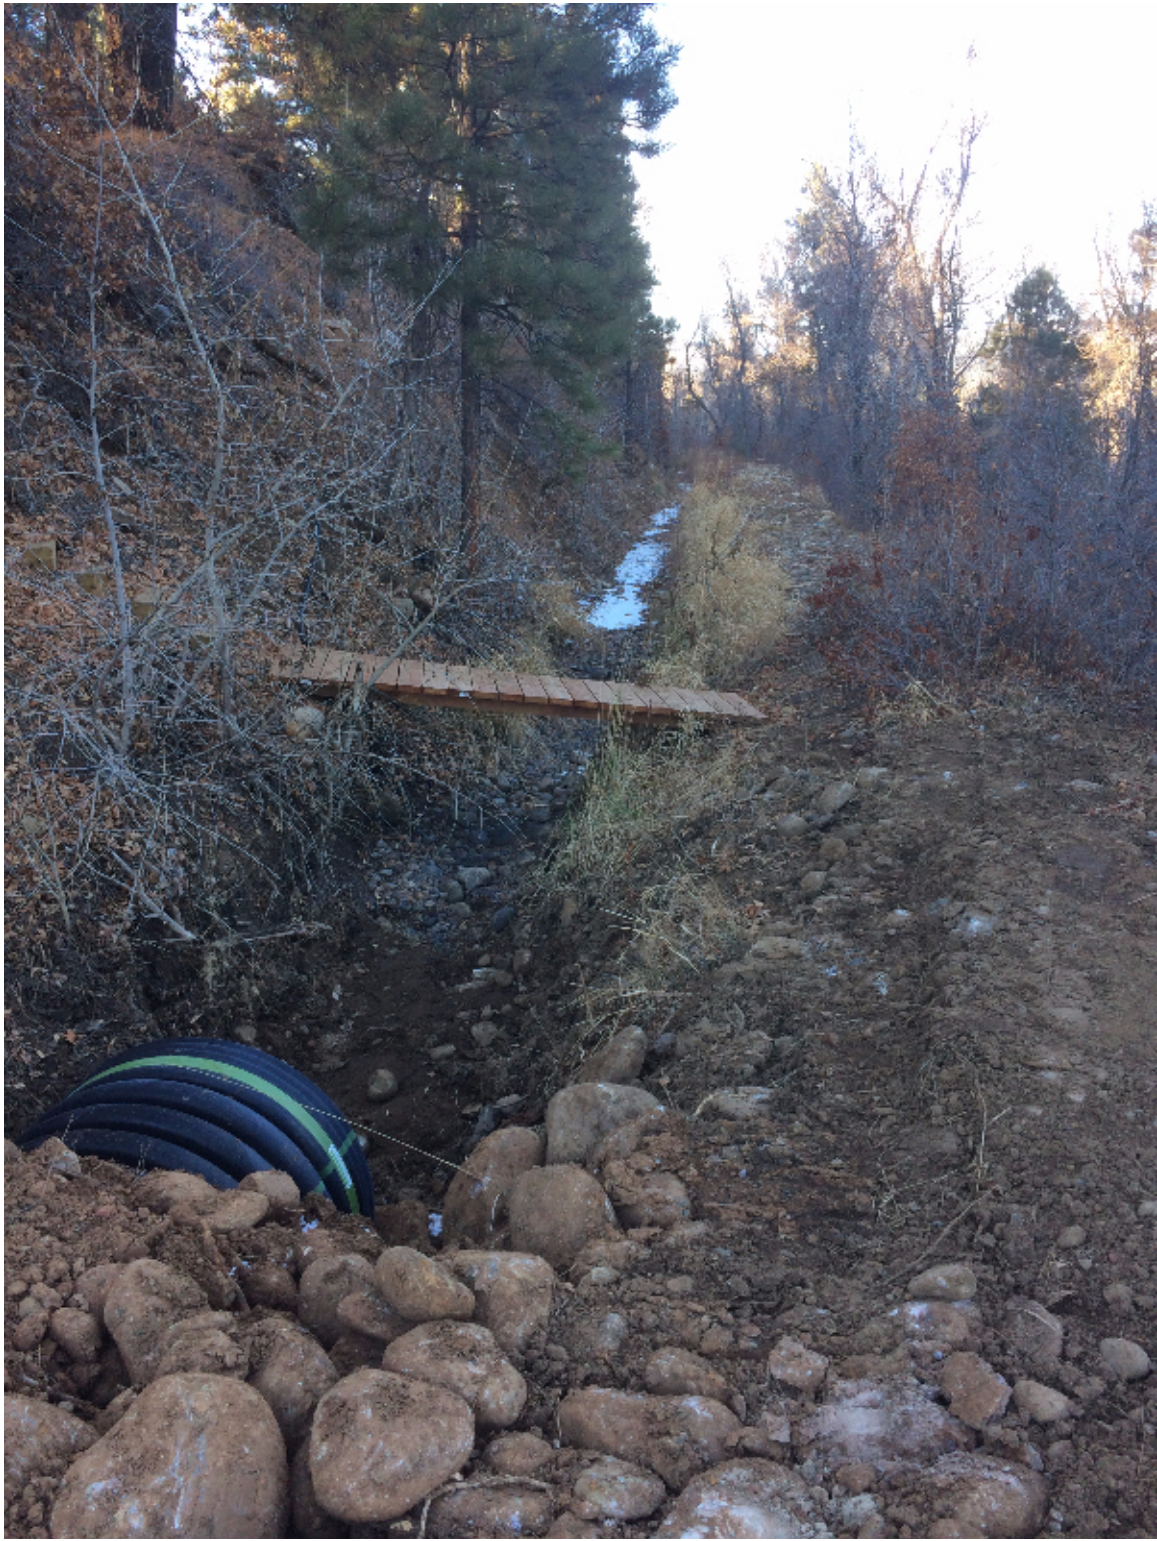
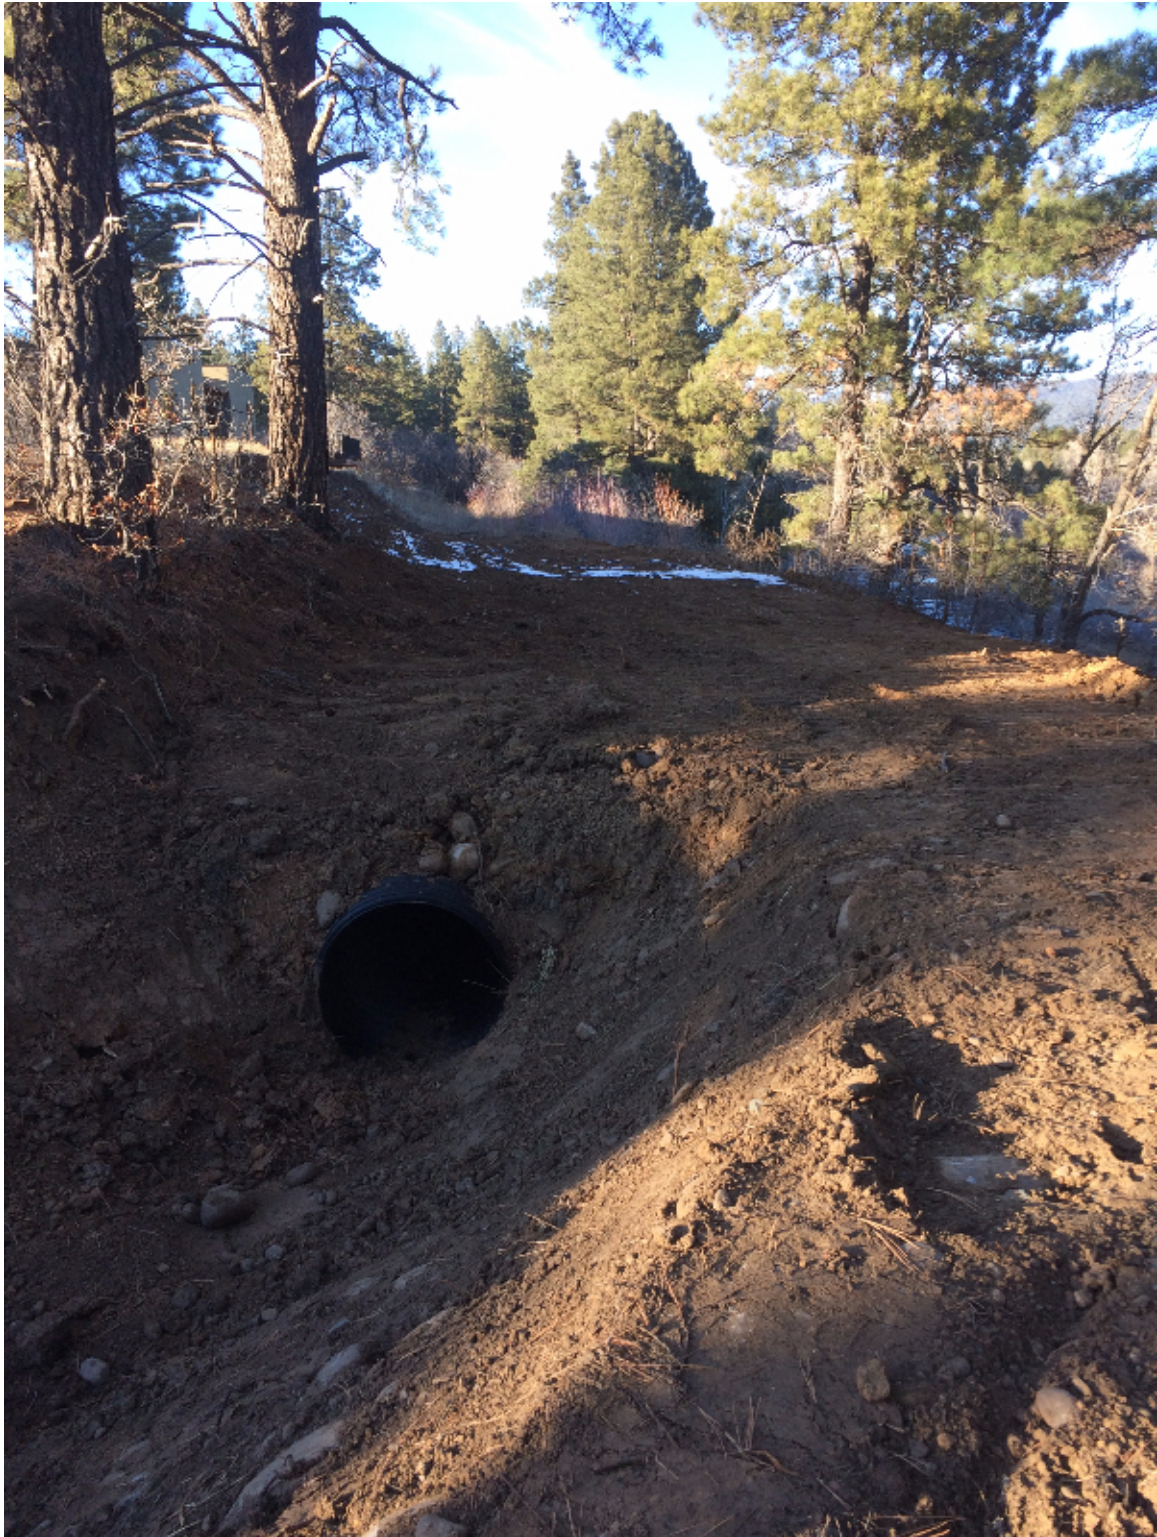
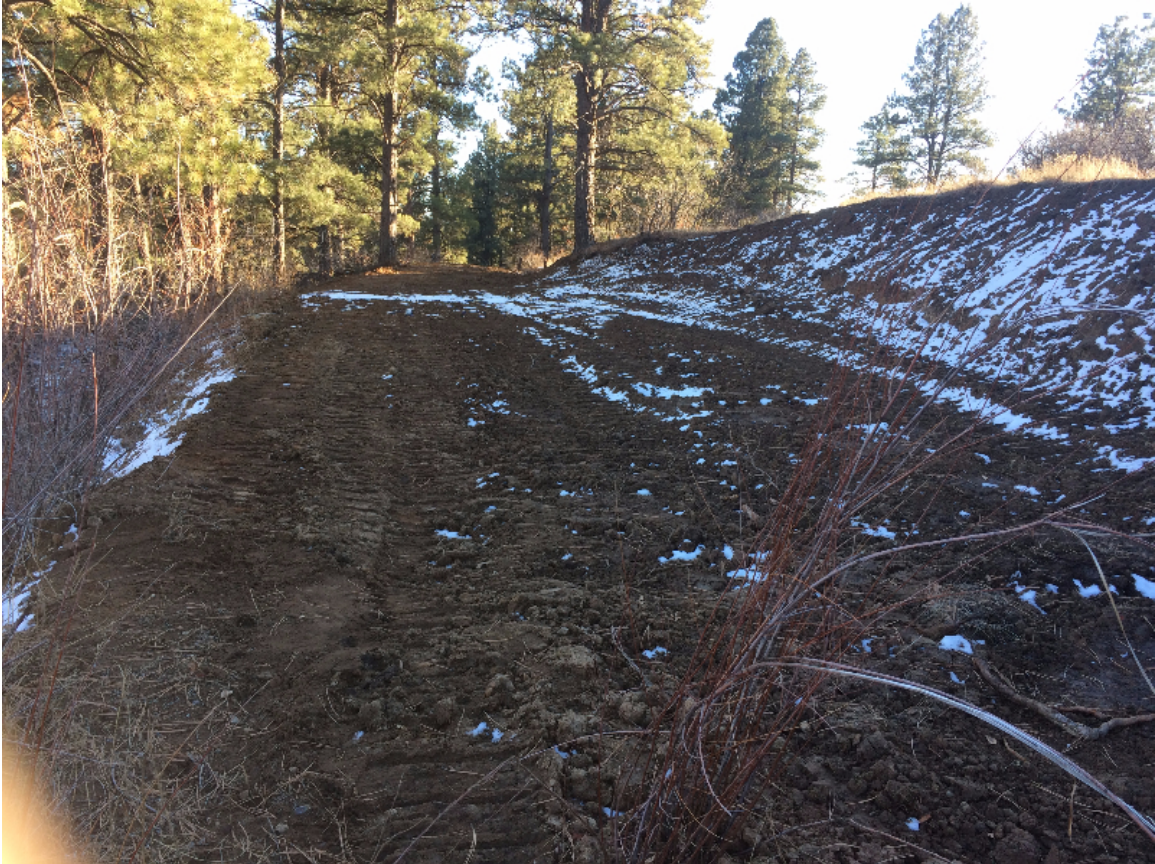
The Ditch Company installed 125' of 3' in diameter piping. Rock fill was used to improve the berm and pipe base as well as the pipe entrance and exit. The site has not yet been reseeded and will be reseeded in the spring.

The Ditch Company purchased the pipe and mobilized construction area for the southern cliff area designated in the grant proposal.
