## Colorado Water Conservation Board

### Water Plan Grant Application

Name of Applicant	Colorado Open Lands	
Name of Water Project	Watershed Analysis of Beaver Restoration Potential in Park County	
CWP Grant Request Amount	\$ 45,450	
Other Funding Sources: Park County Land & Water Trust Fund	\$ 78,170	
Other Funding Sources	\$	
Other Funding Sources	\$	
Applicant Funding Contribution	\$ 0	
Total Project Cost	\$123,620

Twelvemile Ranch:  
A reconnaissance assessment of stream and riparian condition for the Riparian Reconnect project with recommendations for restoration and management

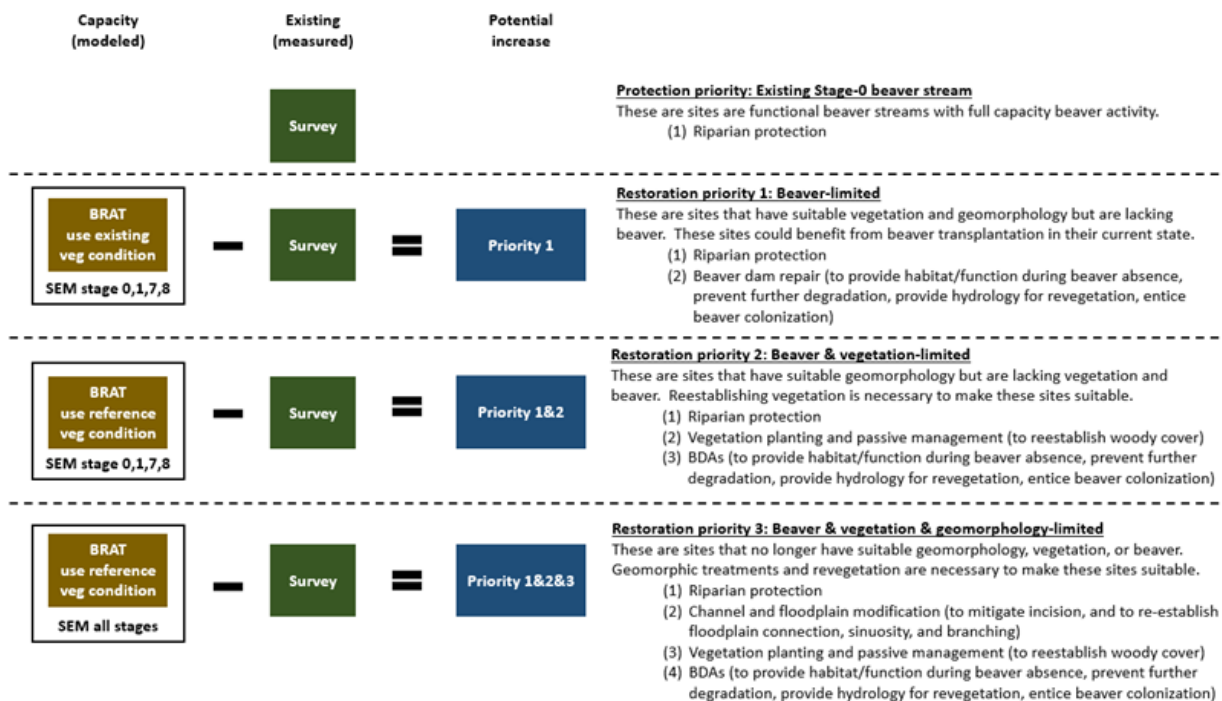
Figure 1. Schematic showing how this study quantifies the potential for beaver restoration. Basin-wide beaver activity surveys (pond area/mile, dams/mile) define the existing level. Capacity is predicted using BRAT, and the potential for increase is the difference of capacity minus existing. Reaches with a high level of beaver activity are protection priorities. Restoration priorities 1-3 represent reaches for which increasing levels of effort are required to restore sustainable beaver activity. Capacity for the priority 1 (beaver-limited) condition is given by BRAT simulations using existing vegetation on reaches that are not entrenched. Increased capacity for the priority 2 (beaver & vegetation-limited) condition is estimated by BRAT simulations that use reference vegetation on reaches that are not entrenched, assuming that vegetation can be restored. Increased capacity for the priority 3 (beaver & vegetation & geomorphology-limited) condition is estimated by BRAT simulations that use reference vegetation on all reaches that are not entrenched, assuming that vegetation and entrenchment can be restored.

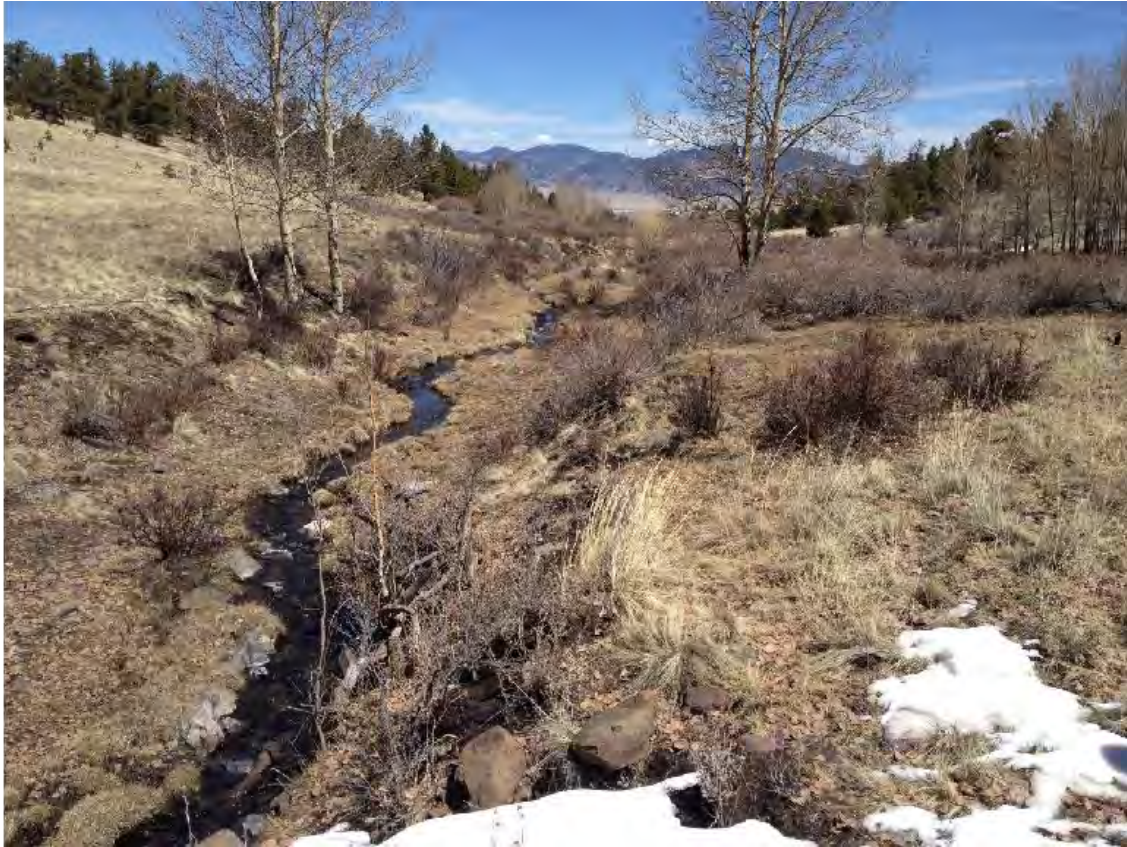
**Figure 2: On artificially channelized reaches, the stream is entrenched and dissociated from its historic floodplain. Deeply entrenched segments such as this have limited wetland restoration potential as bank heights exceed the height of typical stable beaver dams.**

The LP-2 reach apparently has good potential, but the stream is deeply incised on this reach. Some of the historic beaver dams on this reach are, in fact, now perched 5-10 feet above the present elevation of the creek. Some more recent relic dams were observed along the creek at its present elevation within the entrenched channel, which is a strong indication that beavers could gain a foothold on this site and succeed in building dams. Nevertheless, the depth of entrenchment would probably severely limit the potential for expanding wetland area laterally, since hydrologic effects of the dams would be confined within the entrenched channel (see Figure 2).

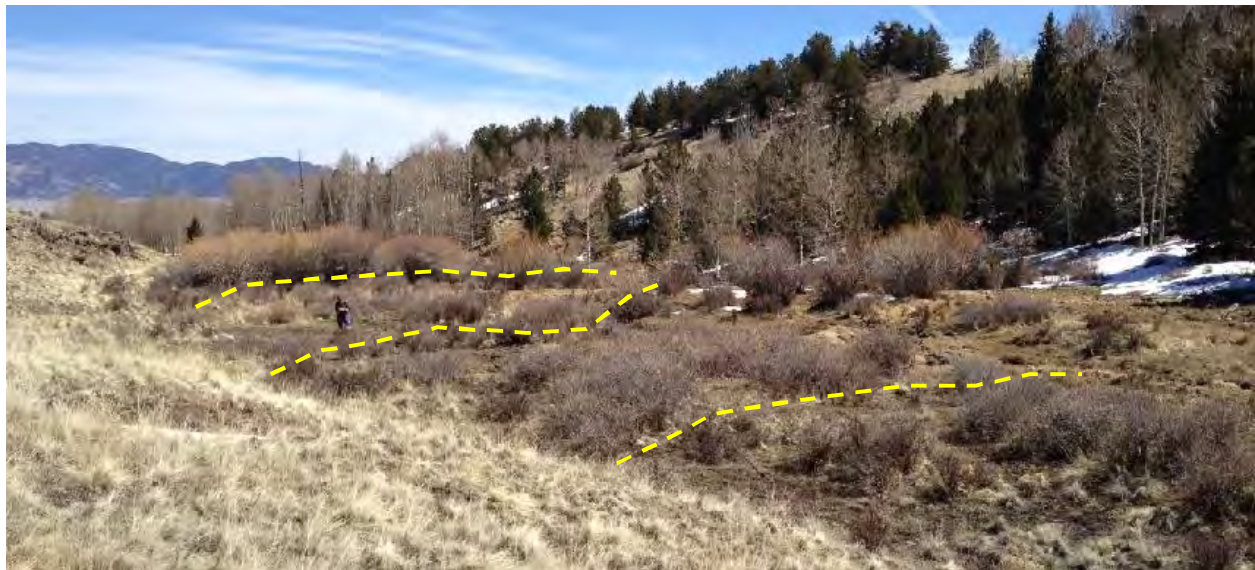
**Figure 3: The single thread channel of Pruden Creek is visible on the right side of the image running through a historically active floodplain. Relic beaver dams are identified by the dashed lines.**

Pruden and Cross Creeks offer good potential for restoration of wetland functions by reintroducing beavers. About 8900 ft of the Pruden Creek drainage and 4500 ft on Cross Creek have good or excellent habitat suitability for beavers. From these suitable reaches, we identified two priority sites on Pruden Creek (about 1900 ft) and one site on Cross Creek (about 700 ft) where beaver reintroduction is predicted to result in the restoration of about 2.5 and 0.9 acres worth of wetland functional units, respectively. (These are the blue segments in Figure 1). Figure 3 is a photo of the selected Middle Pruden Creek restoration site taken in September of 2014.

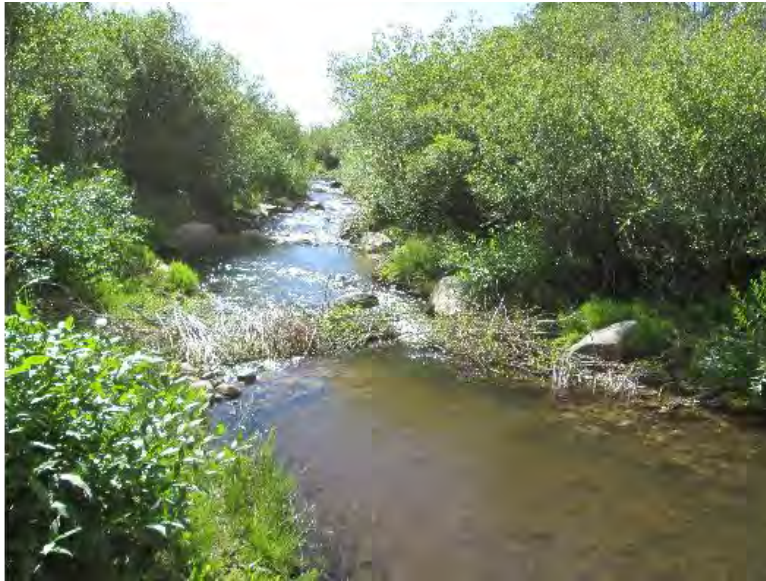
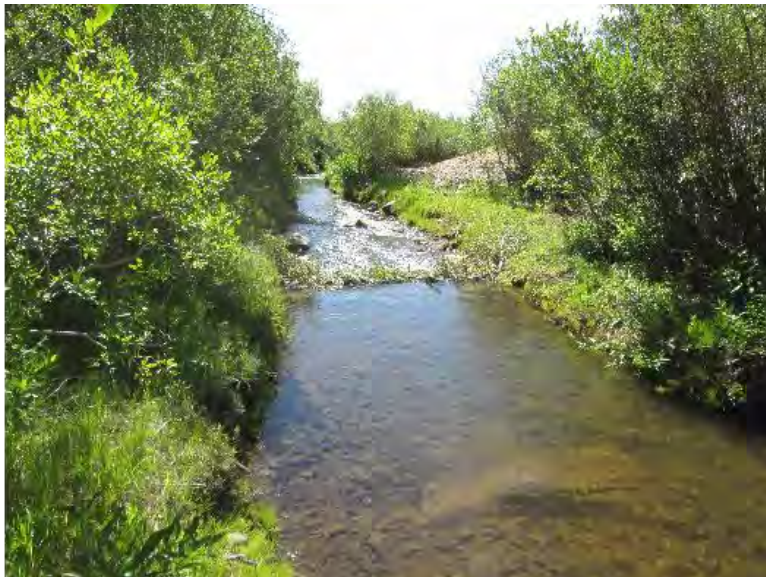
**Figure 4: Example brush dam beaver dam analogs on Tarryall Creek .**

**Aquatic escape cover** - The construction of temporary brush dams or other types of BDAs are

recommended to create pools that provide aquatic escape cover for beavers by impounding water along these tiny creeks. BDAs should be constructed to produce at least 500 sq. ft of standing water at least 1.0 ft deep. At the selected sites on Pruden Creek, a series of two or three BDAs will be necessary to create an adequate area of standing water. Multiple BDAs also gives the beavers options while allowing them to move about the site with more comfort and safety from predators. The structures should be located to create situations where impounded water exists under overhanging vegetation, and as close as possible to food sources.

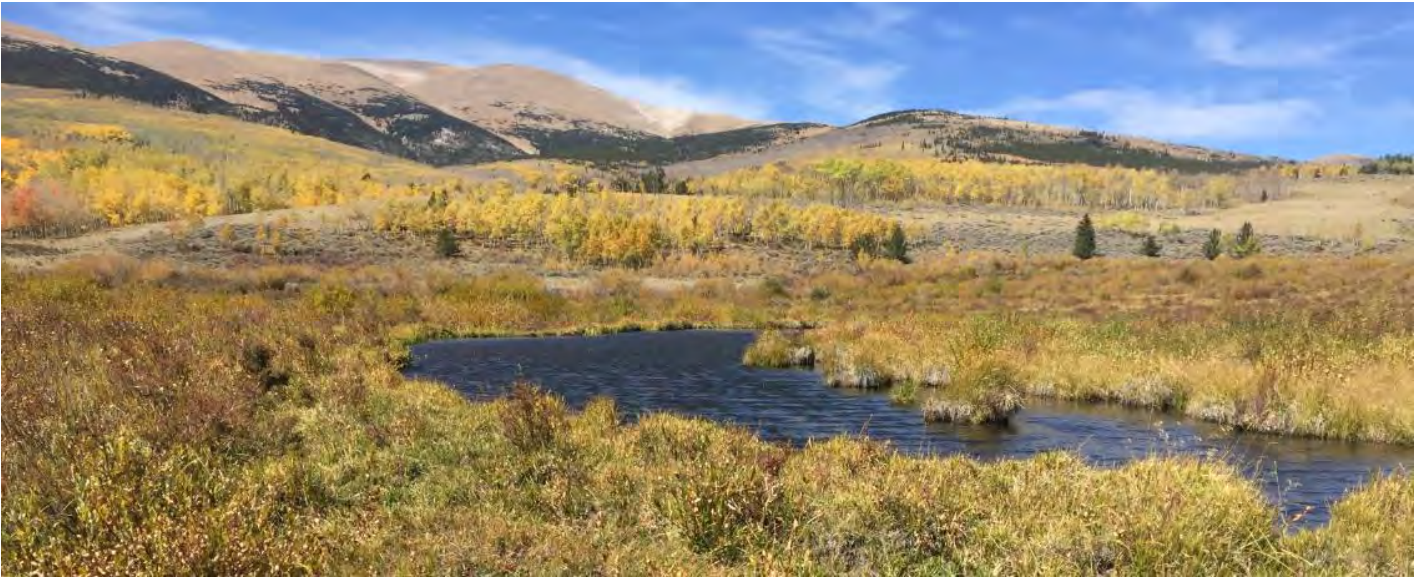
← Looking upstream on Twelvemile Creek. Most of the 9.5-square-mile contributing watershed is in the alpine and subalpine terrain in the background.

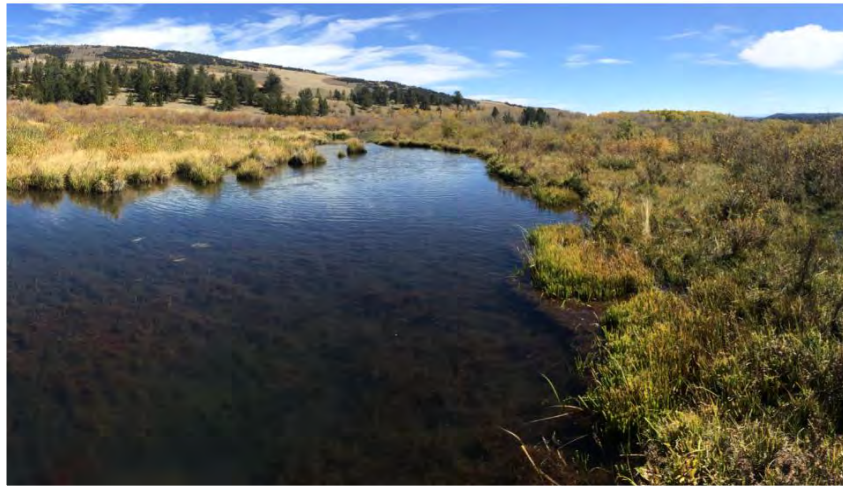
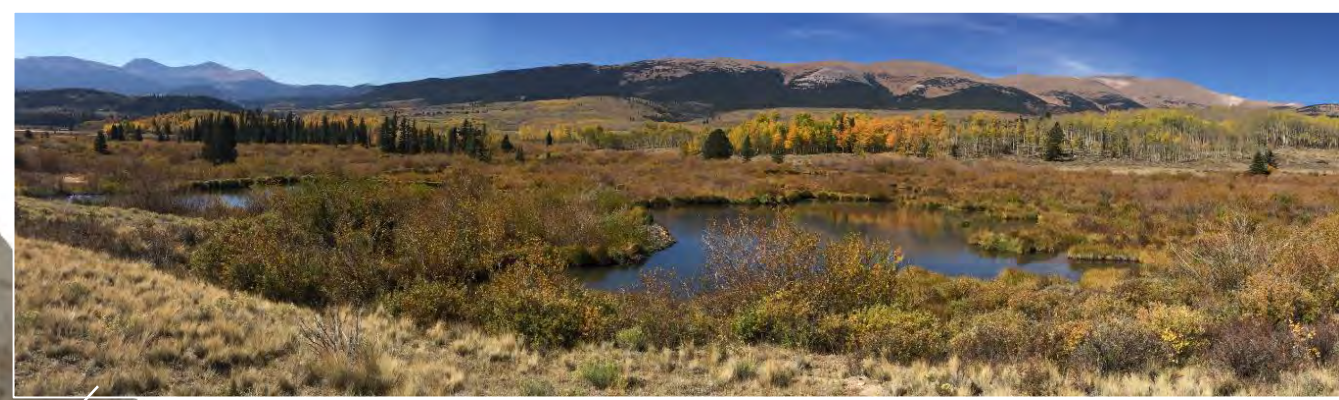
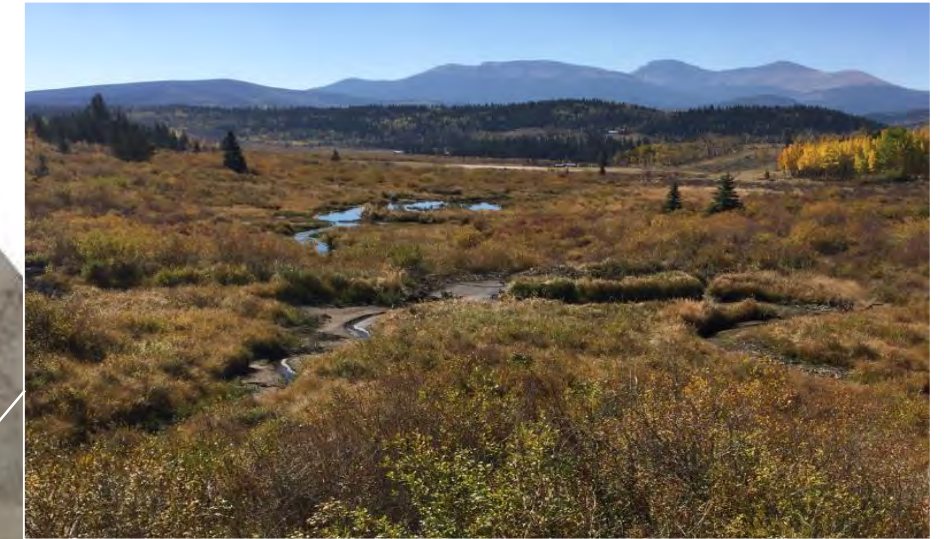
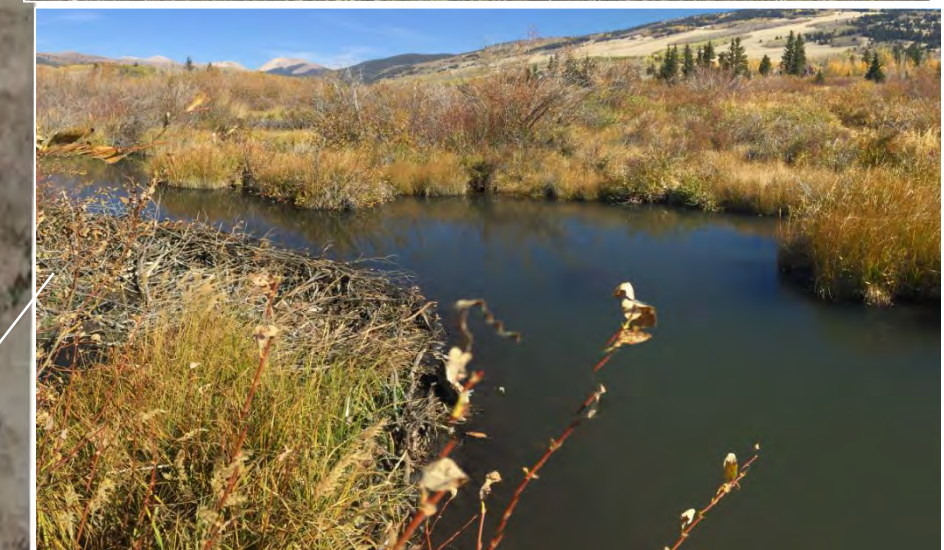
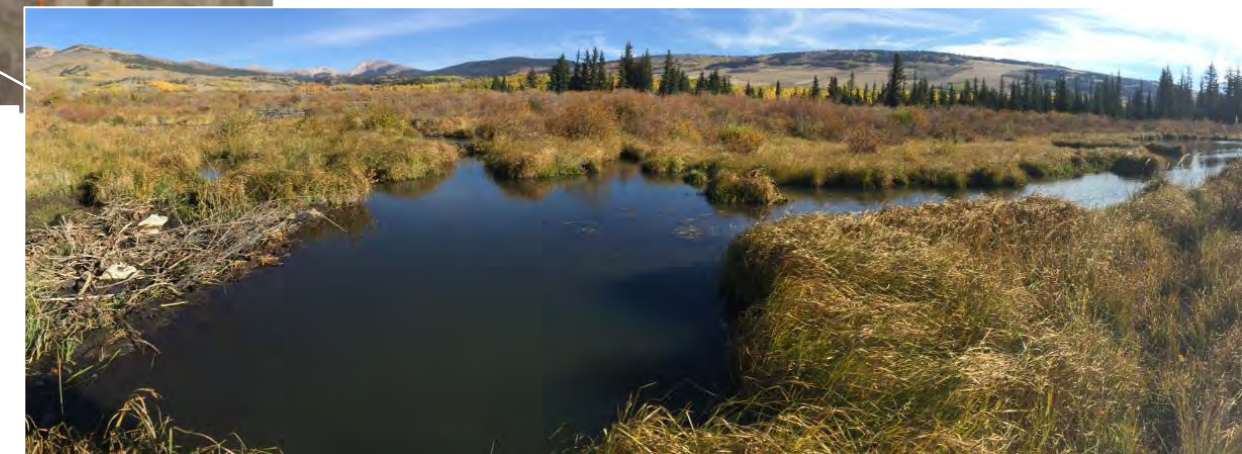
# Stream functional assessment reaches

Streams and riparian areas were divided into eight reaches, as shown here. Each reach is evaluated independently.

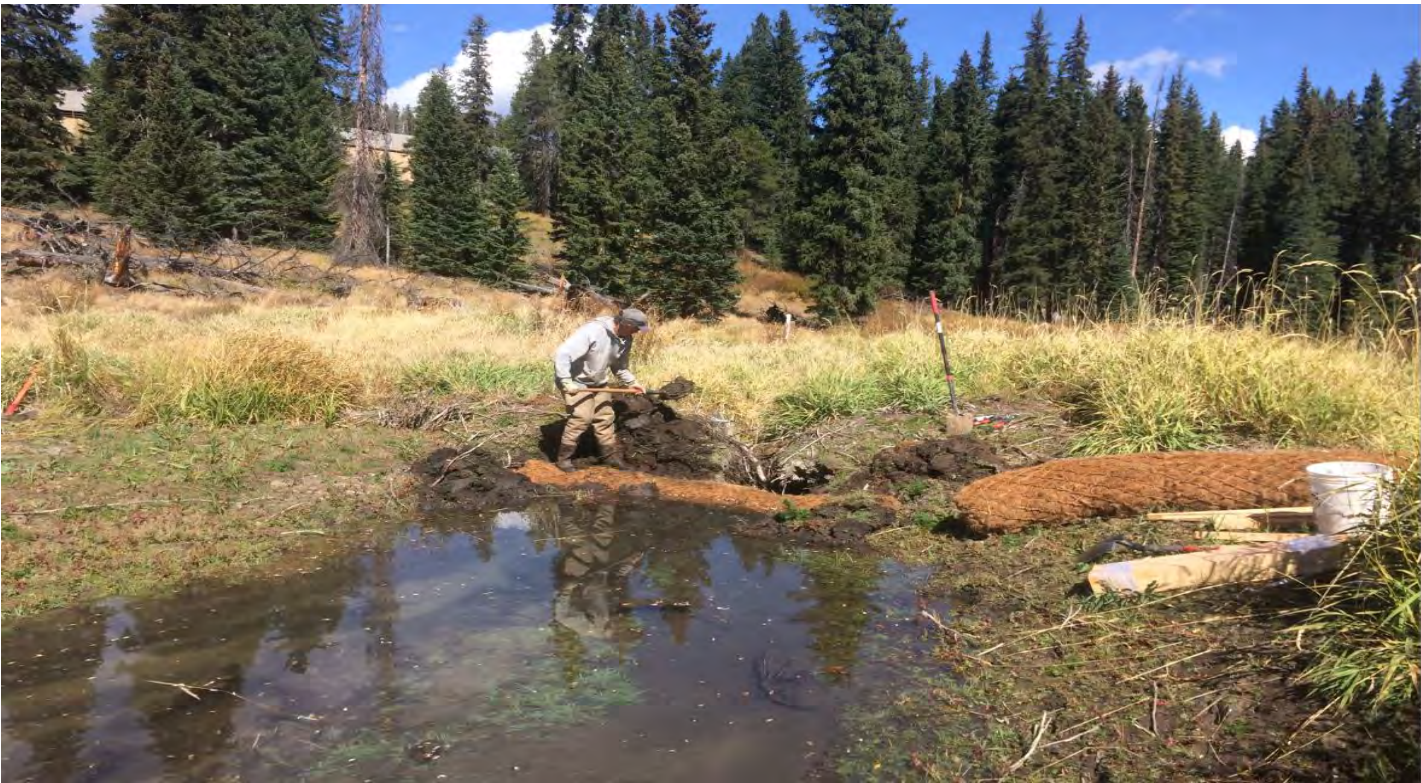
↑ Repairing breached beaver dams with coir logs and sod. ↓ Before and after.

Repairing or reconstructing beaver dams in places where beavers have been inactive is a good way to ensure continued function and habitat benefits during periods of prolonged beaver absence. Repaired dams also create deep water and cover that attracts dispersing beavers and entices them to recolonize an area. These treatments are highly recommended on Cave Creek, and could also be employed a spot treatments along Sheep and Twelvemile Creeks.

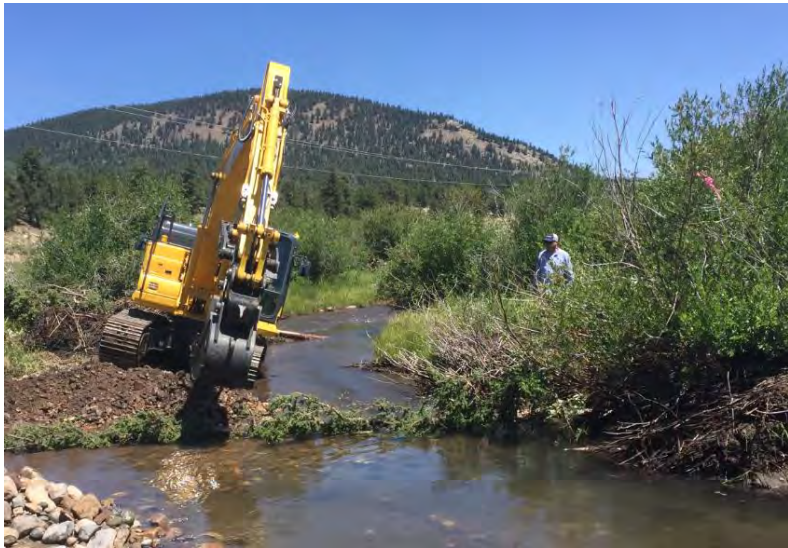
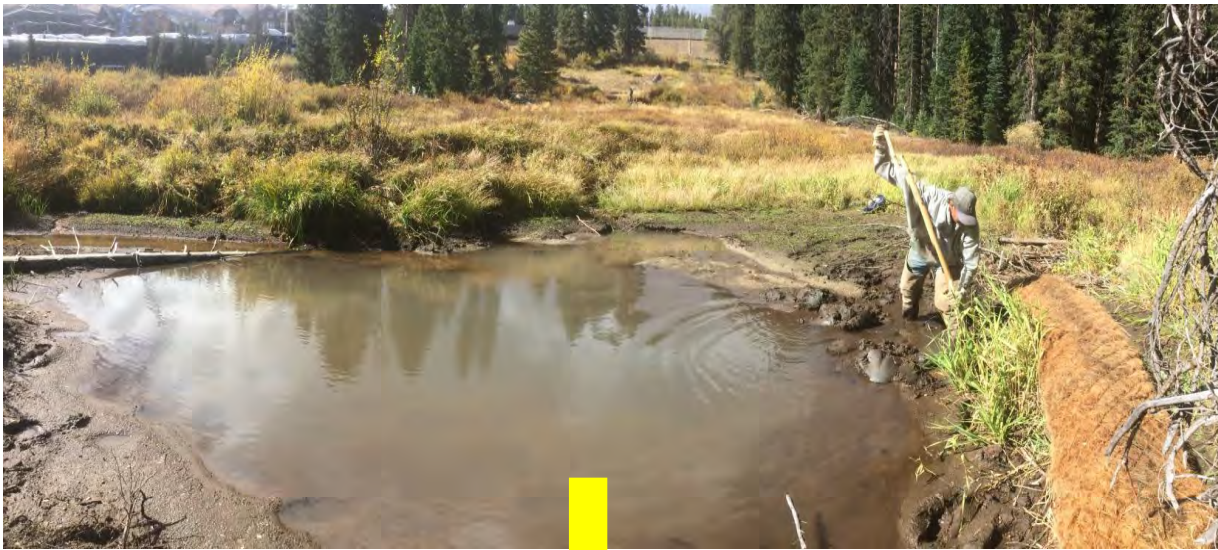
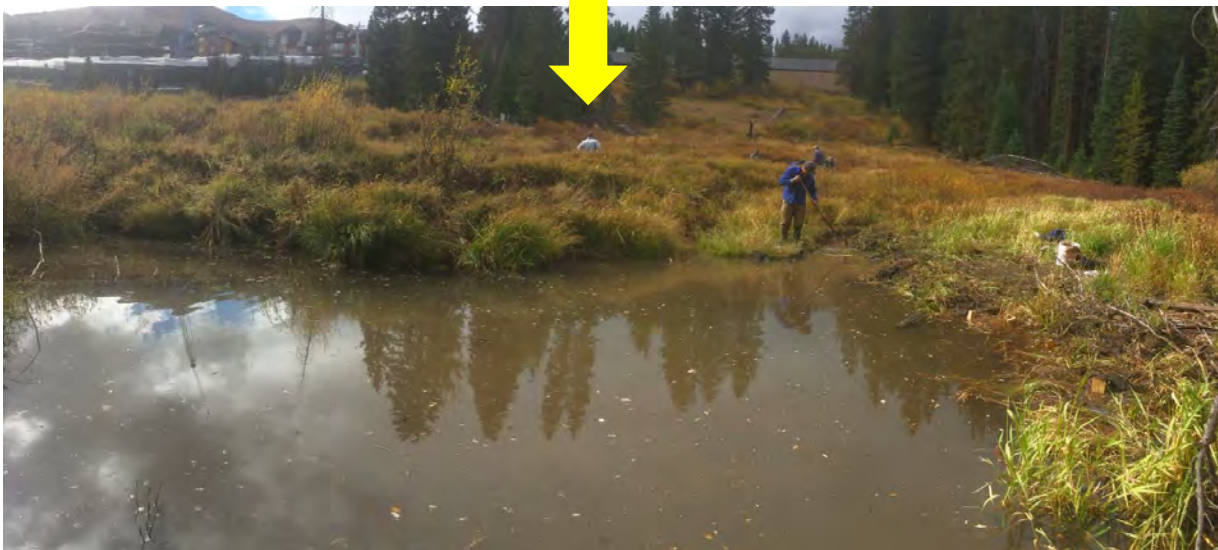
Restoration concepts: Beaver dam repair and rebuilding

**Design specs**  
The diagrams above and left show specifications for repairing cross-channel dams. These structures are designed to persist through normal runoff events, but are not permanent. They are constructed of native materials that assimilate into the streamscape over time.

Heavy equipment can greatly improve the quality and efficiency of beaver dam repair and construction, especially on larger creeks

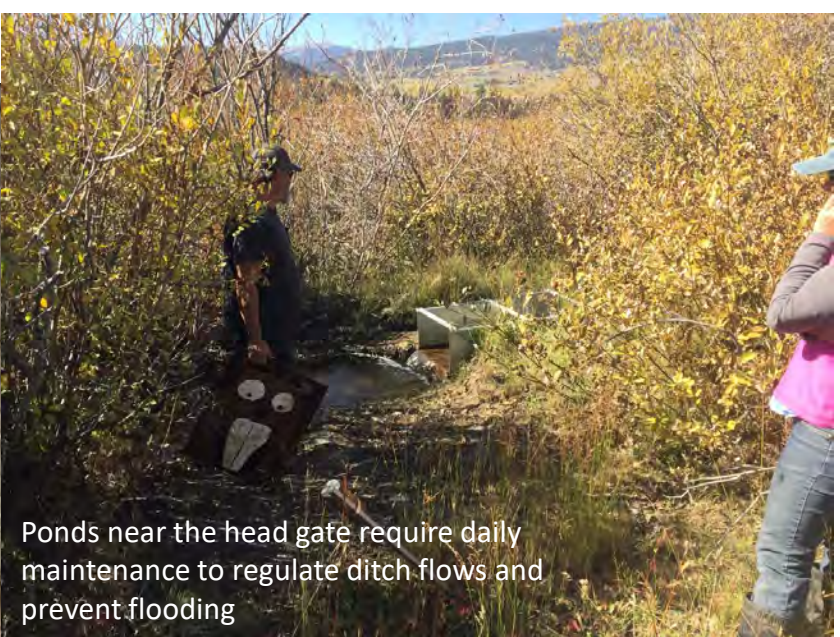
- A series of flow devices on the ponds on the west branches of Sheep Creek (point A) and at the head gate (point B) may help alleviate the daily maintenance burden ranch managers currently expend to:
  - (1) manage ditch flows,
  - (2) prevent flows entering ditch via path 3, and
  - (3) maintain perennial flow through both branches of Sheep Creek.
- Additional flow devices at the stream culverts (points C and D) may alleviate the need for daily maintenance to:
  - (1) prevent road flooding and erosion, and
  - (2) maintain perennial flow on Sheep Creek.
- Continue maintaining the ditch culver (point E) manually while the ditch is flowing.

Ponds near the head gate require daily maintenance to regulate ditch flows and prevent flooding

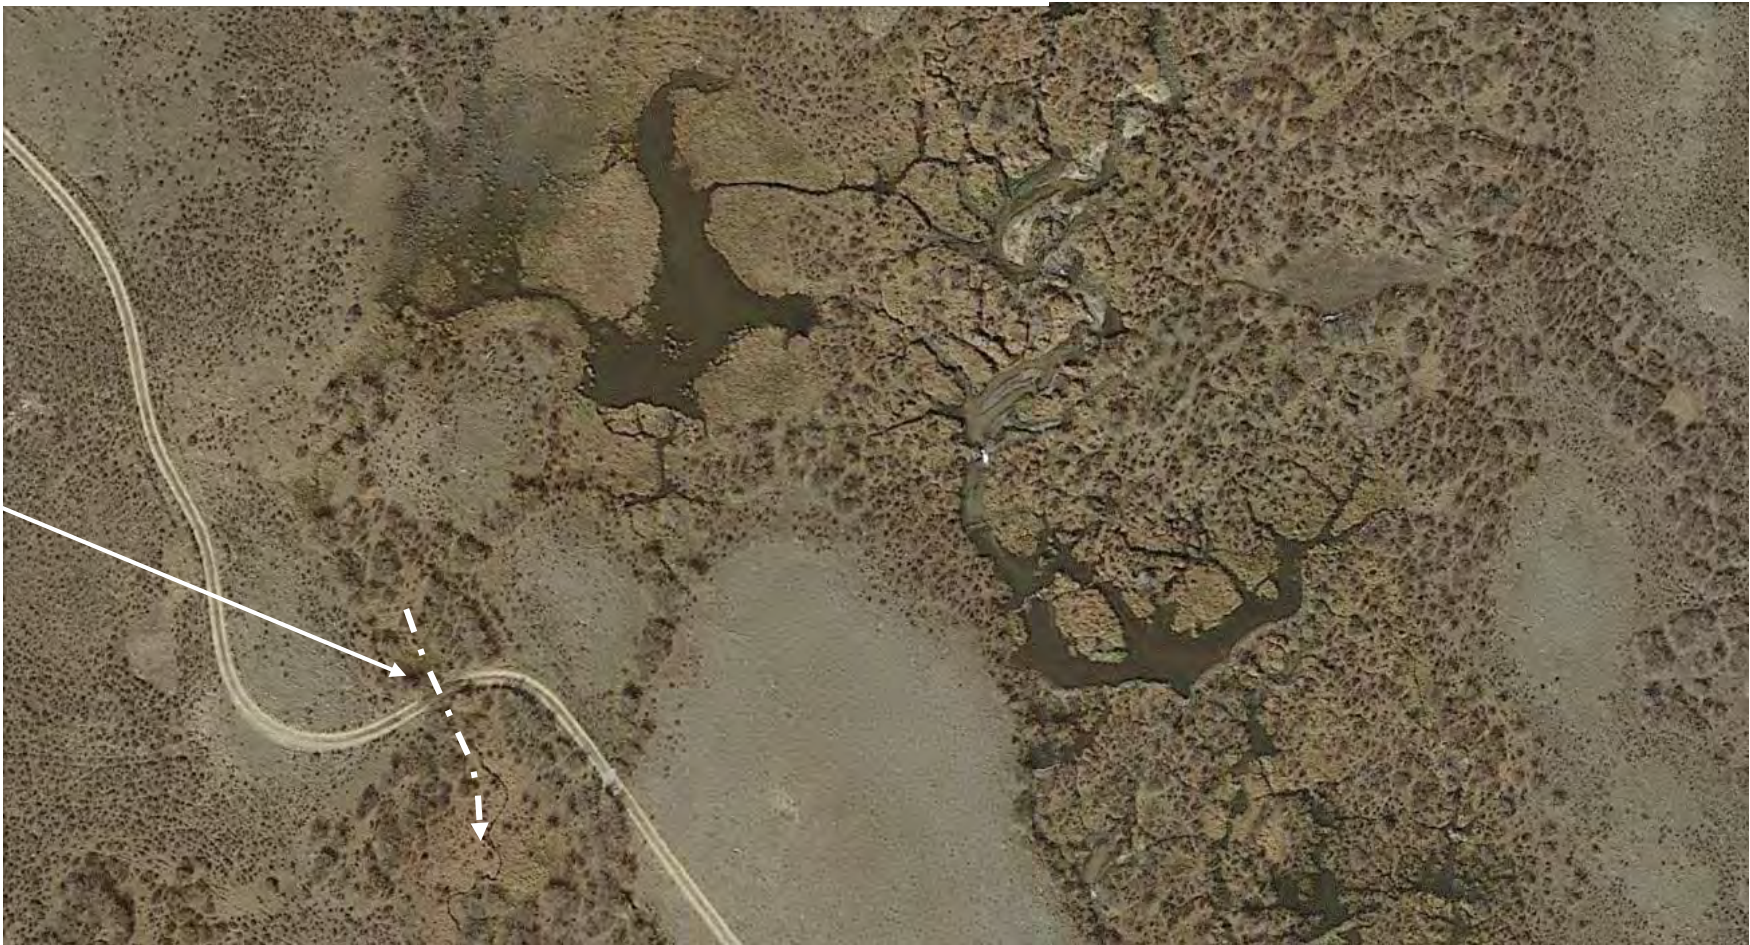
**Management concepts: Upper ranch road crossing**

**Upper ranch road crossing**

Depending on beaver activity upstream, a portion of Twelvemile Creek flows follow the flow path shown, flooding the road as it was in 2018. A culvert and possibly a flow device could help manage this situation.

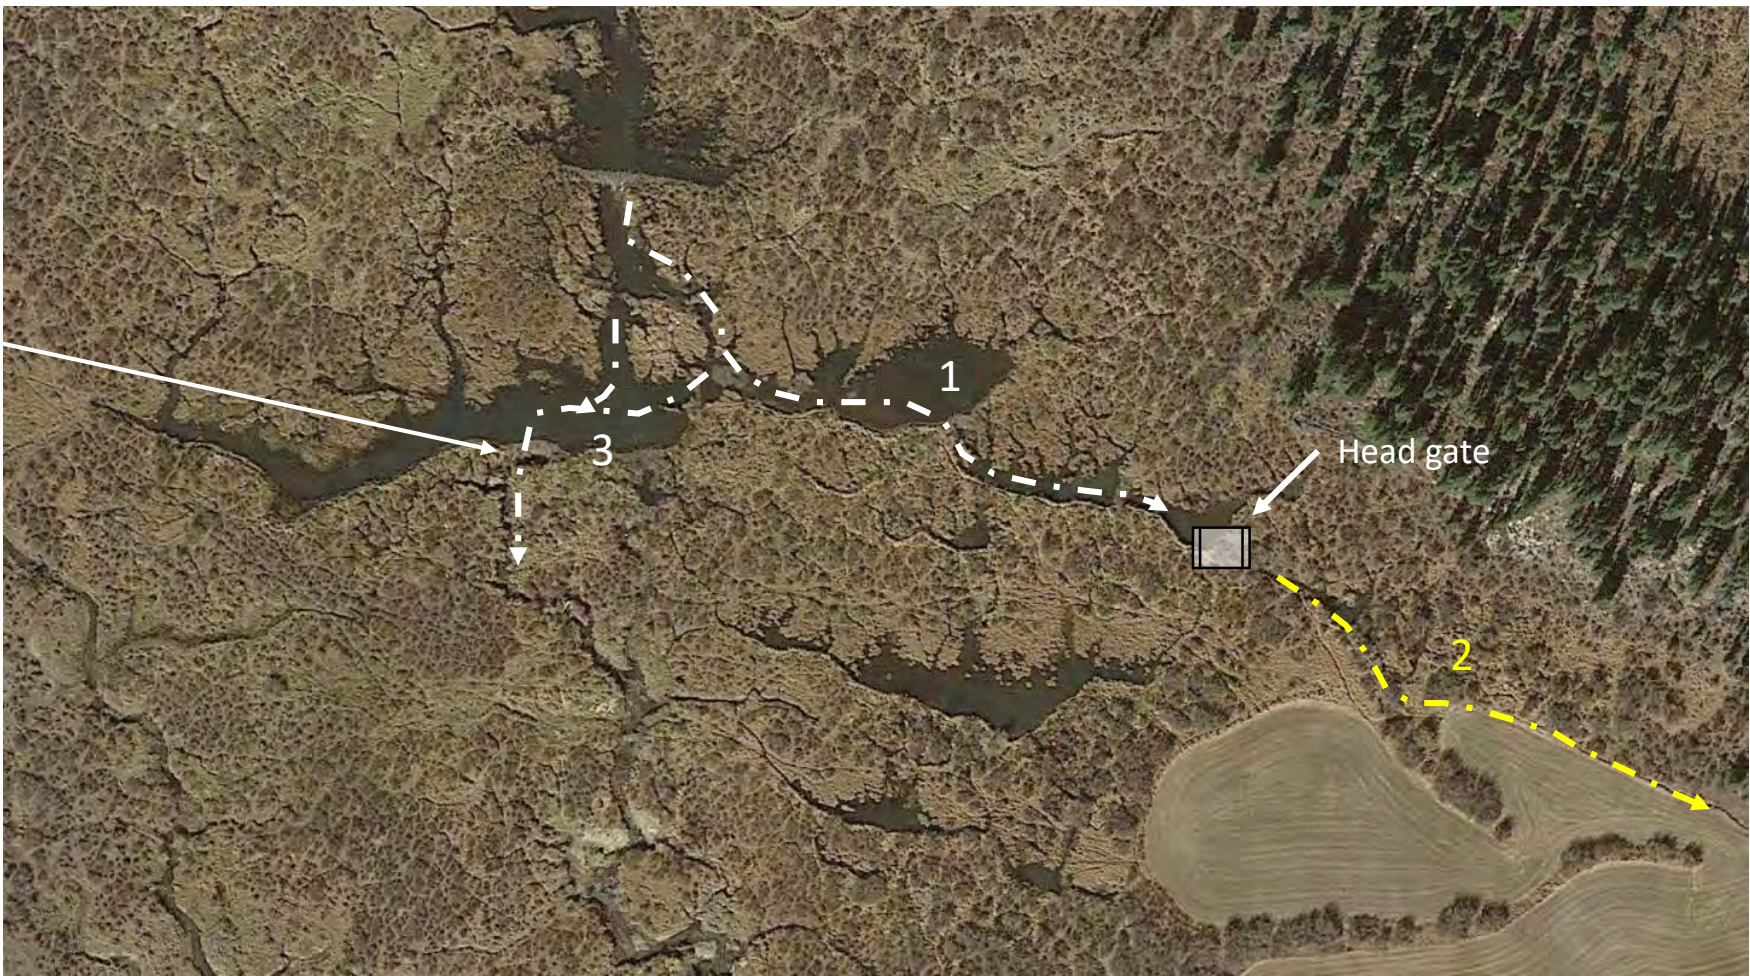
**Management concepts: Twelvemile diversion**

For the diversion to function, some portion of flow must follow path 1 to the head gate and ditch (path 2). A beaver dam that failed in 2018 greatly increases the risk of this path drying up, as flows preferentially direct towards path 3. Repairing this dam would mitigate this risk to the water right. Flow devices could also be considered if necessary.
