Re: POGG1,PDAA,201900002389, Tornay Highline Diversion Improvement Project Report

We have recently completed the Torney Highline Diversion Improvement Project. Please review the following project summary.

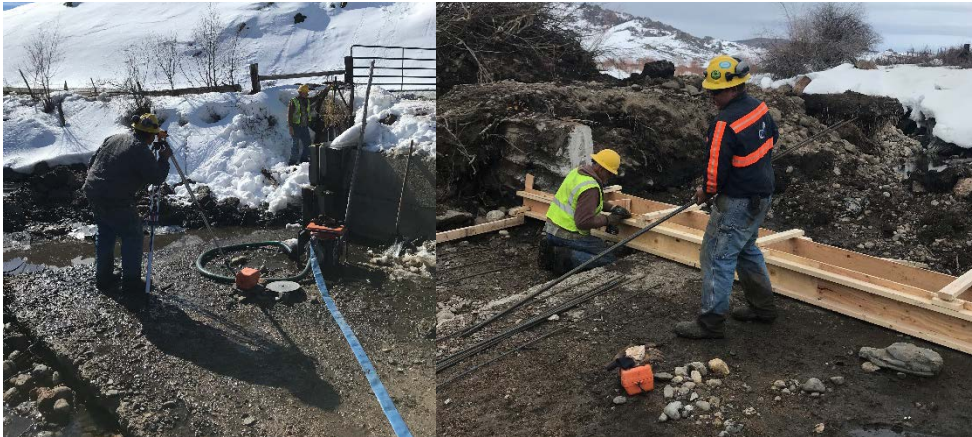
Once the new stem wall and apron were formed up re-bar was drilled into the existing apron and wing walls and suspending within the forms in the area where new concrete was poured. Concrete was poured in one slab and re-bar was also placed vertically to tie the buttress blocks to the apron. Once the concrete had cured 2x2x6 blocks were transported to the site and placed on the outer 2 feet of the apron. Holes in the bottom of the blocks aligned with the vertical re-bar extending from the apron.

The blocks were placed on geogrid fabric and tied together with metal strapping to further reduce the likelihood of movement.

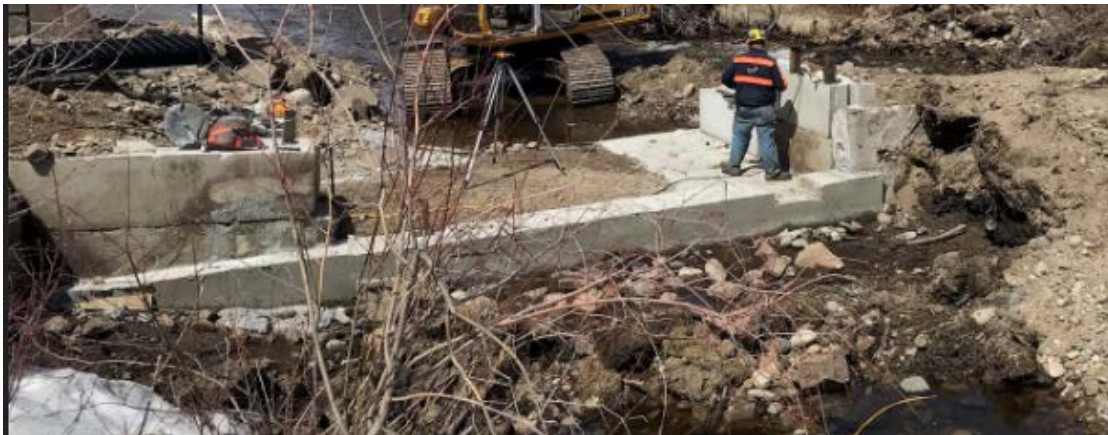
Once the blocks were set, the walkway (see task 3) was transported to the site and placed to span the channel between the buttresses. Metal straps and anchor bolts were used to secure the walkway to the buttresses.

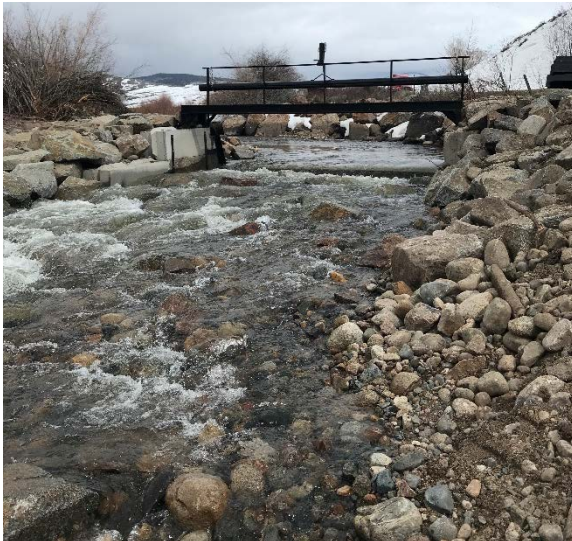
Looking up stream (above)

Once the on-site fabrication was completed and the walk way was secured, the coffer dam was removed. The bypass channel was filled with native cobble material and compacted. This area was sloped to a 5-1 grade and covered with 1-3 ft rock rip-rap. The finished elevation on the right bank, opposite the ditch inlet, is the same as the top of the ditch inlet pipe. This is the inside of the meander and will serve as a spillway during extremely high flows. The spill way on the right bank and the blocks on the left bank are reinforced with angular rock rip-rap.

Rock was also placed in the channel downstream of the apron and spillway to reduce scour and provide refuge for trout during high and low flows.

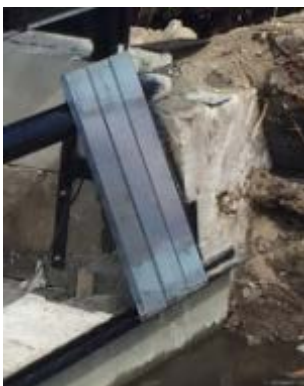
Panel (below)

The panels are a ¼ inch thick metal that resembles sheet piling. Each panel is 30 inches wide and 4 feet tall. Rather than flat stock these panels have a “V” every 6 inches. This type of panel was chosen for three reasons: 1) Rigidity 2) When in place, the panels will overlap, and the “V” will lock each panel to the next 3) When lowering a panel, the overlapping V will serve to guide it into position.

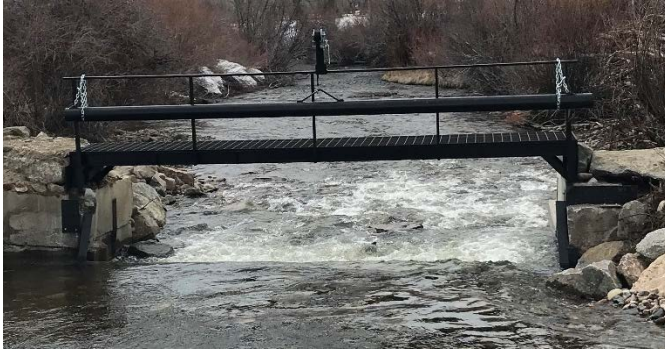
Panel Support in up position

The walkway, panels, and structure to support the panels were fabricated off site. The walkway is constructed from 6-inch I-beams, metal lattice, 4-inch angle iron, plate, and tubing. A hand rail is located on the upstream side of the walkway. The hand rail will improve operator safety and serve to support a wench used to raise/lower panels and raise/lower the panel support pipe. The 6-inch panel support pipe will be lowered into position prior to placing panels. It will provide support for the top of the panels and the bottom of the panel will rest on the stem wall under water. This pipe will be raised and chained in the “up” position during the winter and spring to reduce issues with ice dams and high flows.
