COLORADO Colorado Water Conservation Board Department of Natural Resources Water Plan Grant Application	Colorado	Park County Open Lands
		19 Board Meeting
Lat: 39.224 Long: -106.003	Total Project Cost:Water Plan Grant Request:Recommended amount:Other CWCB Funding:Other Funding Amount:Applicant Match:	\$ \$123,620 \$45,450 \$45,450 \$0 \$78,170 \$0
	Project Type(s): Study Project Category(Categories): Environ	
LOCATIONCounty/Counties:ParkDrainage Basin:South Platte	Recreation        Measurable Result: approx. 500 miles of corridor evaluated for restoration	of stream

# **Twelvemile Ranch: Beaver stream dynamics study — Summary**

**Twelvemile Ranch:**

A reconnaissance assessment of stream and riparian condition for the Riparian Reconnect project with recommendations for restoration and management

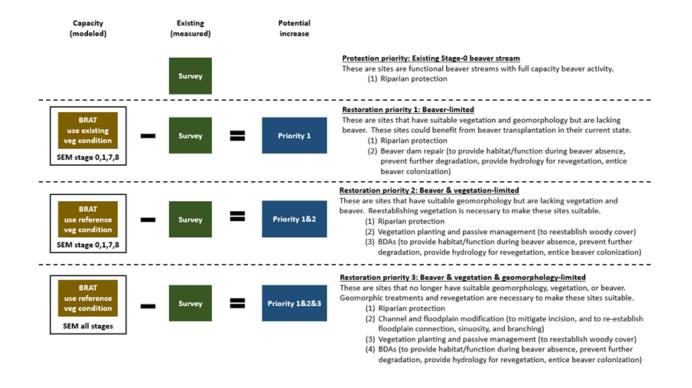
Figure 1. Schematic showing how this study quantifies the potential for beaver restoration. Basin-wide beaver activity surveys (pond area/mile, dams/mile) define the existing level. Capacity is predicted using BRAT, and the potential for increase is the difference of capacity minus existing. Reaches with a high level of beaver activity are protection priorities. Restoration priorities 1-3 represent reaches for which increasing levels of effort are required to restore sustainable beaver activity. Capacity for the priority 1 (beaver-limited) condition is given by BRAT simulations using existing vegetation on reaches that are not entrenched. Increased capacity for the priority 2 (beaver & vegetation-limited) condition is estimated by BRAT simulations that use reference vegetation on reaches that are not entrenched, assuming that vegetation can be restored. Increased capacity for the priority 3 (beaver & vegetation & geomorphology-limited) condition is estimated by BRAT simulation and entrenchment can be restored.

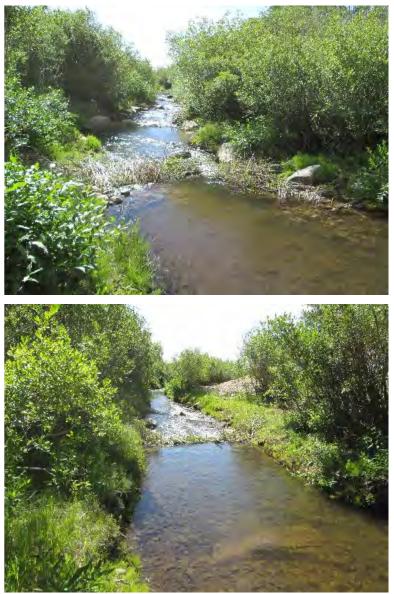
Figure 4: Example brush dam beaver dam analogs on Tarryall Creek .

We recommend using brush dams (Figure 4) as the select BDA structure where possible since they are simple and easy to construct using small diameter wood, rock, and sod mats that are

available on site. They are also low impact, temporary, and generally passable by most aquatic organisms including fish. Relict beaver dams are present at both of the recommended release sites, and an ideal strategy would be to utilize these existing dams by simply plugging the areas that are breached with constructed brush dams. Brush dams about five feet wide and one to two feet tall will be sufficient at most locations for this purpose.

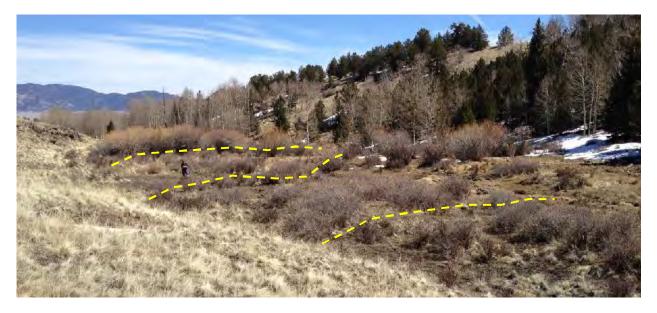
Figure 3: The single thread channel of Pruden Creek is visible on the right side of the image running through a historically active floodplain. Relic beaver dams are identified by the dashed lines.

Pruden and Cross Creeks offer good potential for restoration of wetland functions by reintroducing beavers. About 8900 ft of the Pruden Creek drainage and 4500 ft on Cross Creek have good or excellent habitat suitability for beavers. From these suitable reaches, we identified two priority sites on Pruden Creek (about 1900 ft) and one site on Cross Creek (about 700 ft) where beaver reintroduction is predicted to result in the restoration of about 2.5 and 0.9 acres worth of wetland functional units, respectively. (These are the blue segments in Figure 1). Figure 3 is a photo of the selected Middle Pruden Creek restoration site taken in September of 2014.

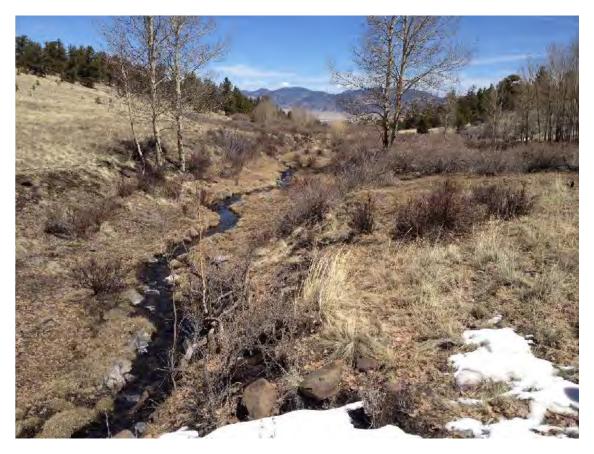
Figure 2: On artificially channelized reaches, the stream is entrenched and dissociated from its historic floodplain. Deeply entrenched segments such as this have limited wetland restoration potential as bank heights exceed the height of typical stable beaver dams.

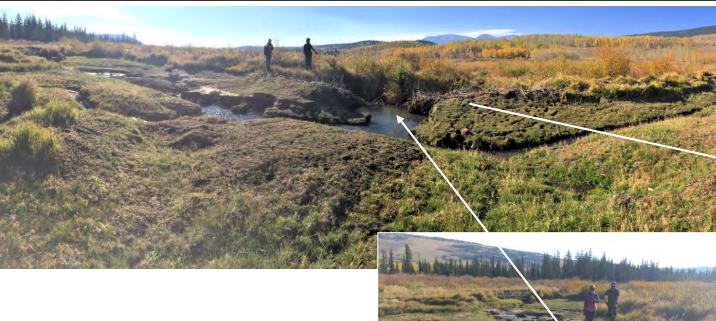
For the diversion to function, some portion of flow must follow path 1 to the head gate and ditch (path 2). A beaver dam that failed in 2018 greatly increases the risk of this path drying up, as flows preferentially direct towards path 3. Repairing this dam would mitigate this risk to the water right. Flow devices could also be considered if necessary.

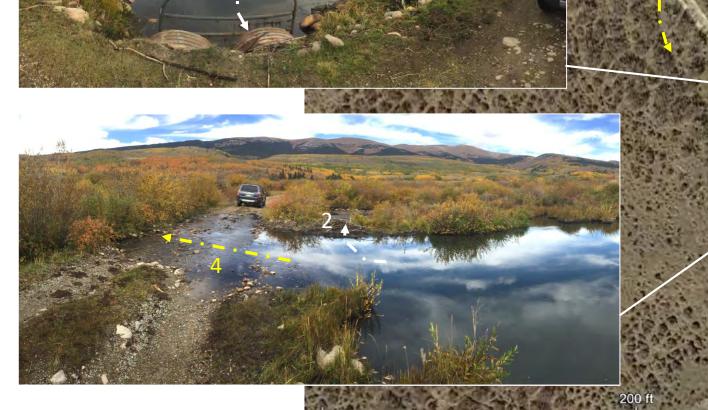
Road flooding and road damage are common where the road crosses Twelvemile Creek. Notes:

- Twelvemile Creek flows are intended to cross the road via flow paths 1 and 2, through the culverts.
- Keeping the culvert open requires constant manual maintenance.
- Beavers frequently divert the creek so it flows over the road via path 3. This was the case when we visited in 2018.
- The road is also at high risk of flooding at via flow path 4.

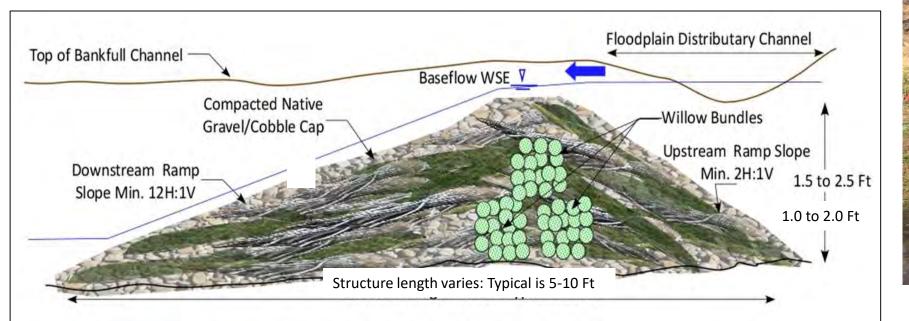
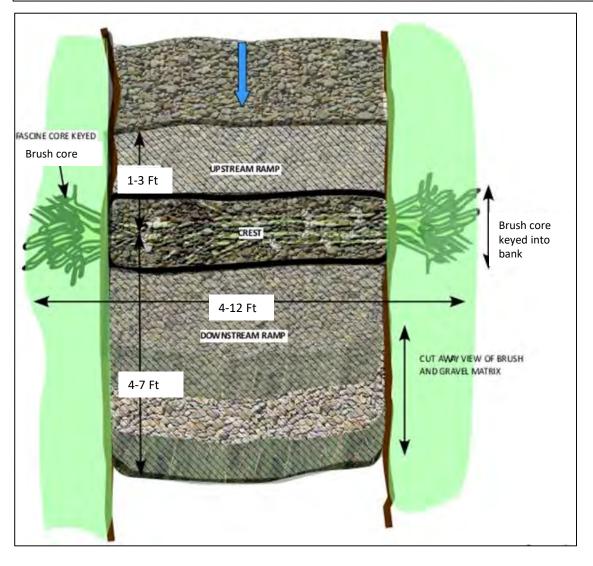
The diagrams above and left show specifications for repairing cross-channel dams. These structures are designed to persist through normal runoff events, but are not permanent. They are constructed of native materials that assimilate into the streamscape over time.

Repairing or reconstructing beaver dams in places where beavers have been inactive is a good way to ensure continued function and habitat benefits during periods of prolonged beaver absence. Repaired dams also create deep water and cover that attracts dispersing beavers and entices them to recolonize an area. These treatments are highly recommended on Cave Creek, and could also be employed a spot treatments along Sheep and Twelvemile Creeks.

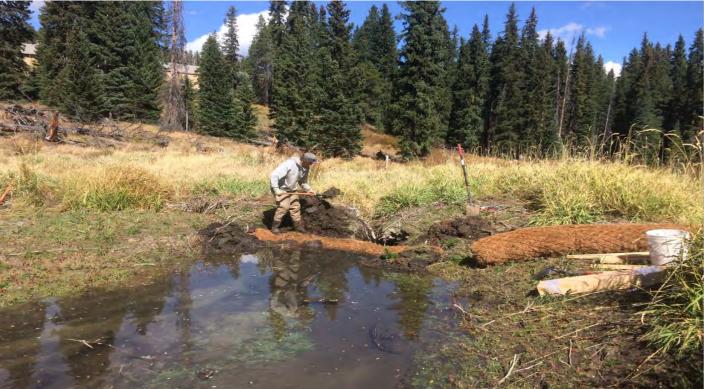
↑Repairing breached beaver dams with coir logs and sod

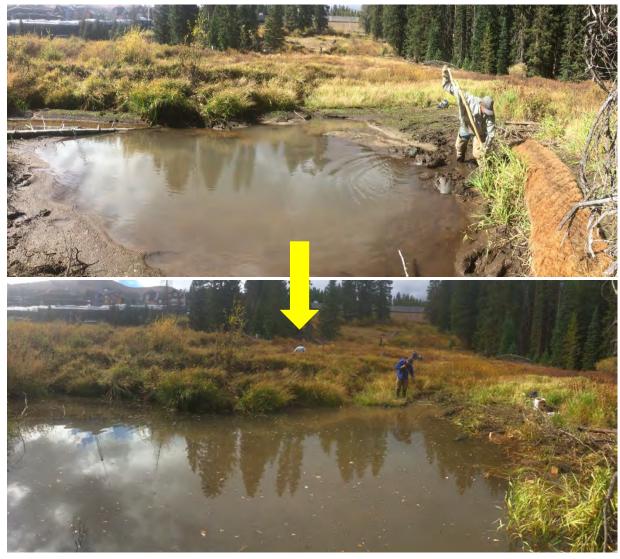
$\downarrow$  Before and after.
