**RE: Martin Springs Irrigation & Storage Improvements Project -  
Letter of Substantial Completion**

The purpose of this letter is to summarize the status of private improvements completed with the Martin Springs Irrigation and Storage Improvements Project and serves as the WSRF Grant "Final Report". (POGG1 2021-45)

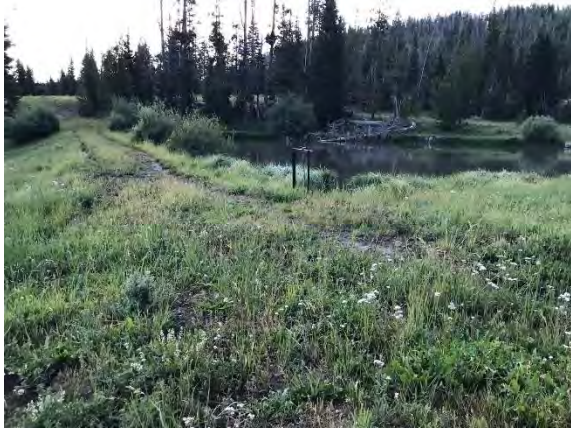
**Existing Earthen Dam**

The existing "Martin Pond" was restored to original absolute capacity of 3.5 acre-feet (Case#08CW92) by removing excess sediment from the bottom of the pond with methods of excavation. Fill material from onsite was placed in compacted lifts on the existing earthen dam to mitigate erosion and re-establish a constant grade of "freeboard" at the top of the dam. The existing 12-inch CMP outlet pipe was replaced with an 18-inch HDPE pipe to convey overflows.

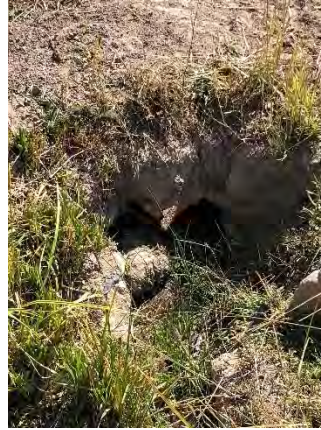
**Existing 12-inch CMP Outlet Pipe**

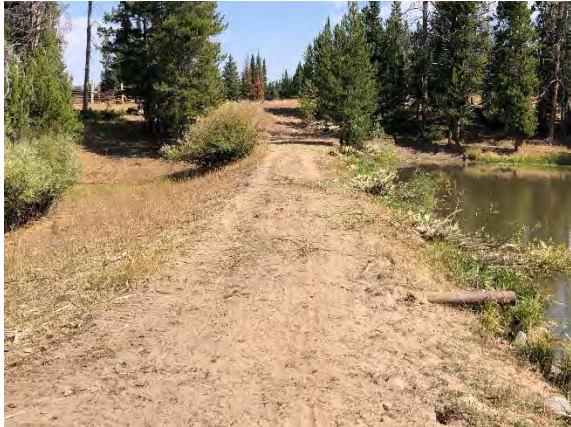
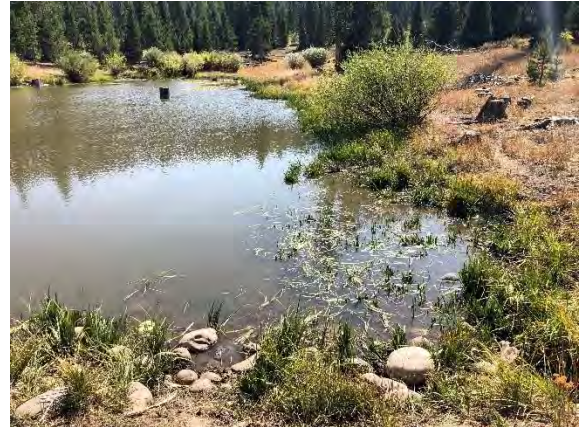
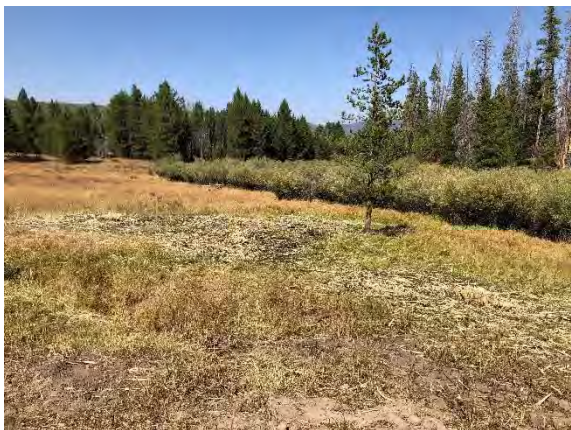
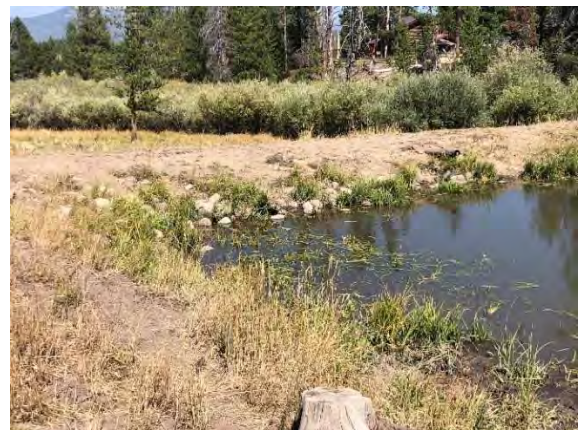
**Site Preparation (Clearining and Grubbing)**

Initial clearing and grubbing was conducted to remove excess overgrowth from the earthen dam and remove debris prior to construction. Riprap erosion control measures were installed and native grass seed mix was planted on all disturbed areas upon project completion to promote natural vegetation re-growth and to minimize erosion.

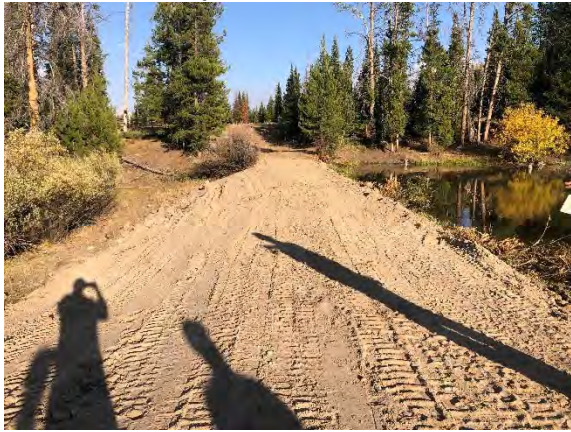
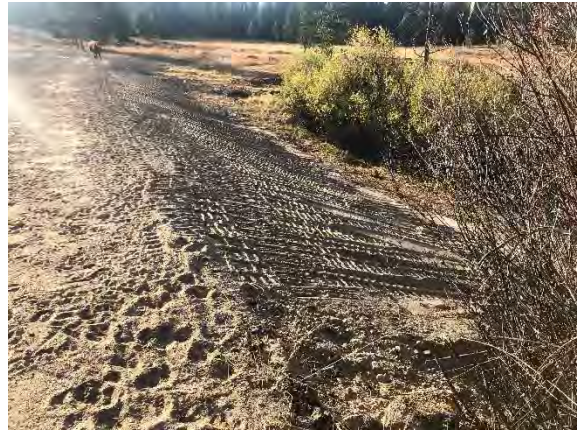
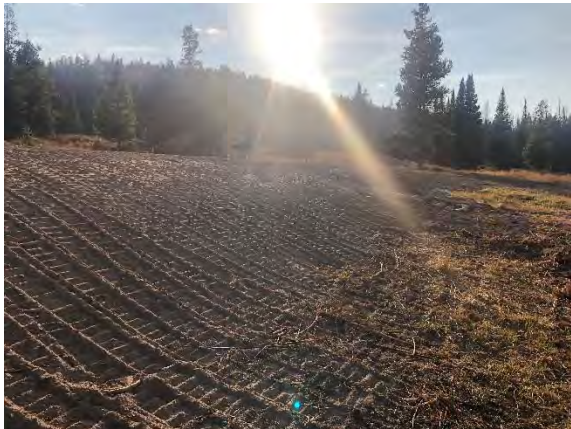
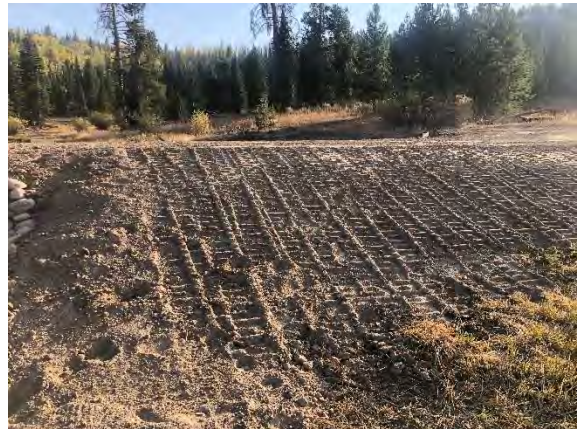
### Earthen Dam Improvements (Interim & Final)

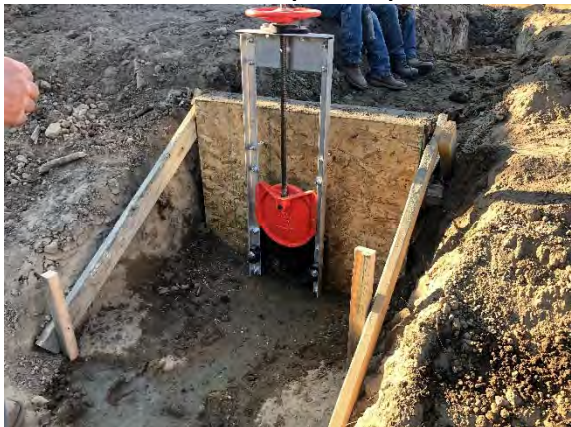
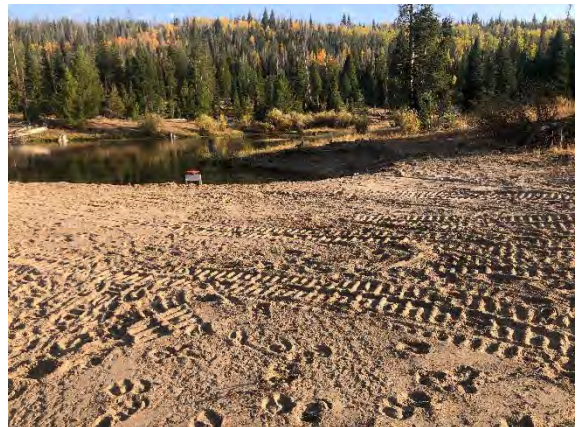
### Diversion Construction (Interim)

In addition, a new surface water diversion was created to divert 0.6 cfs of irrigation water (Case#18CW8). A 10-inch spigot back headgate with a 10-inch HDPE culvert was installed during re-construction of the earthen dam to create a diversion from the normal surface water level of the existing to pond for the purpose of irrigation.

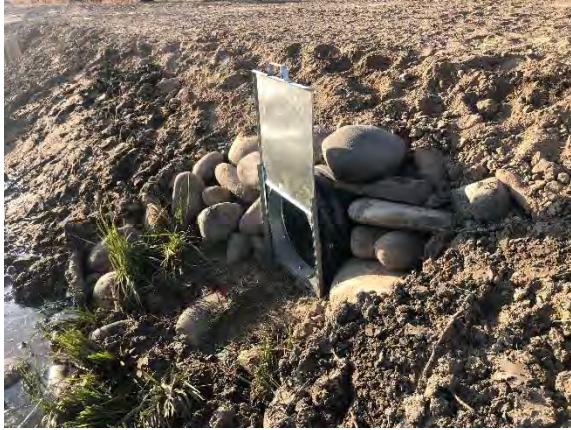
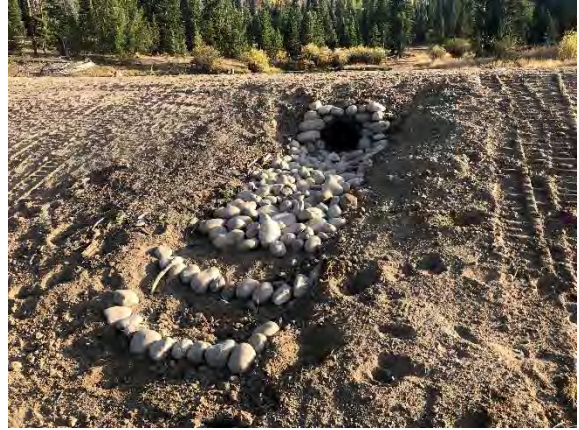
### New 18-inch HDPE Outlet Pipe

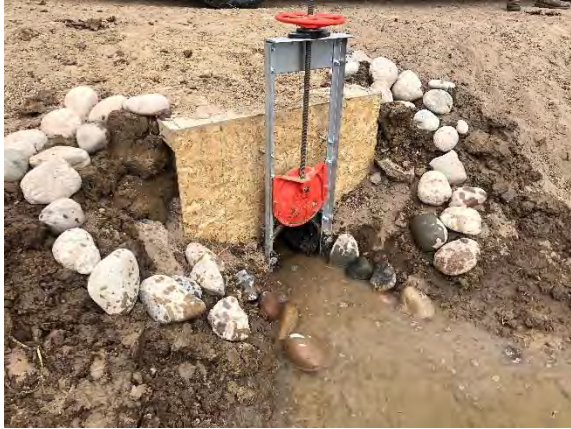
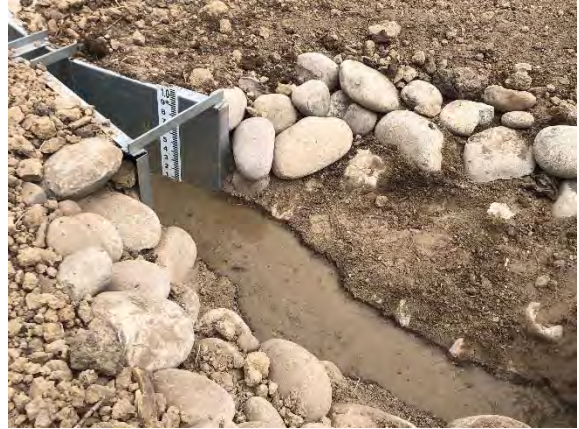
### New Diversion Headgate and Flume

Lastly, a swale/ditch was constructed to convey irrigation water diverted from the headgate to an adjacent hay meadow for the purpose of flood irrigation. A 3-inch x 12-inch Parshall Flume with Staff Gauge was constructed to accurately measure surface water flows used for irrigation.

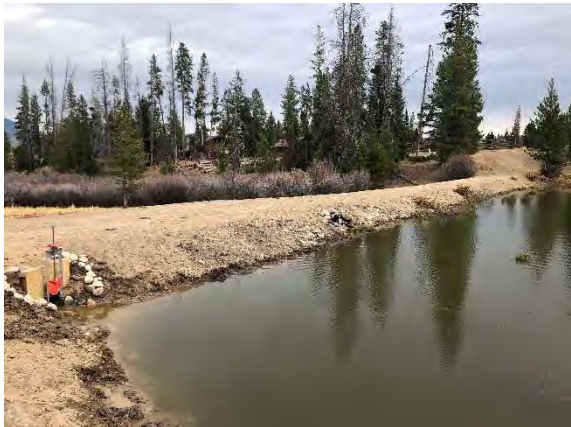
### Post-Construction Conditions (Final)
