## **Blue River Integrated Water Management Plan Phase I Report**

Colorado Water Conservation Board

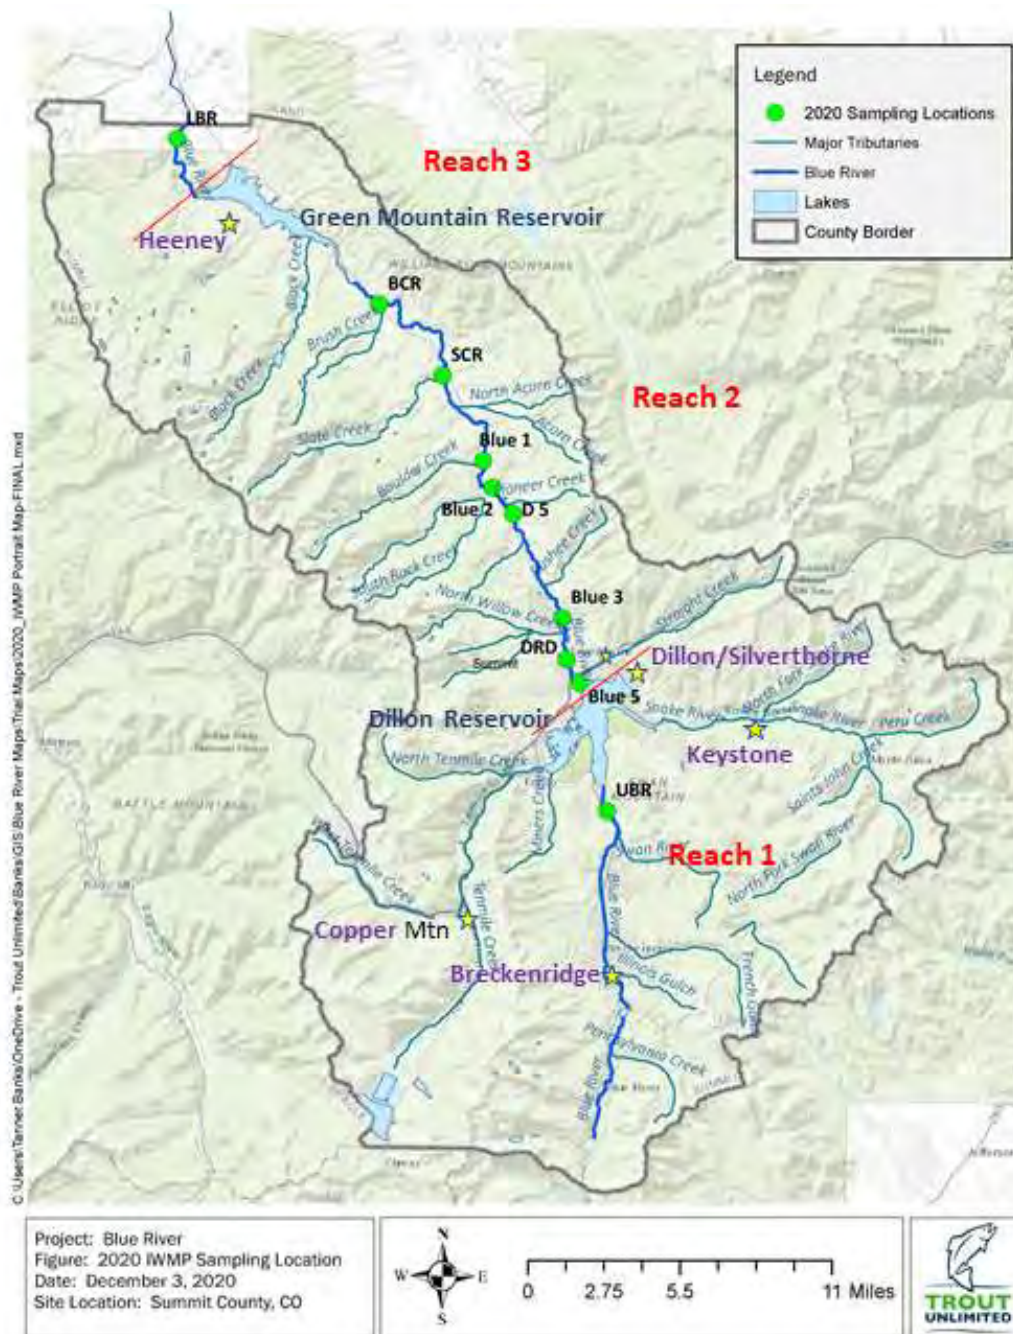
Figure 4. Blue River Reach Designations.

For purposes of this report the Blue River watershed is divided into three distinct reaches (Figure 4):

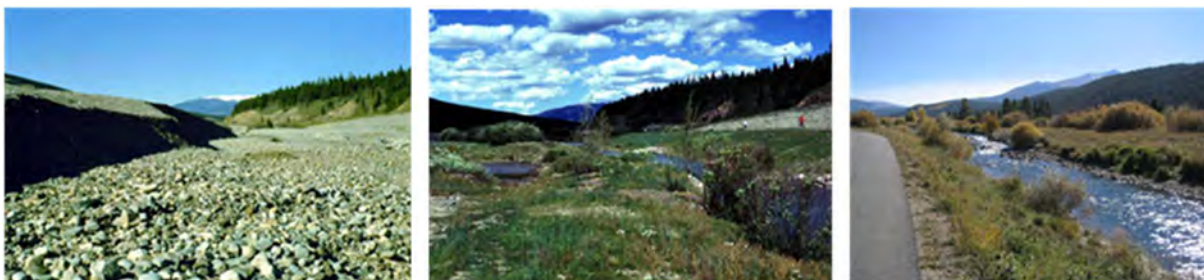
Figure 7. Blue River north of Breckenridge: left photo is before restoration, middle photo of overbank wetlands pond after restoration; right photo is river channel after restoration.

The Blue River mainstem within R1.2 and R1.3, had been heavily disturbed by dredge boat mining from the turn of this century until 1940. Dredge boats extracted the river alluvium and sifted through the material for gold, washing fines downstream and leaving behind large piles of rock, often deposited in uniform sizes due to the sorting process. As a result of this activity, the original river channel and surrounding floodplain was destroyed. What remained of the river was an indistinguishable channel containing flows only during snowmelt runoff. As late-season flows receded, the river was conveyed in the subgrade through the voids of the massive dredge rock piles. The dredge tailings were devoid of vegetation, fines and boulders, were highly mobile and very unstable (**Figure 7**).

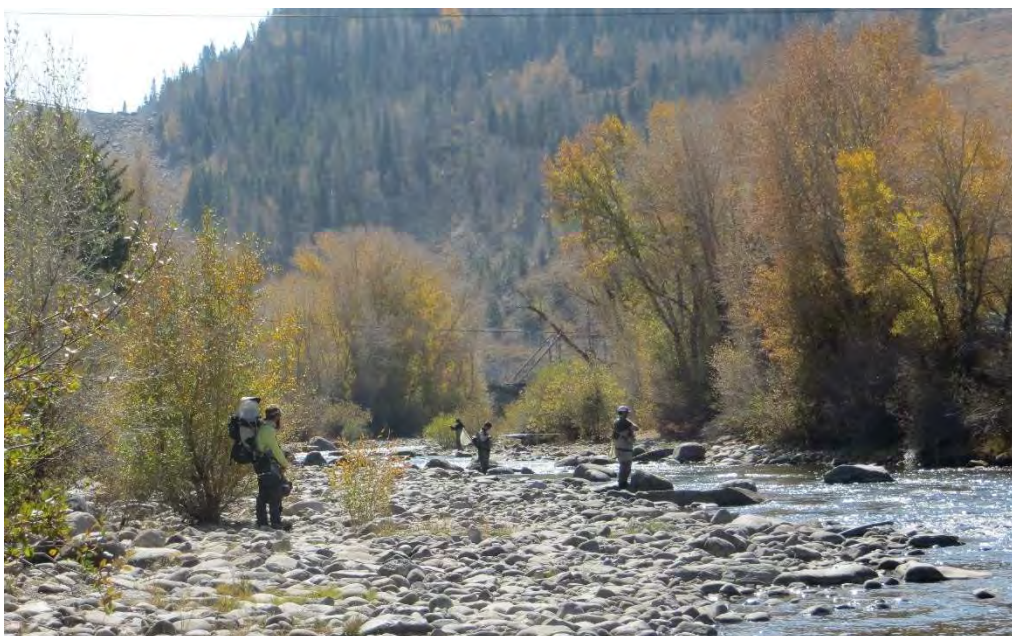
Figure 10. Reach 2: Blue River downstream (north) of Dillon Reservoir.

Reach 2 is approximately 20 miles long, measured along the valley floor from the Dillon Dam outlet (**Figure 10**) to Green Mountain Reservoir inlet. Green Mountain Reservoir is operated by the U.S. Bureau of Reclamation. For purposes of this assessment, Reach 2 is further subdivided into three subreaches to represent the changing morphology and different settings in terms of river form, urban development, and land use. The assessment does not include tributaries to the main stem of the Blue River or Green Mountain Reservoir.

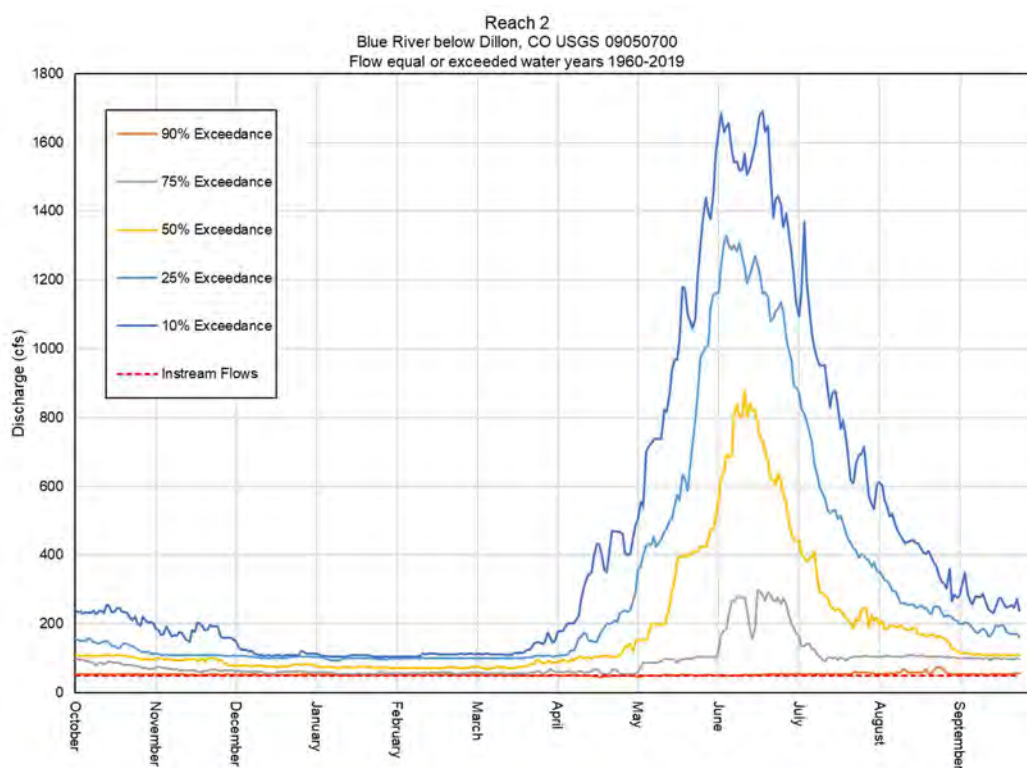
Figure 12. Station 09050700 (Blue River below Dillon) Exceedance Hydrograph.

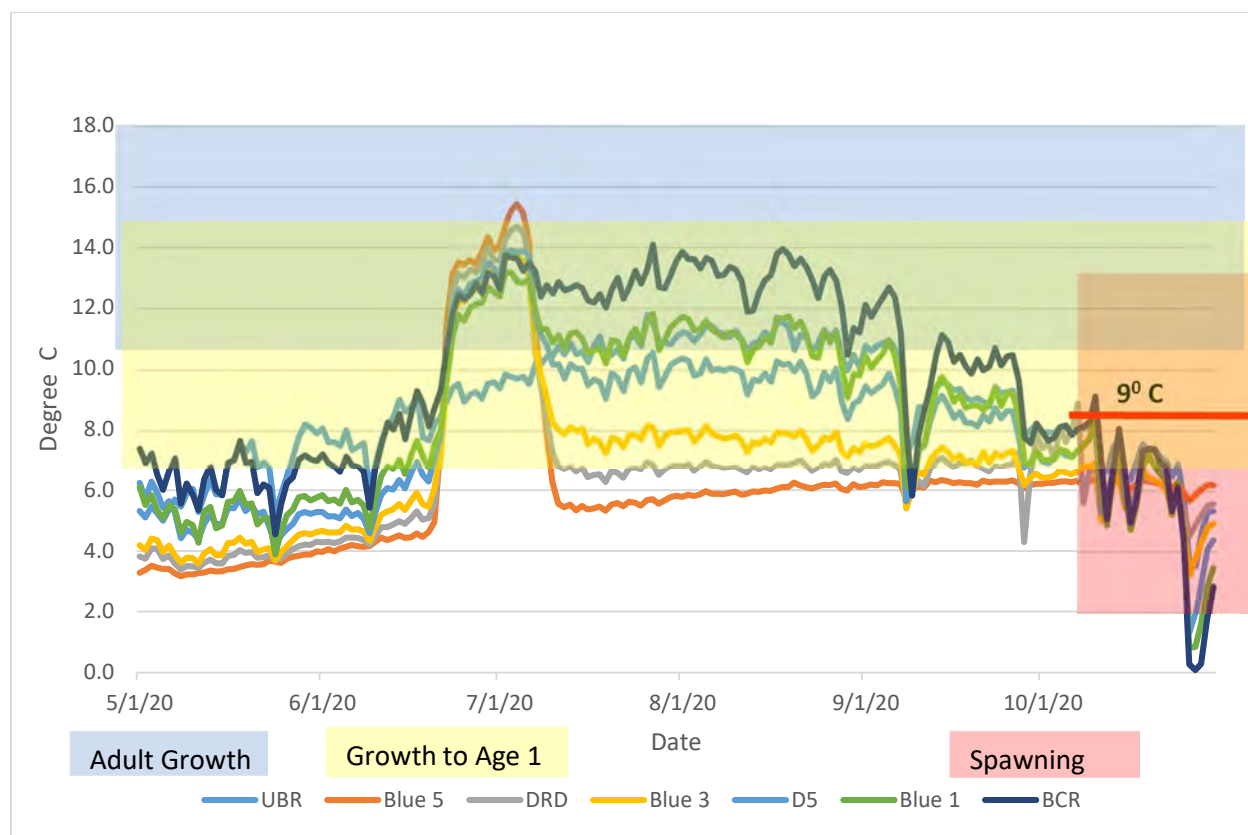
Figure 14. Temperature Ranges for Optimal Growth and Spawning for brown trout presented with Blue River Daily Average Temperatures.

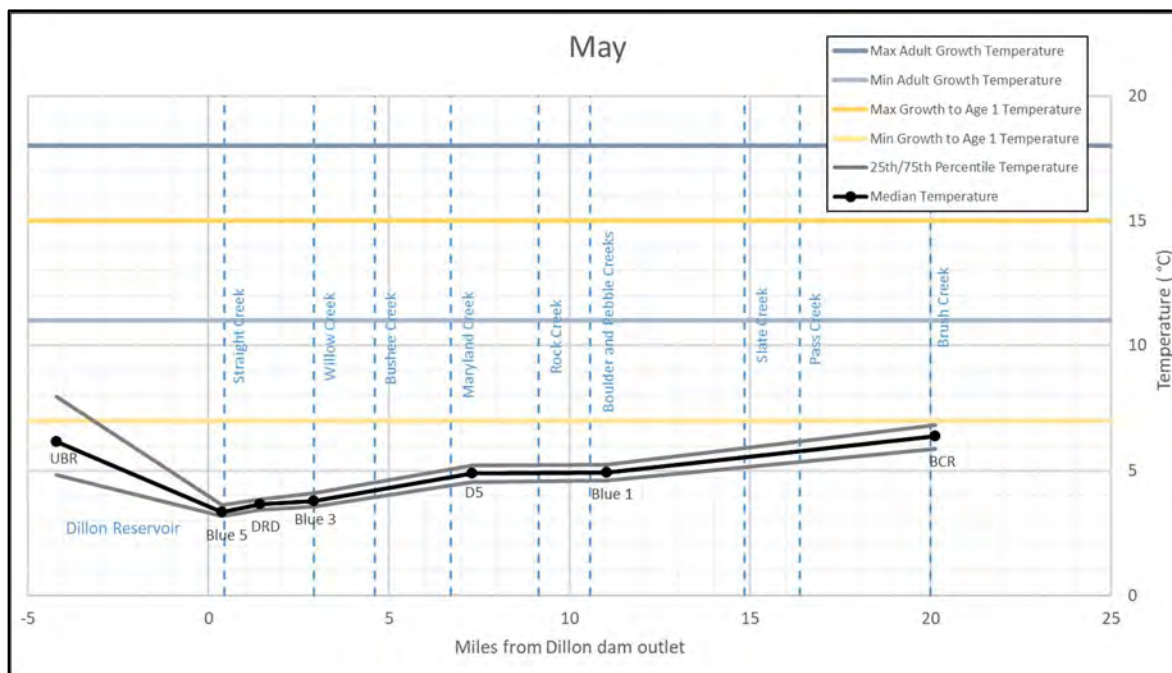
Figure 15. Temperature Profile Plots, May 2020.

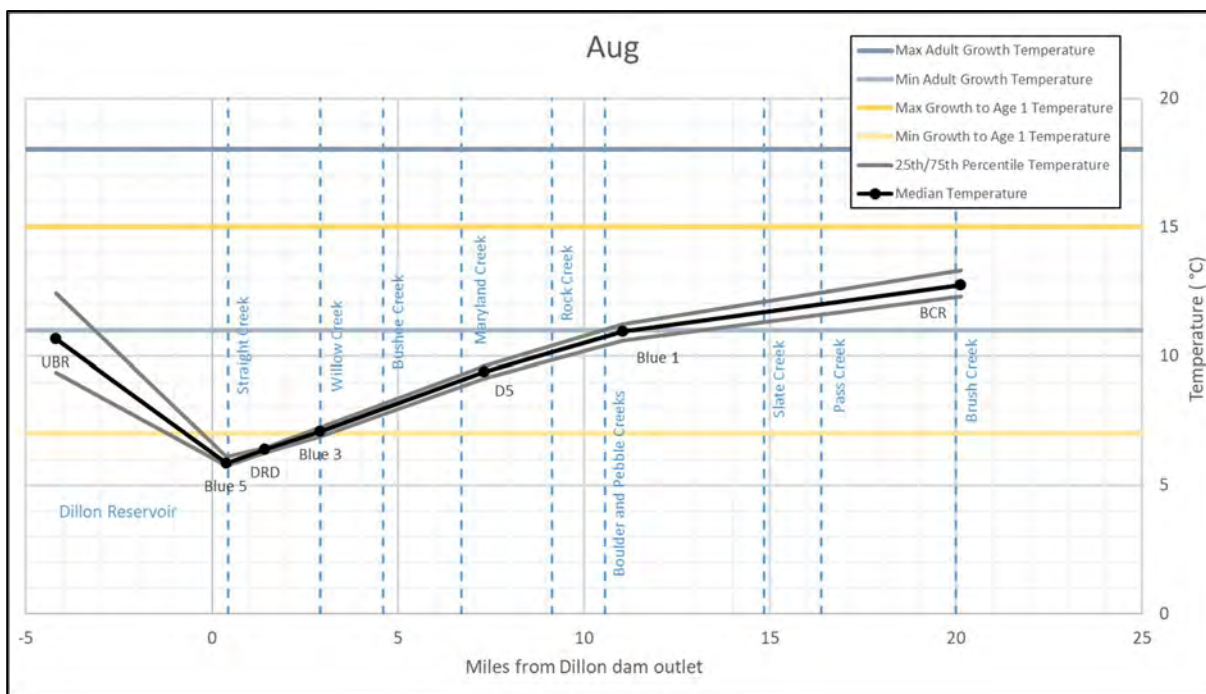
Figure 17. Temperature Profile Plots, August 2020.

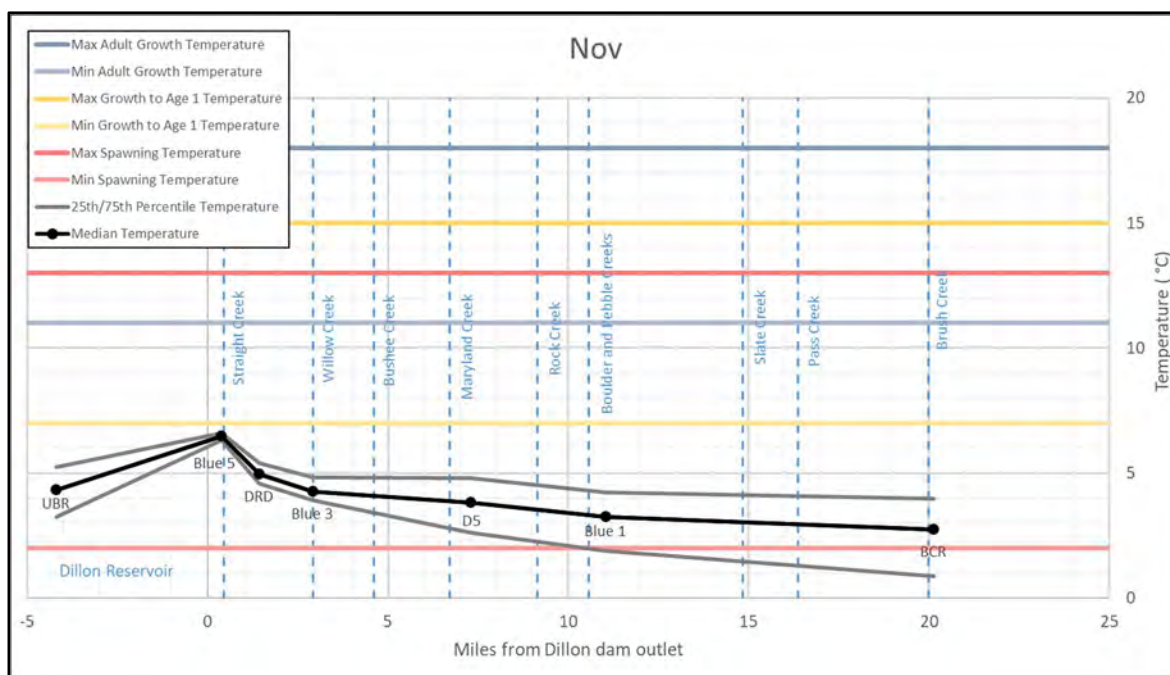
Figure 19. Temperature Profile Plots, November 2020.

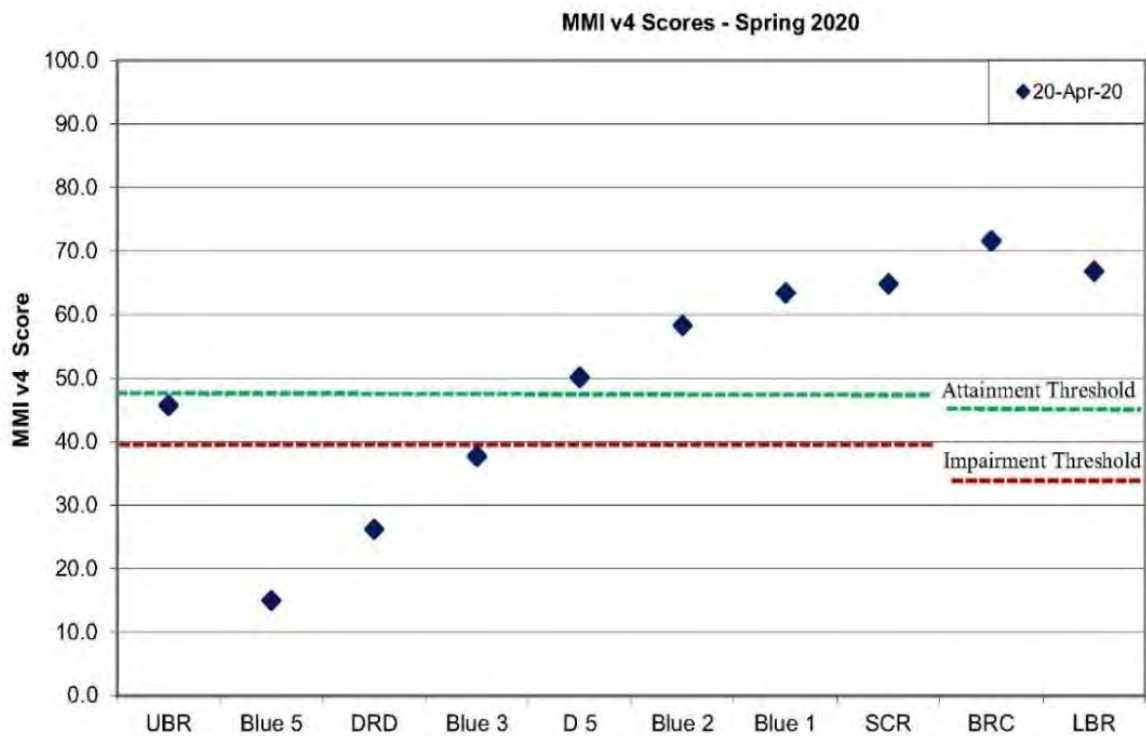
Figure 20. MMI v4 scores from composited quantitative (Hess) samples at study sites on the Blue River during April 2020 (Figure 2, Timberline 2021).

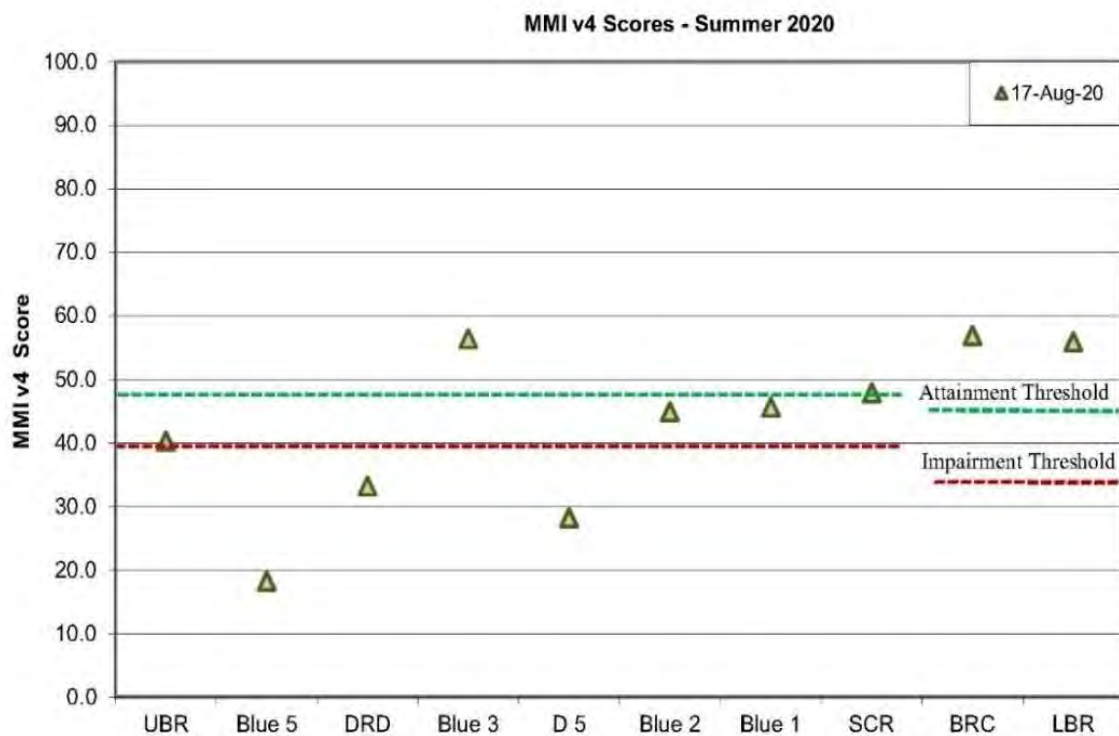
Figure 21. 2020 MMI v4 scores from composited quantitative (Hess) samples at study sites on the Blue River during August 2020 (Figure 3, Timberline, 2021).

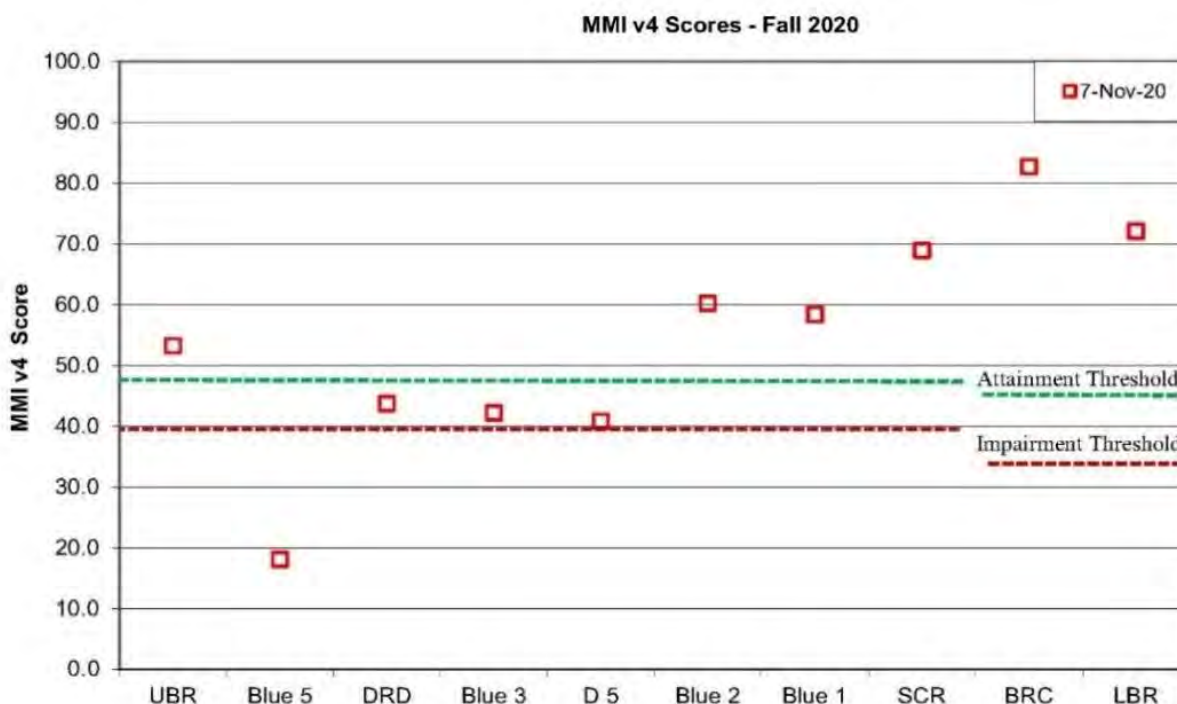
Figure 22. 2020 MMI v4 scores from composited quantitative (Hess) samples at study sites on the Blue River during November 2020 (Figure 4, Timberline 2021).

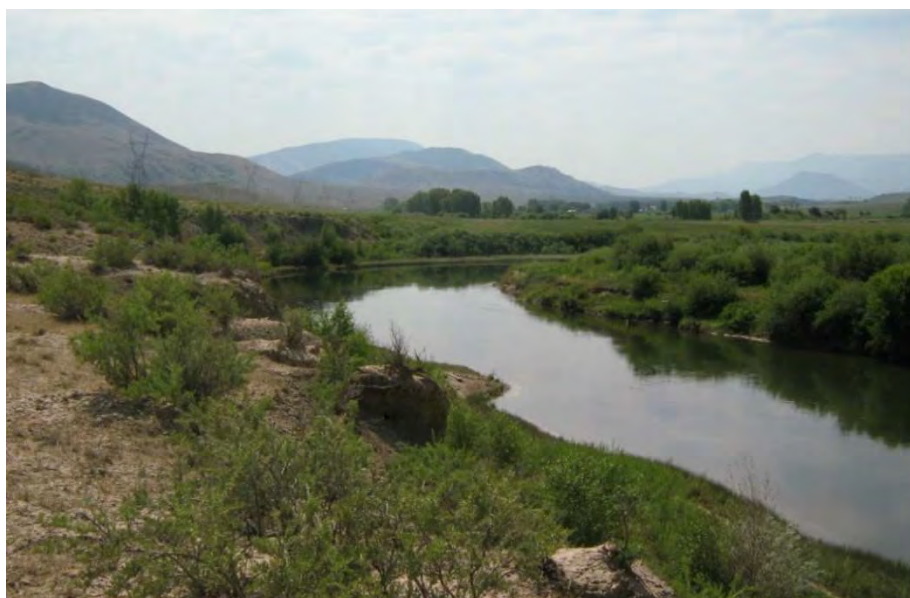
Figure 23. Reach 3: Blue River immediately upstream of the Colorado River confluence, looking south.

The watershed area directly tributary to Reach 3 is about 102 square miles measured at the confluence of the Colorado River (**Figure 23**) representing about 15 % of the total 699 square mile watershed. Most of the land is federal property managed by the BLM and USFS, and agricultural property held in private ownership. Approximately 8 miles of the Blue River is located within the Blue Valley Ranch (BVR), which has implemented a large-scale restoration effort including the installation of grade control structures, bank protection and off-channel wetlands. Other notable private land holdings include the San Toy Land Company located downstream the BVR. There are two privately held parcels along the Blue River downstream of BVR that are under proposal to be exchanged from private to public property as part of a land exchange with the Blue Valley Ranch and BLM<sup>1</sup>.

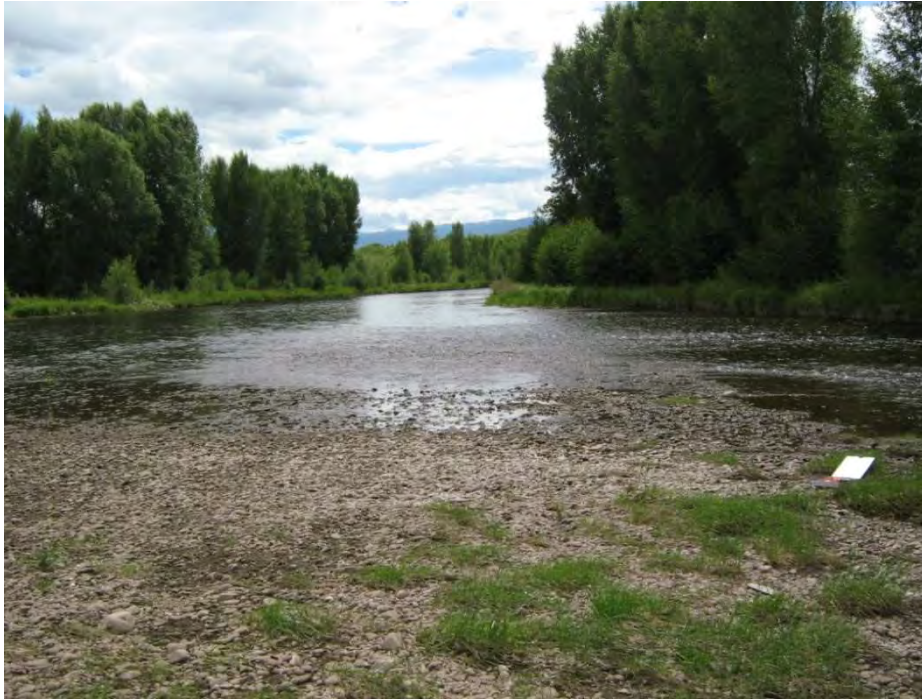
Figure 25. Reach 3: Blue River below Trough Road at the old railroad crossing, looking upstream. This is the location of the 2008 PHABSIM “spawning site” (GCSMP).

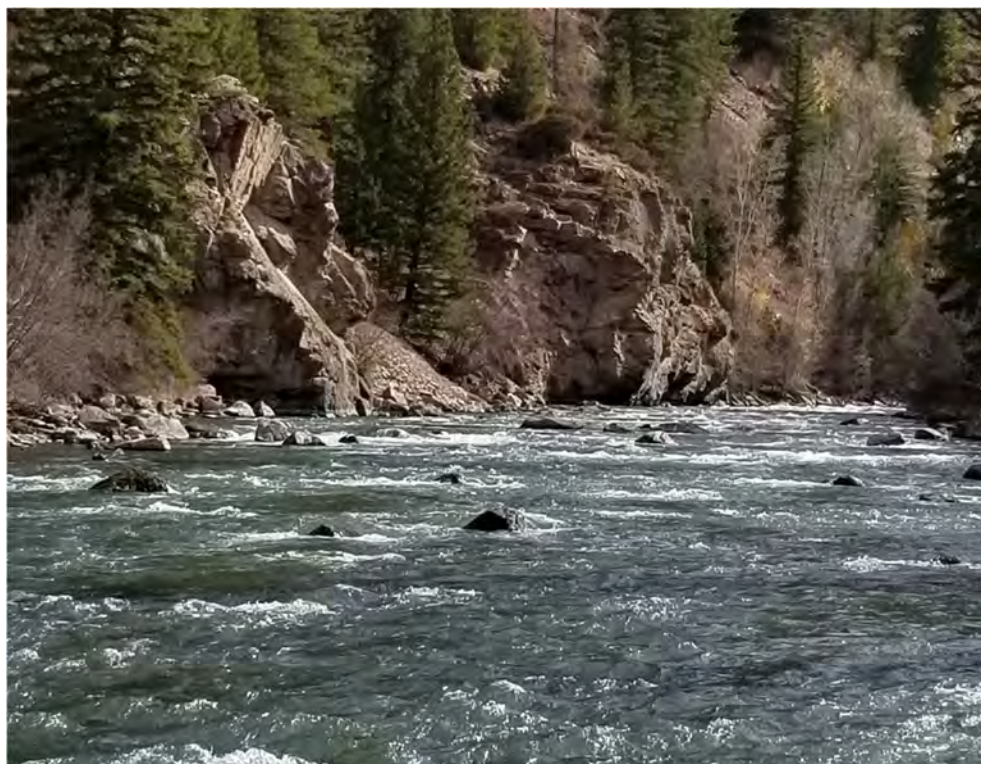
Figure 27 Reach 3: Blue River near the Green Mountain Reservoir outlet.

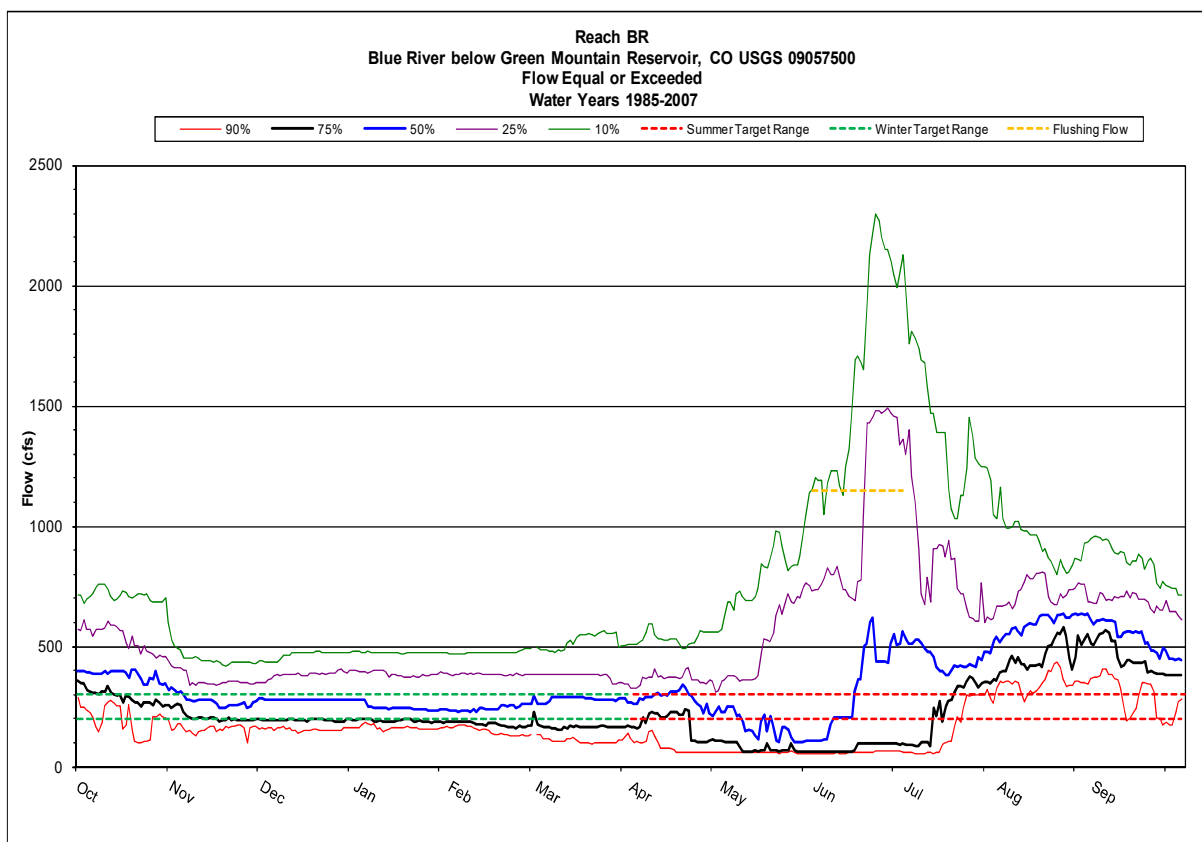
Figure 28. Station 09057500 (Blue River below Green Mountain Reservoir) Exceedance Hydrograph.

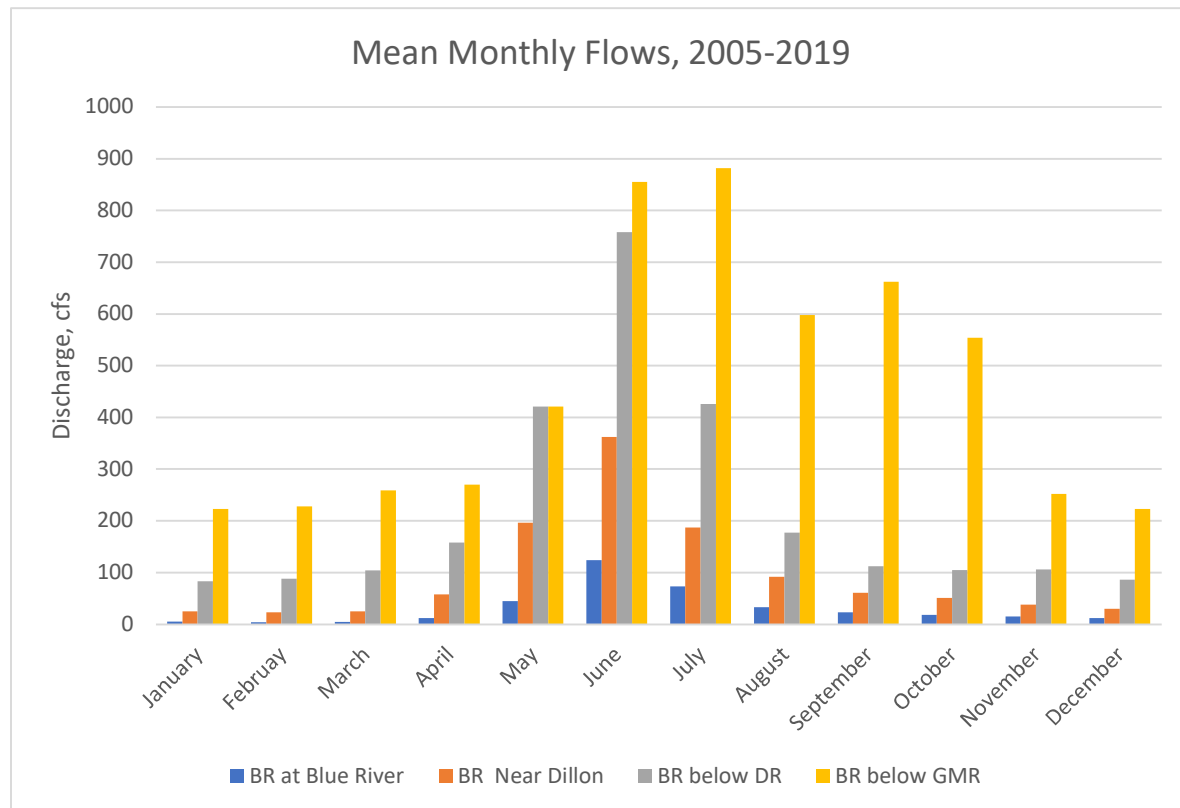
Figure B-3. Mean monthly flows, 2005-2019 at four Blue River gage stations.

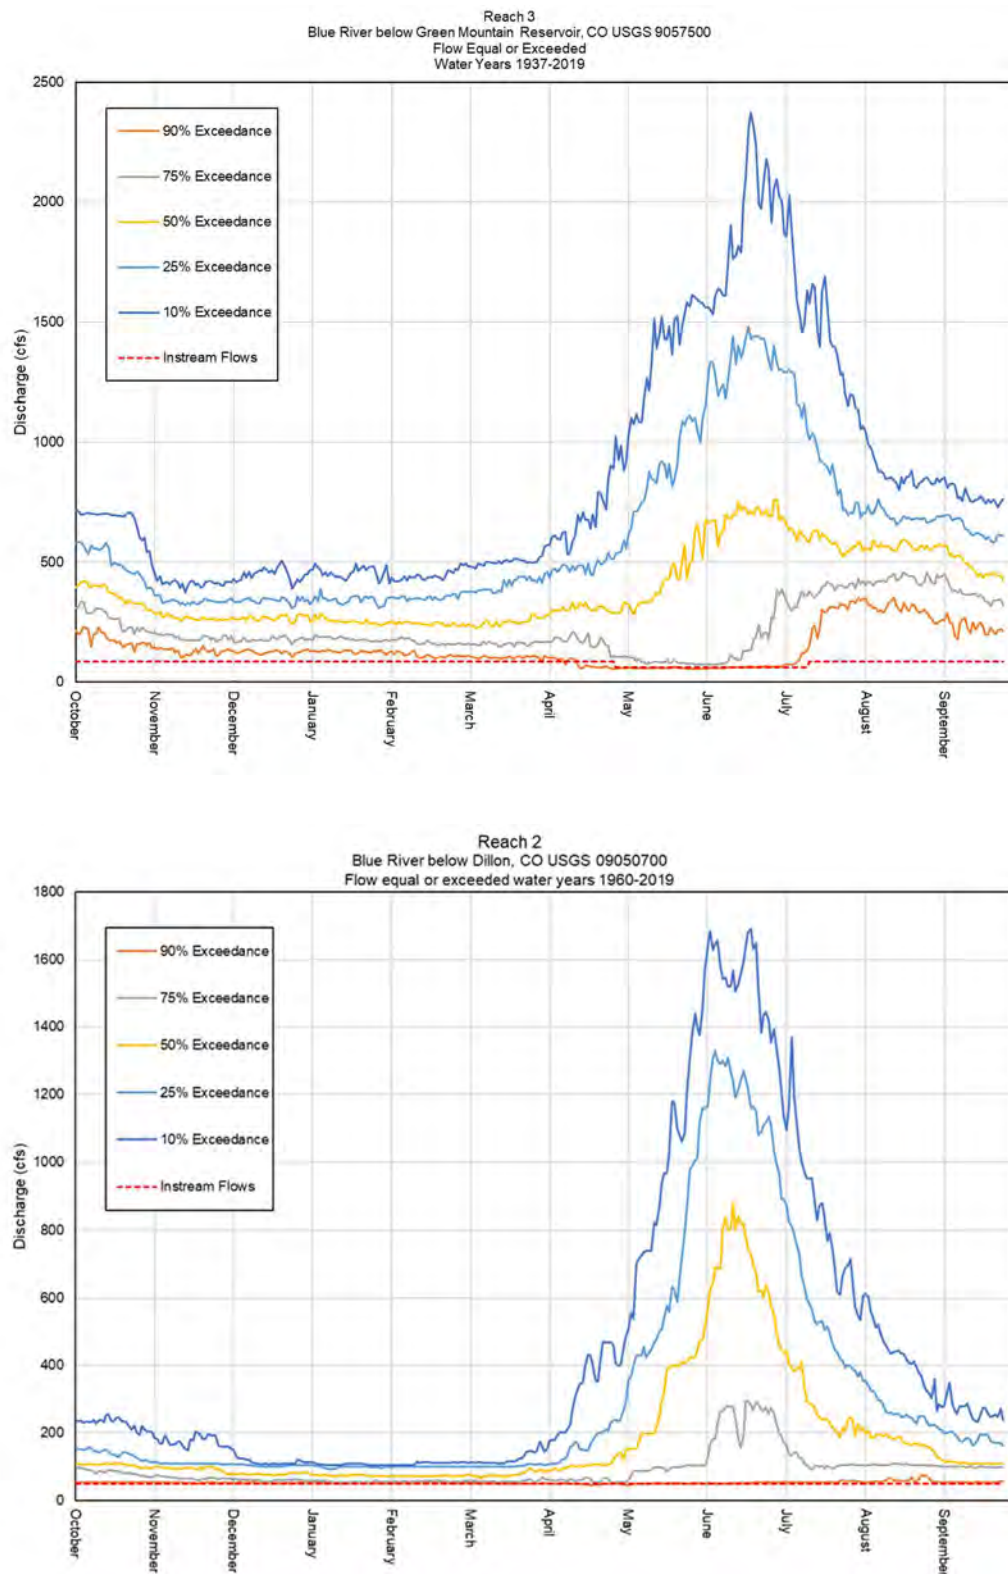
Figure B-4. Exceedance Plots for the Four Blue River Main Stem Gage Sites.

Figure B-4. Exceedance Plots for the Four Blue River Main Stem Gage Sites (cont.).

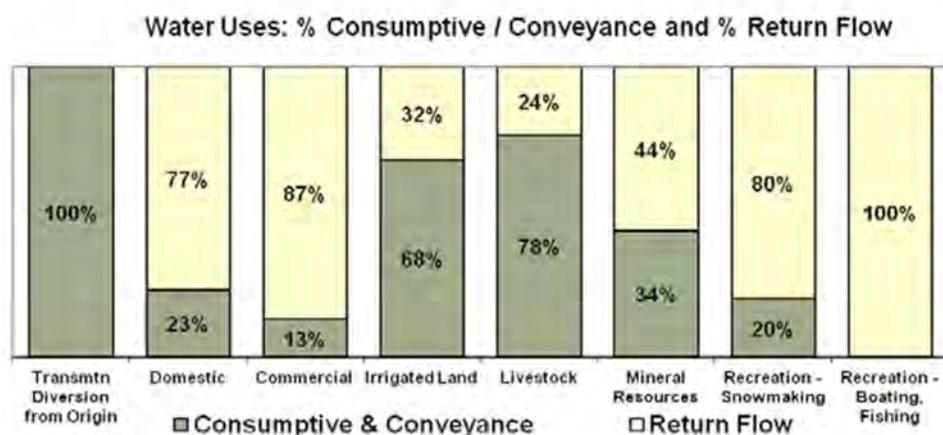
Figure B-6. Typical Consumptive Water Uses (Coley/Forrest, Inc. 2011)
