# State of the Upper Poudre River Watershed

## A River Health Assessment

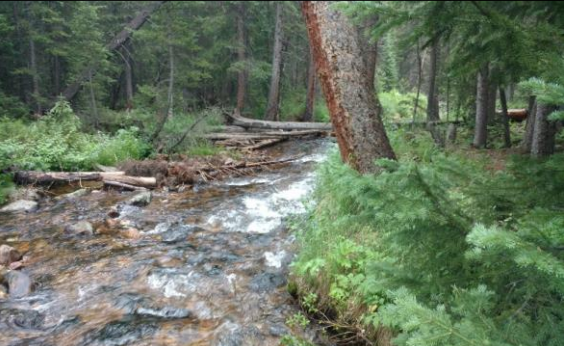
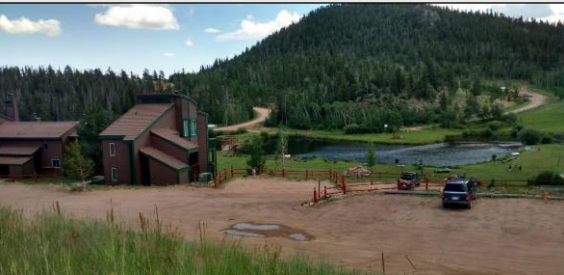
The riparian zone is typically narrow and intact. In several areas the valley bottom widens, and complex beaver habitat supports excellent health of the riverine system. Some areas where these habitats historically existed have been cleared for development, such as at Beaver Meadows Resort, or light agriculture.

Above, the North Fork near its headwaters is in excellent condition. Below, despite the fairly remote location, portions of the North Fork have been cleared, ponded and channelized.

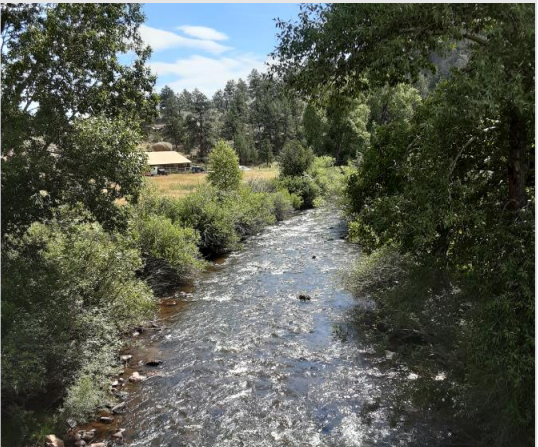
There are three distinct reaches of the North Fork in this watershed that can be thought of as Phantom Canyon, Cherokee Park and Bonner Peak Canyon. The upper reach has narrow riparian zone with commonly excellent vegetation. Through Cherokee Park the riparian zone has been largely been converted to agriculture, however, a strip of riparian vegetation is usually maintained. Areas of wetland in this reach are commonly supported by irrigation return flows. In the Bonner Peak reach high quality habitat returns to the riparian zone. Most of the river below Halligan Reservoir is not publicly-accessible, however, numerous floodplain benches appear to have become isolated from the river through flow alterations. Agricultural practices exacerbate riparian zone losses.

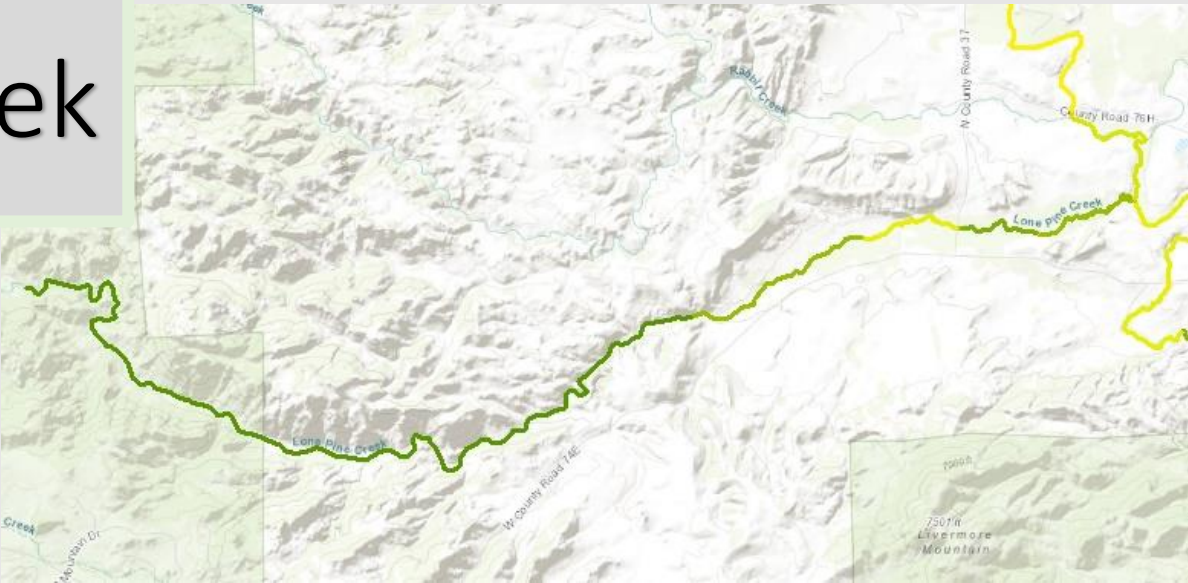
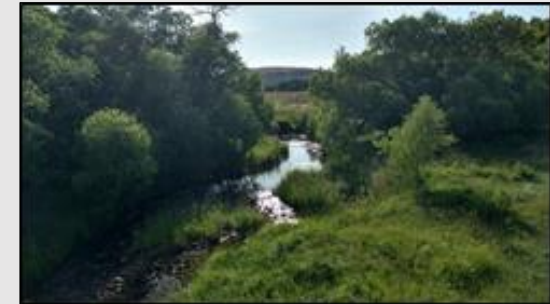
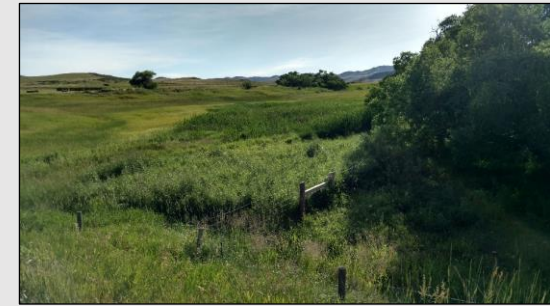
Riparian condition is largely very good. Below the confluence of the north and south forks, the stream is in excellent conditions. As it enters State land it passes through a cattle impacted reach, however these impacts diminish as the creek passes through the State Wildlife Area (SWA). Exiting the SWA, condition declines again as the stream enters private lands used for light agriculture.

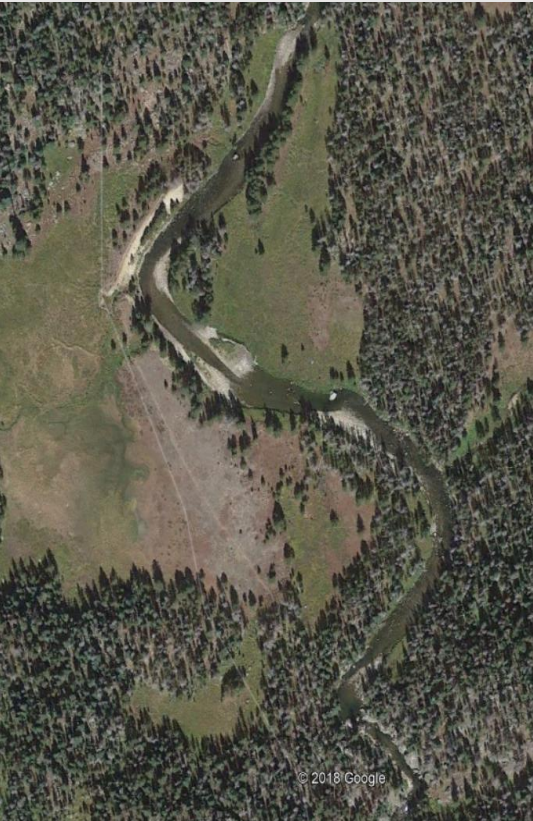
This reach of the river includes its headwaters in RMNP, which is managed as Wilderness, followed by a long reach through the Comanche Wilderness. Other than minor, near-stream recreational impacts, the riparian habitat appears intact and in largely outstanding condition.

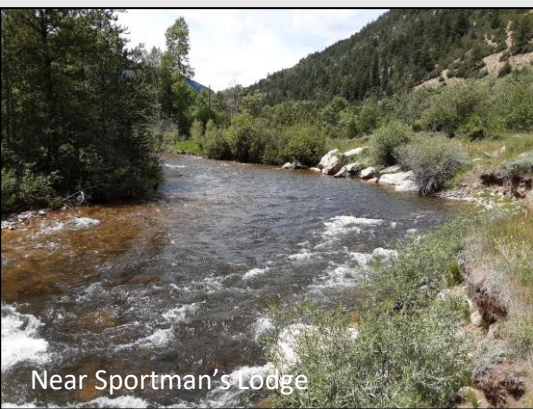
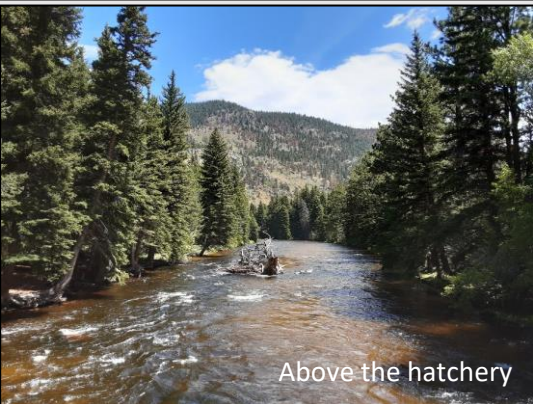
Cache la Poudre River - Joe Wright Creek to Little South Fork

Riparian through this habitat is generally quite narrow throughout this reach, with the notable exception of the stretch near the CPW fish hatchery. Ironically, this management facility was placed in what was probably the largest headwater wetland complex along the mainstem of the Poudre. Despite the impact, some high-quality habitats remain in the area. Highway 14 is no doubt the greatest impact on Poudre River riparian habitats in this reach.

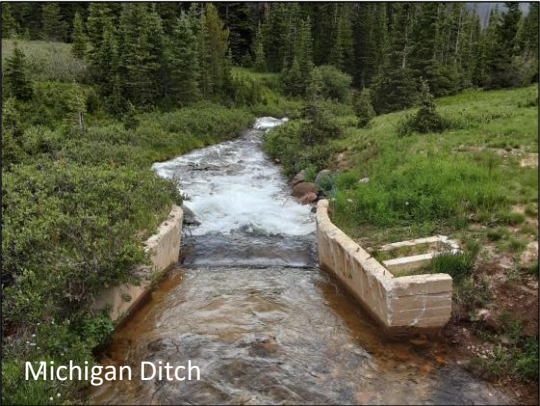
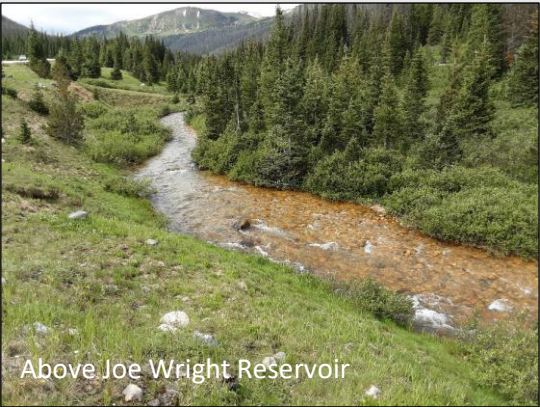
The riparian zone along Joe Wright Cr is generally narrow or non-existent. Flow regime alteration has no doubt had some effect on riparian condition, but those effects a minimal or otherwise difficult to detect. Highway 14 and associated fill is the major impact to this stream's riparian area.

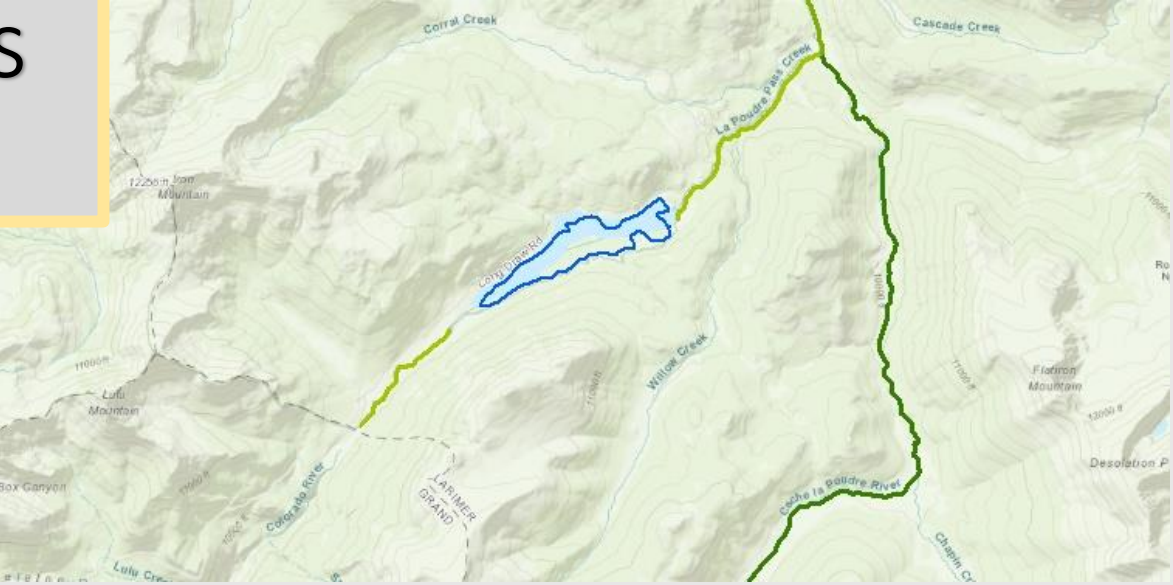
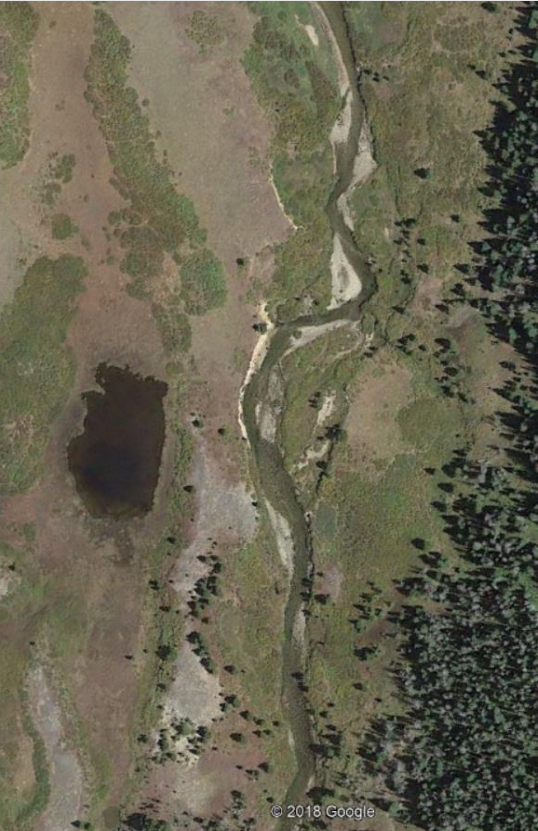
Despite its remote location, the riparian habitats along La Poudre Pass Creek have suffered from water management infrastructure and practices, as well as pockets of substantial recreational impacts.

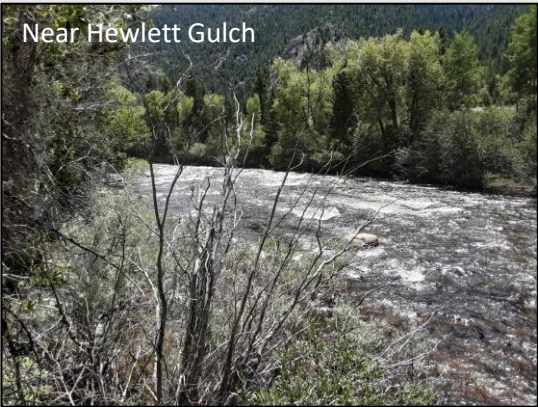
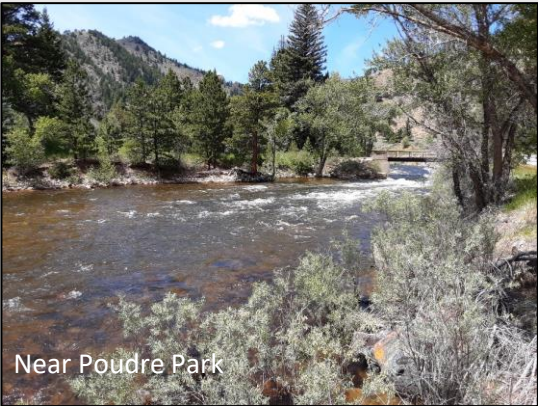
Cache la Poudre River - South Fork to North Fork

The riparian habitat along this reach of the naturally narrow or non-existent (see pictures). In general, remaining habitat is in good to excellent condition but much of the riparian habitat on the road-ward side has been destroyed by the construction of the road. The habitat on the bank opposite the road is almost uniformly in reference standard condition

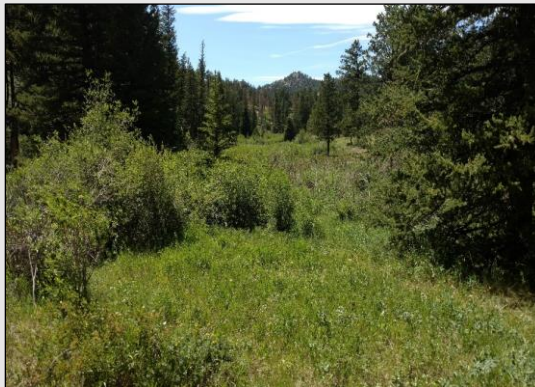
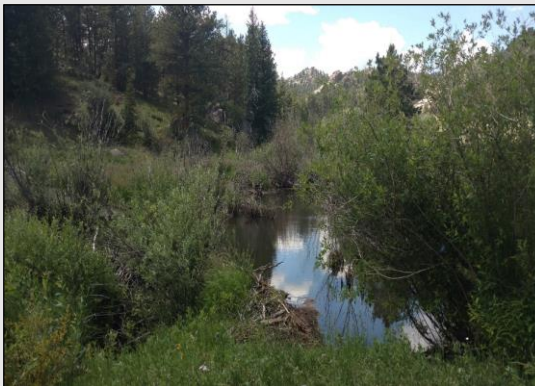
The majority of Elkhorn Creek is in excellent to outstanding condition. Pockets of isolated rural development, small inline ponds and some haying constitute the main detectable impacts to these habitats.

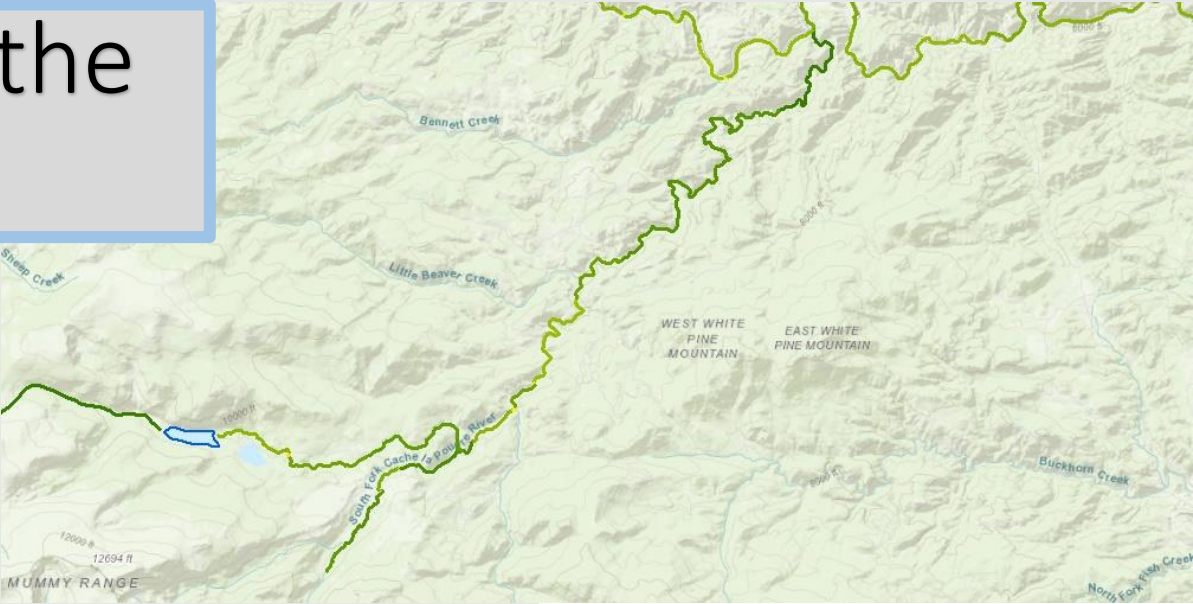
Most of the South Fork naturally has a very narrow riparian zone. Much of that riparian habitat is in excellent to outstanding condition. One canyon reach through which the Pingree Park Road was built, suffered a large percentage loss of riparian habitat on the roadward side of the river, but in absolute terms the loss may have been only a few feet in width.

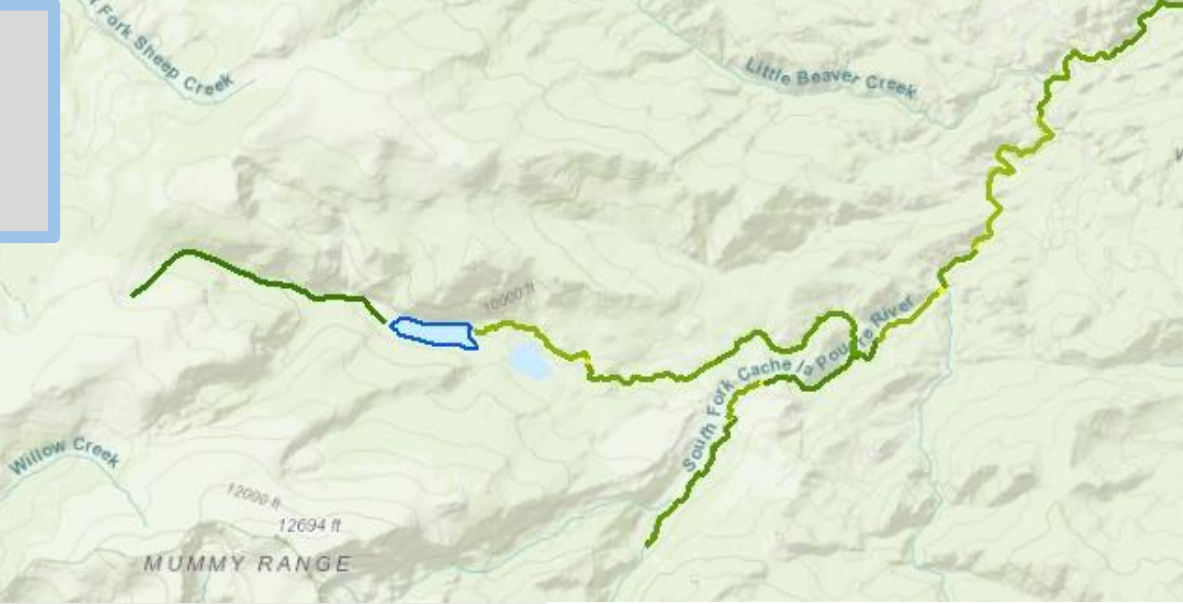
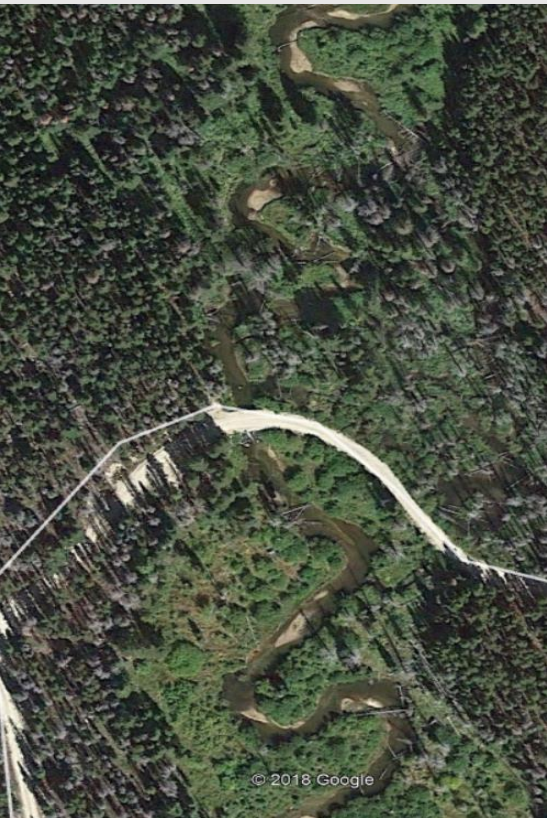
Beaver Creek begins as an essentially pristine riverine habitat in the Comanche Peaks wilderness but was converted to reservoir right outside of what is now wilderness. Below the reservoirs the riparian habitat quickly improves in condition. In the lower, strongly confined reaches of the creek reservoir impacts on riparian habitats are likely trivial or otherwise difficult to detect.
