COLORADO DIVISION OF RECLAMATION, MINING AND SAFETY
MINERALS PROGRAM INSPECTION REPORT
PHONE: (303) 866-3567

MINE NAME: Incas Mine	MINE/PROSPECTING ID#: M-1986-076	MINERAL: Gold and silver	COUNTY: La Plata
INSPECTION TYPE: Monitoring	INSPECTOR(S): Kate A. Pickford	INSP. DATE: October 1, 2013	INSP. TIME: 13:00
OPERATOR: DGMCC	OPERATOR REPRESENTATIVE:	TYPE OF OPERATION: 110d - Designated Limited Impact

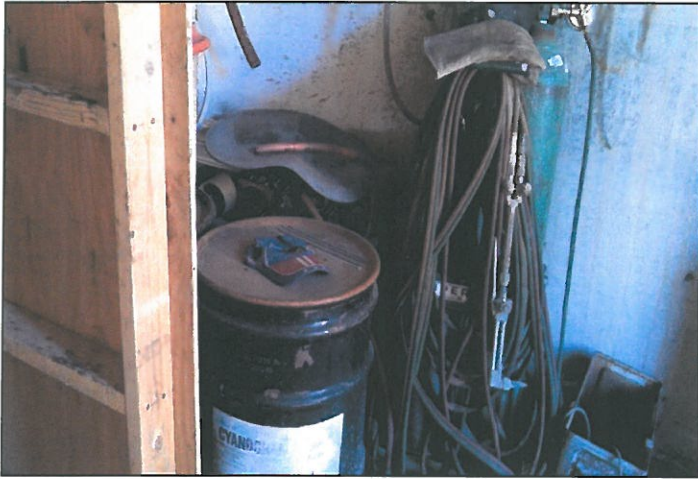
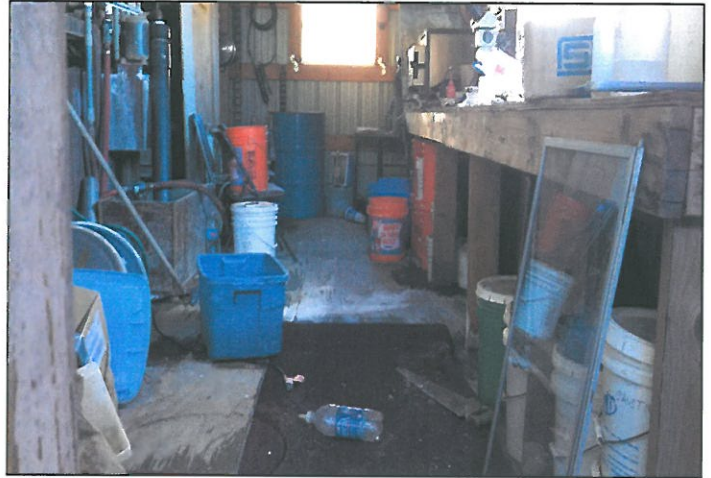
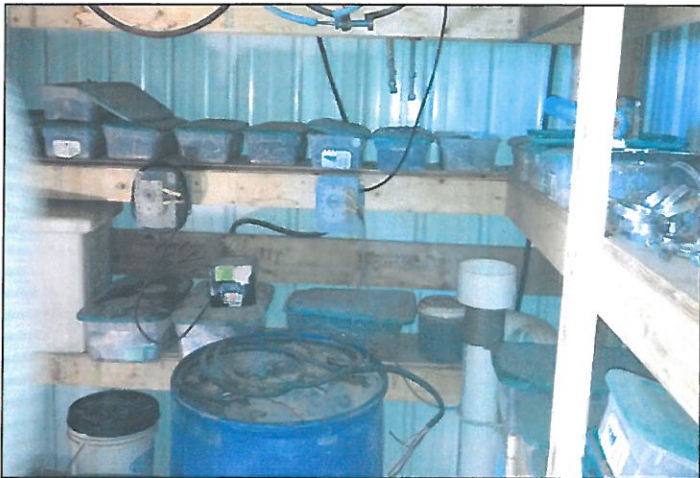
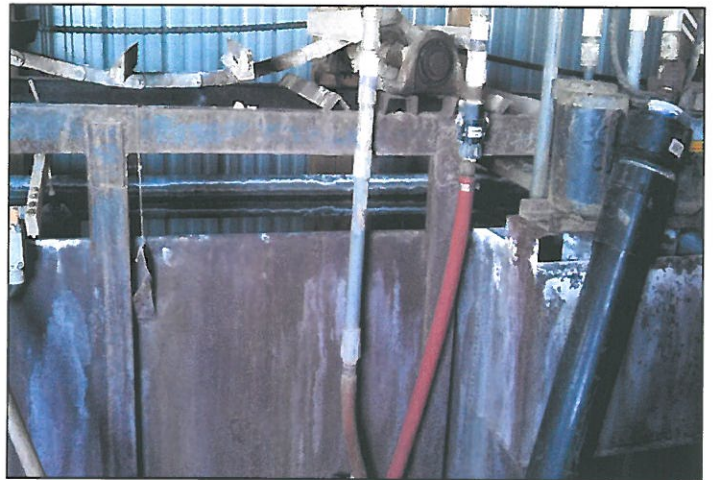
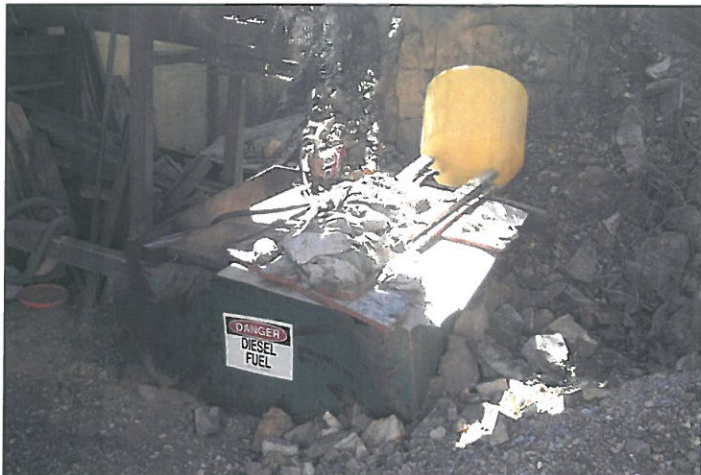
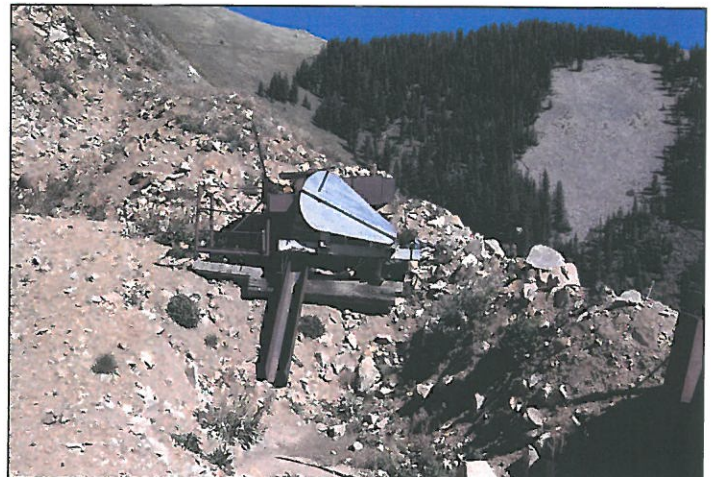
PHOTOGRAPHS

The site is in the same condition as it was during the inspection conducted in November of last year. The mill is not operating, but has been maintained. It appears to be secure, although one of the upper windows is out. Therefore the inside of the building is exposed to the elements.

A 55-gallon drum with a label identifying the contents as cyanide is located in the containment area just inside the access door. Milling equipment is located throughout the remainder of the building. The cut into the side of the hill, where ore is extracted, is still in the same condition as during the last inspection, as is the tailings pond adjacent to the cut. Various processing equipment is located on the site, outside of the mill building.
