COLORADO DIVISION OF RECLAMATION, MINING AND SAFETY
MINERALS PROGRAM INSPECTION REPORT
PHONE: (303) 866-3567

MINE NAME: Spring Creek Pit	MINE/PROSPECTING ID#: M-1994-097	MINERAL: Sand and gravel	COUNTY: Montrose
INSPECTION TYPE: Monitoring	INSPECTOR(S): Dustin M. Czapla	INSP. DATE: April 17, 2014	INSP. TIME: 14:00
OPERATOR: Oldcastle SW Group dba United Companies of Mesa County	OPERATOR REPRESENTATIVE: Tom Davis	TYPE OF OPERATION: 112c - Construction Regular Operation

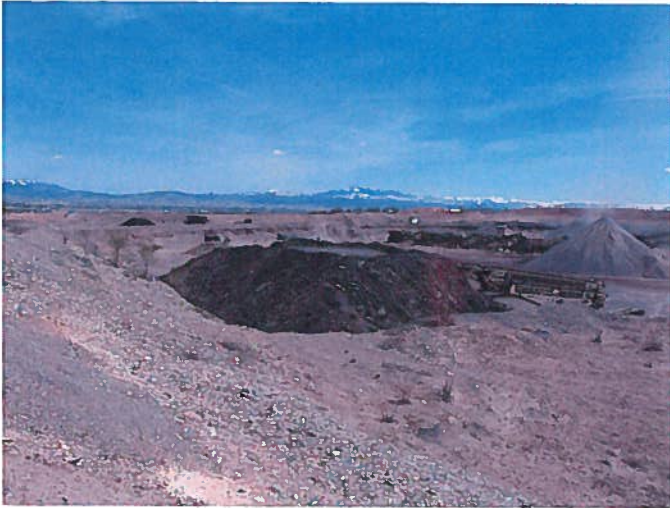
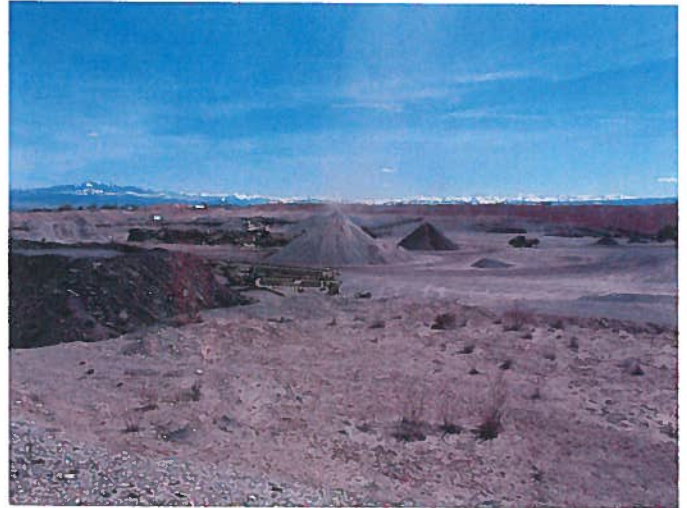
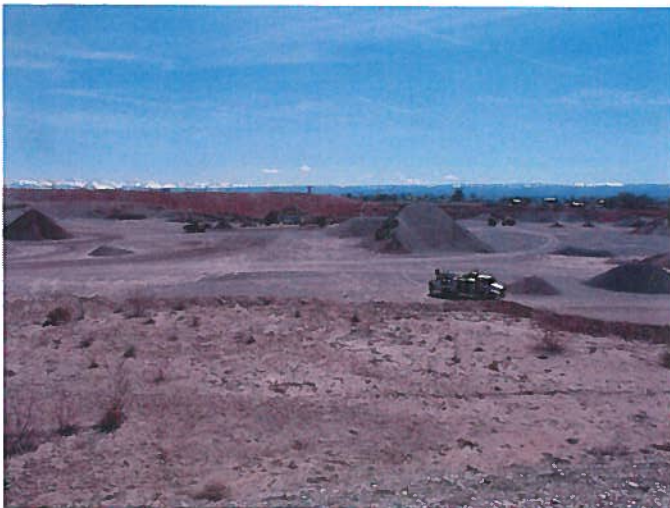
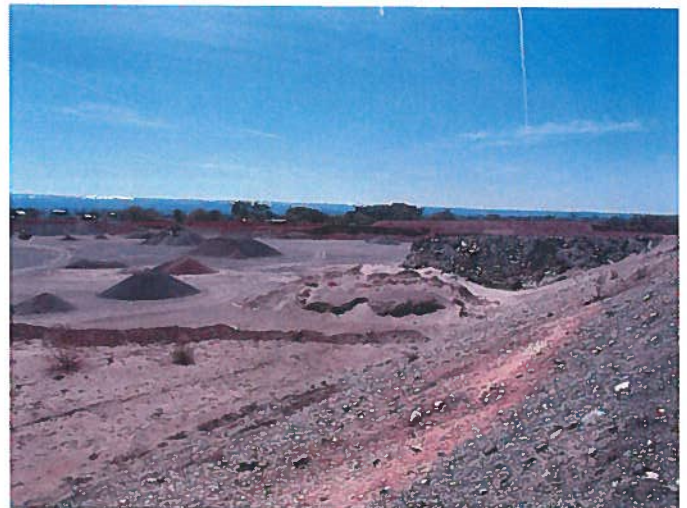
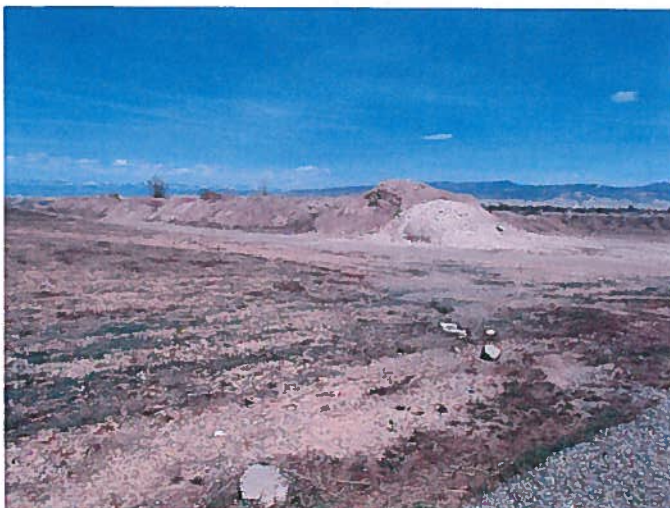
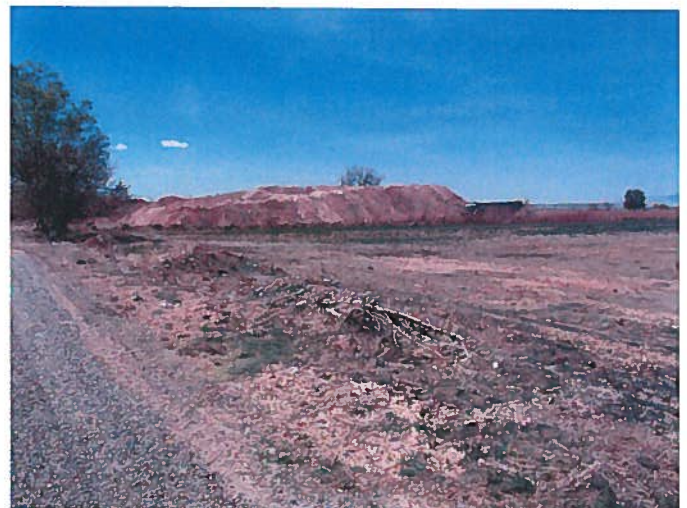
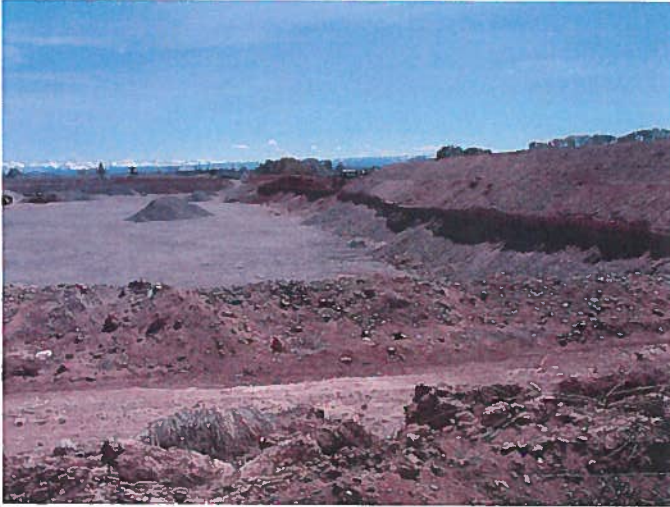
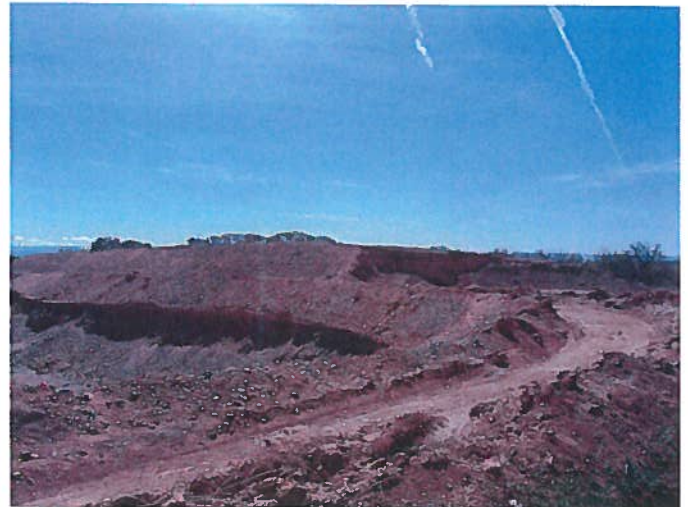
PHOTOGRAPHS

The pit has been excavated to a depth of approximately twenty feet. The pit slopes on the east and west sides were approximately 1H:1V. The south slope was graded at approximately 2H:1V and the north slope approximately 3H:1V. Topsoil is stockpiled around the perimeter of the pit. Materials stockpiles are located throughout the pit floor. Wash ponds are located in the south part of the pit. Several piles of waste asphalt were located in the north part of the pit.
