**COLORADO DIVISION OF RECLAMATION, MINING AND SAFETY**  
**MINERALS PROGRAM INSPECTION REPORT**  
**PHONE: (303) 866-3567**

<b>MINE NAME:</b> Wyman Pit	<b>MINE/PROSPECTING ID#:</b> M-1983-037	<b>MINERAL:</b> Sand and gravel	<b>COUNTY:</b> Routt
<b>INSPECTION TYPE:</b> Monitoring	<b>INSPECTOR(S):</b> Dustin M. Czaplá	<b>INSP. DATE:</b> May 6, 2014	<b>INSP. TIME:</b> 10:45
<b>OPERATOR:</b> Louis M. Wyman	<b>OPERATOR REPRESENTATIVE:</b> None	<b>TYPE OF OPERATION:</b> 110c - Construction Limited Impact

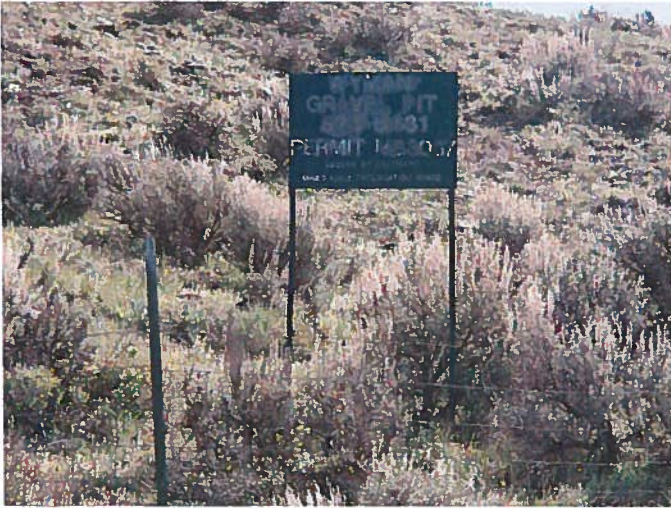
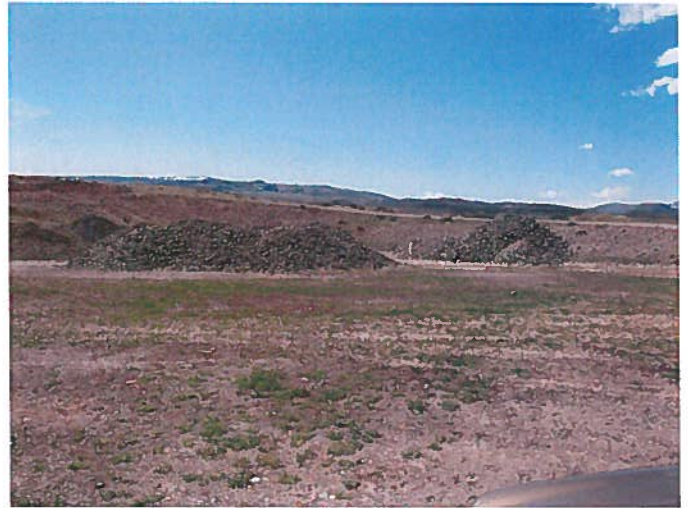
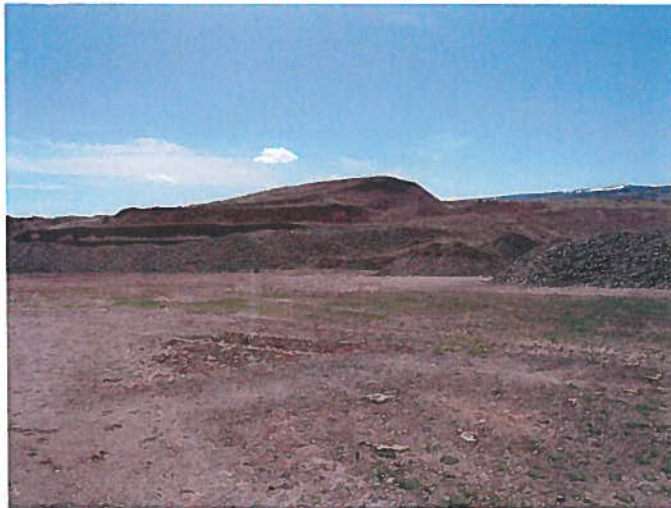
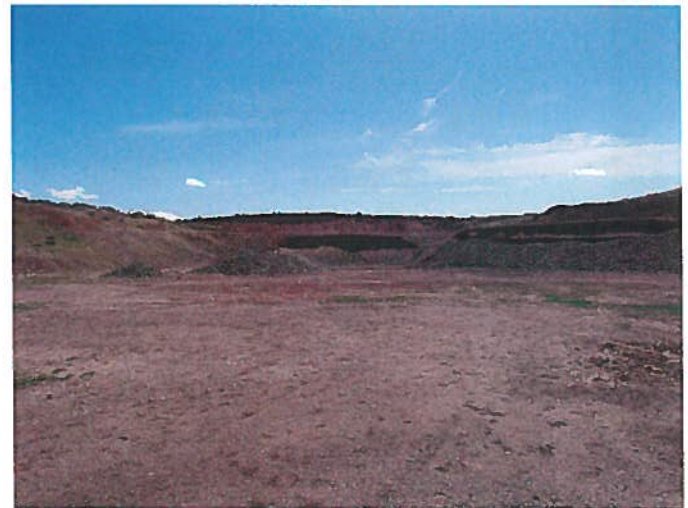
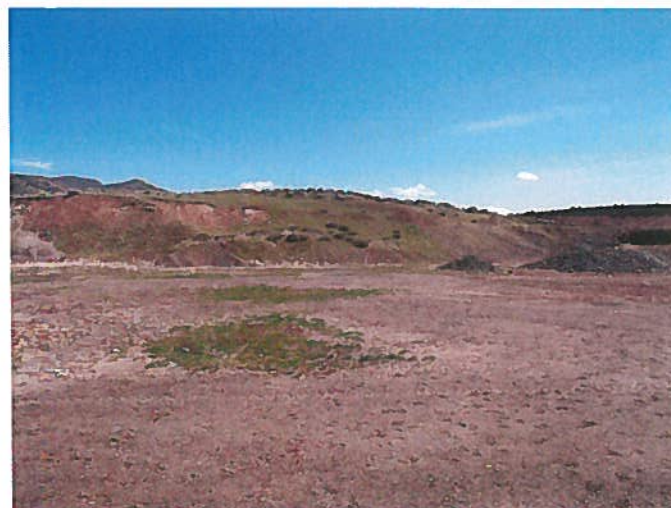
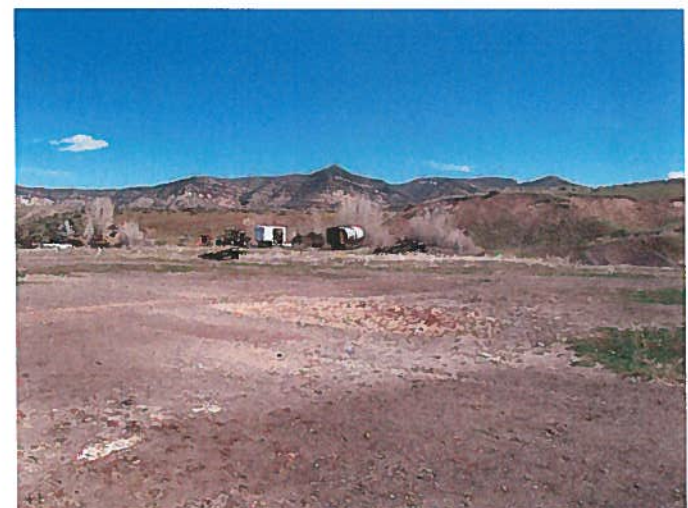
**PHOTOGRAPHS**

Adequate mine identification signage was noted at the entrance to the site.

The affected area was marked by t-posts that were clearly visible and adequate to delineate the affected area boundary.

Conditions at the site appeared unchanged from the Division's 2010 inspection. The Operator's annual report states that the last mining activity occurred in 2009. Per Rule 1.13.5, if an Operator temporarily ceases production of the mining operation for one hundred eighty (180) days or more, the Operator must file a Notice of Temporary Cessation in writing to the Office. The Operator has not submitted their notice of TC. This has been noted as a problem.

**CORRECTIVE ACTIONS:** The Division recommends the Operator file for Temporary Cessation. The start date of the initial 5 year Temporary Cessation period is retroactive to the last date the pit was active. If that date is more than 5 years ago, the operator is required ask the Board for a 5 year extension to the Temporary Cessation period (per rule 1.13.5 (3) and 1.13.8 (b) or begin reclamation.
