COLORADO DIVISION OF RECLAMATION, MINING AND SAFETY
MINERALS PROGRAM INSPECTION REPORT
PHONE: (303) 866-3567

MINE NAME: Bear Ranch Gravel Mine	MINE/PROSPECTING ID#: M-2013-002	MINERAL: Sand and gravel	COUNTY: Gunnison
INSPECTION TYPE: Monitoring	INSPECTOR(S): Dustin M. Czapla	INSP. DATE: August 19, 2014	INSP. TIME: 11:00
OPERATOR: Bear Ranch LLC	OPERATOR REPRESENTATIVE: None	TYPE OF OPERATION: 110c - Construction Limited Impact

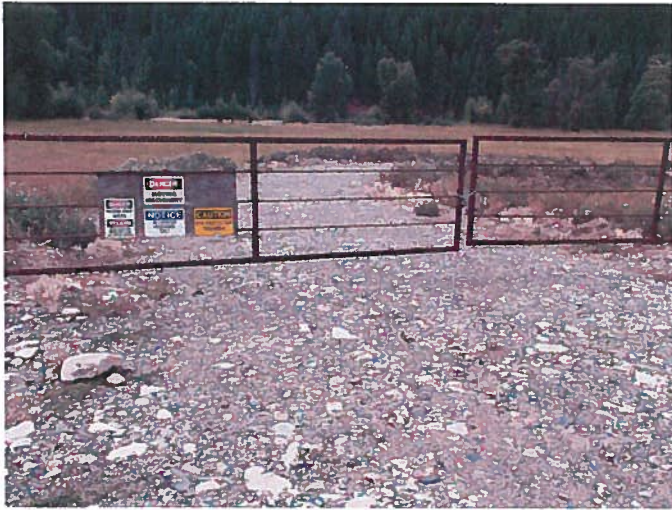
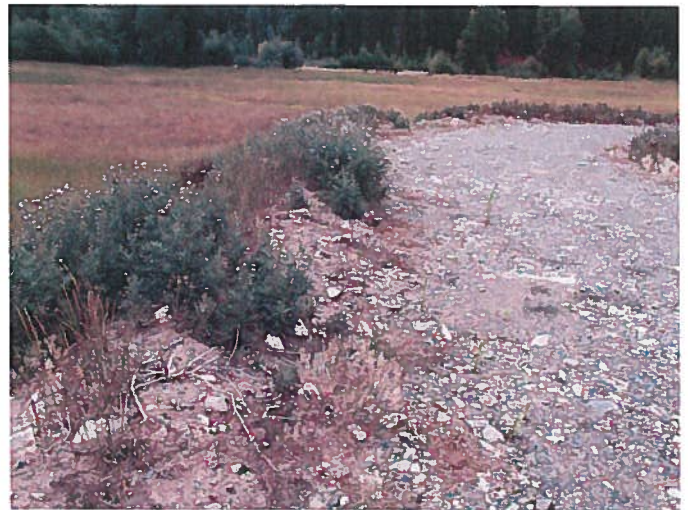
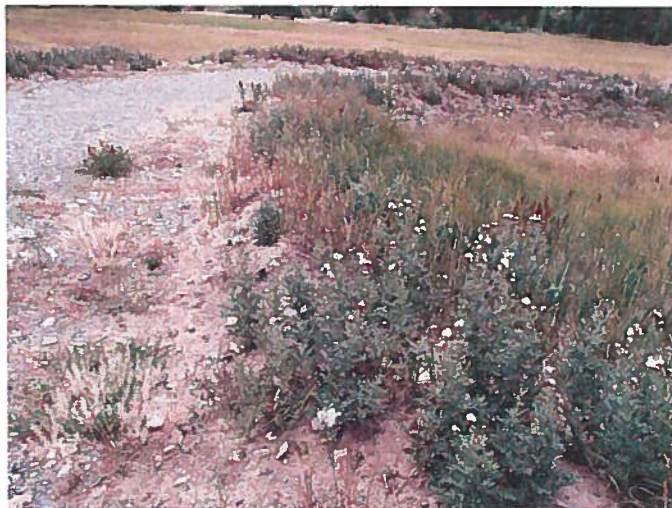
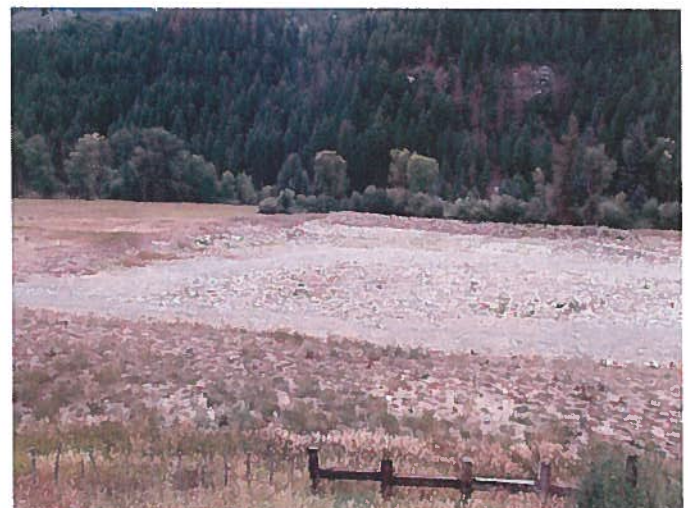
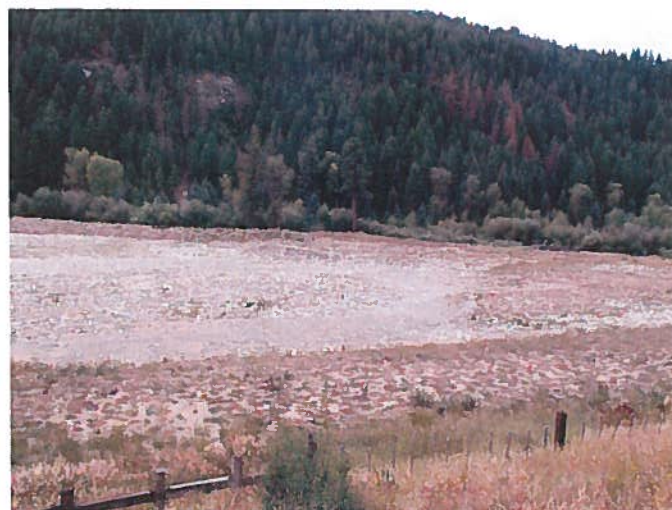
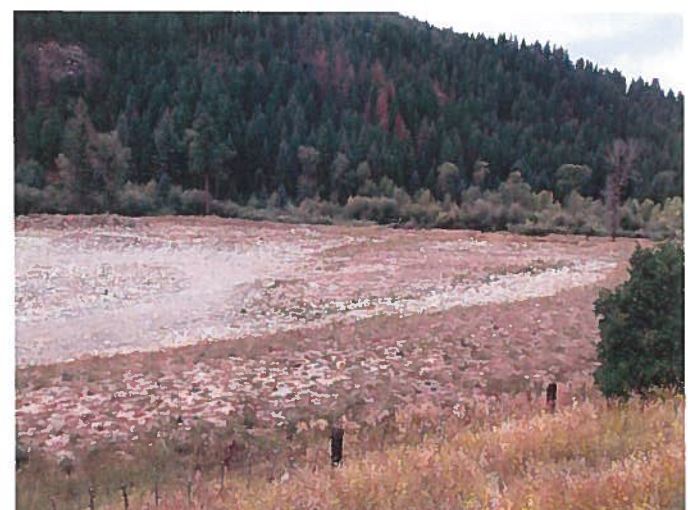
PHOTOGRAPHS

Adequate mine identification signage was not noted at the entrance to the site.

The affected area was marked by fencing that was clearly visible and adequate to delineate the affected area boundary.

Mining has commenced in the west side of the permitted area. Approximately three acres are currently disturbed. Topsoil has been removed and stockpiled on the south side of the disturbed area.

An infestation of musk thistle was noted on the berms along the access road. These noxious weeds should be treated as soon as practicable in order to prevent further infestation.

CORRECTIVE ACTIONS: Implement weed control plan and provide proof to the Division that this has been done. If a weed control plan is not already in place, the operator shall develop a weed control and management plan in accordance with Section 3.1.10 (6) of the Rule. This plan should be developed in consultation with the county extension agency, or weed control district office and should include specific control measures to be applied, a schedule for when control measures will be applied and a post-treatment monitoring plan. This weed control plan shall be submitted to the Division as a Technical Revision to the approved plan with the appropriate Technical Revision fee of \$216.00 by the corrective action date.

CORRECTIVE ACTIONS: The operator shall, at the entrance of the mine site, post a sign which shall be clearly visible from the access road with the following: the name of the operator, a statement that a reclamation permit for the operation has been issued by the Colorado Mined Land Reclamation Board; and the permit number. The operator shall submit photo documentation that a proper sign has been posted by the corrective action date.
