COLORADO DIVISION OF RECLAMATION, MINING AND SAFETY
MINERALS PROGRAM INSPECTION REPORT
PHONE: (303) 866-3567

MINE NAME: Tri County Pit	MINE/PROSPECTING ID#: M-1977-205	MINERAL: Sand and Gravel	COUNTY: Delta
INSPECTION TYPE: Surety Release Inspection	INSPECTOR(S): Stephanie J. Mitchell	INSP. DATE: September 28, 2015	INSP. TIME: 13:00
OPERATOR: United/Old Castle	OPERATOR REPRESENTATIVE: Jason Burkey	TYPE OF OPERATION: 112c - Construction Regular Operation

REASON FOR INSPECTION: Surety Release Requested	BOND CALCULATION TYPE: Complete Bond	BOND AMOUNT: \$303,108.00
DATE OF COMPLAINT: NA	POST INSP. CONTACTS: None	JOINT INSP. AGENCY: None
WEATHER: Clear	INSPECTOR'S SIGNATURE:

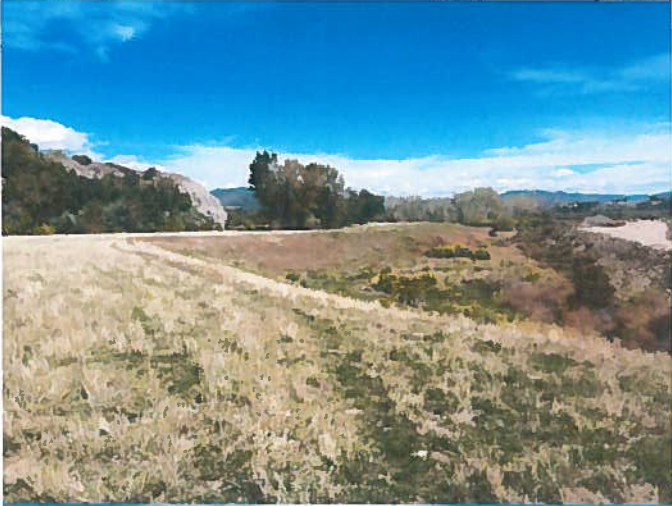
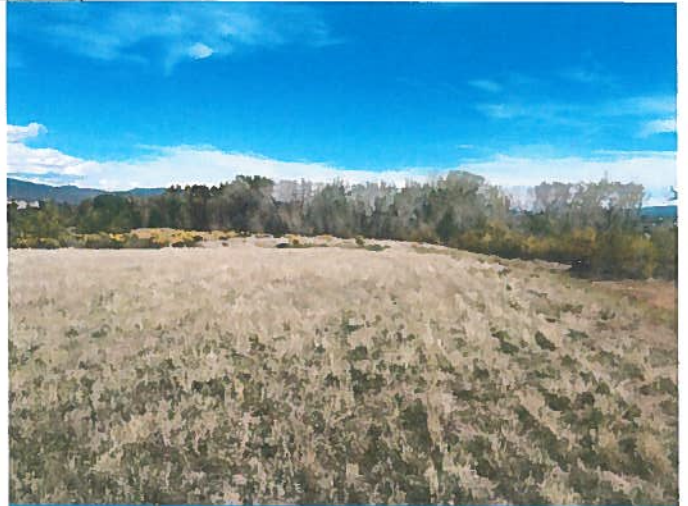
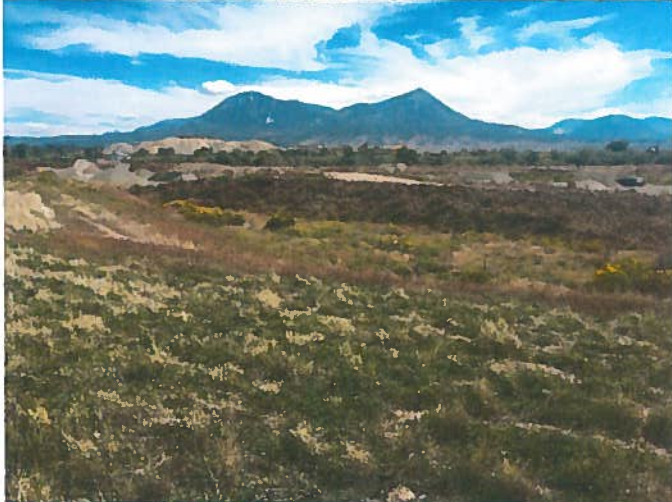
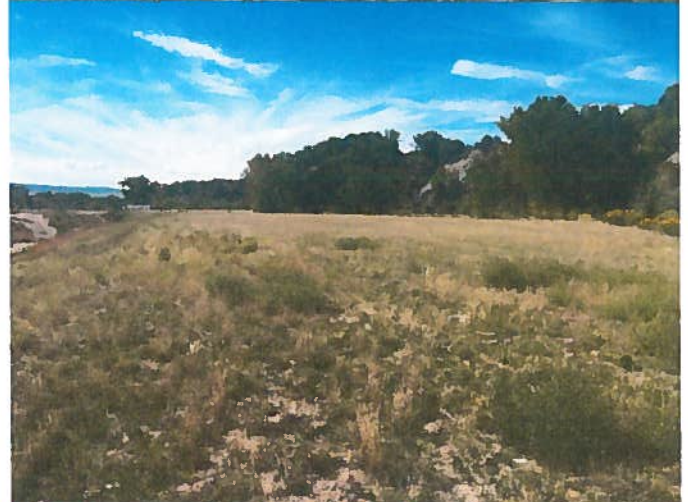
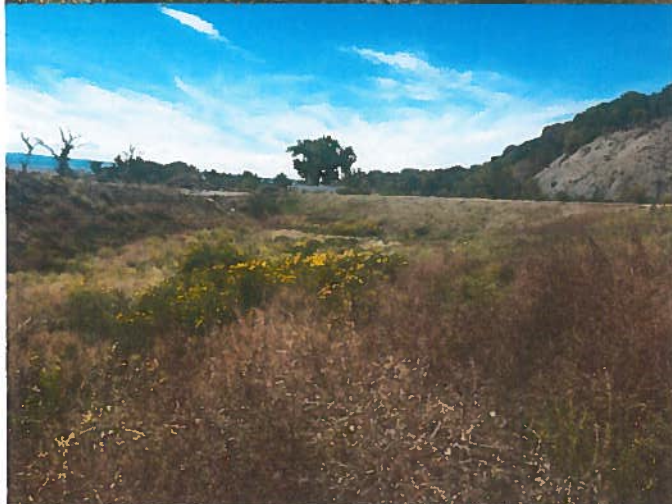
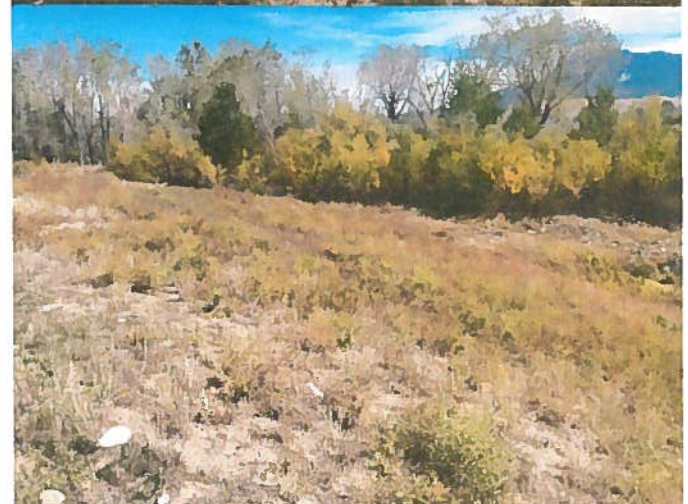
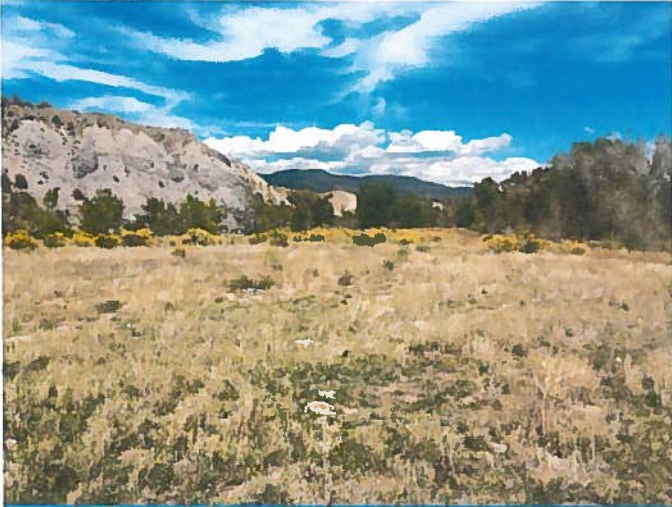
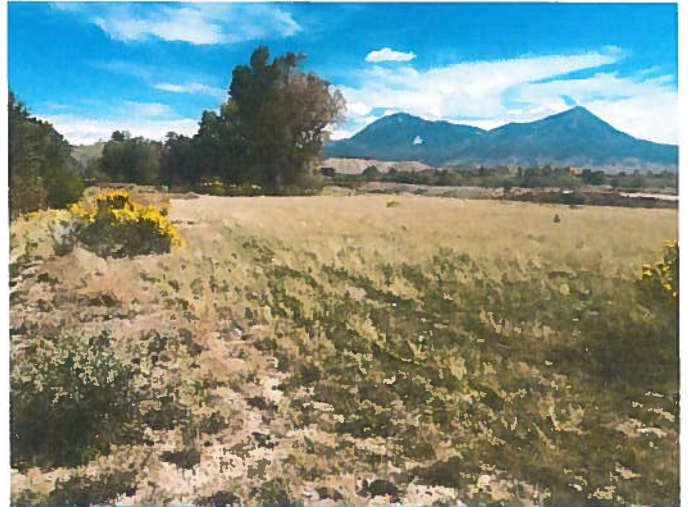
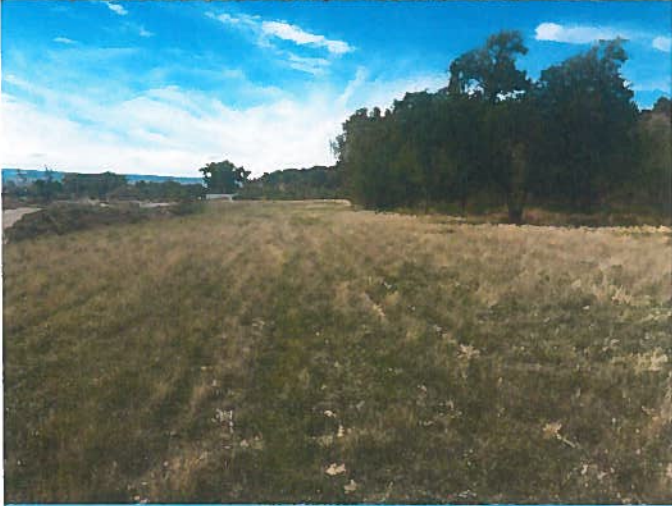
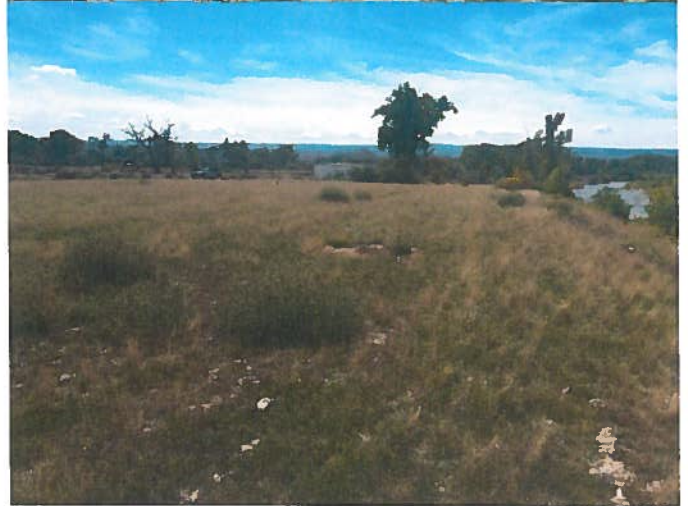
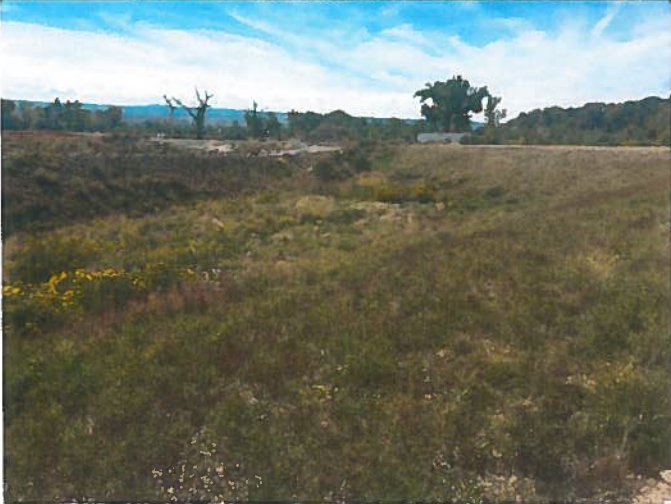
PHOTOGRAPHS

The purpose of the inspection was to observe the reclamation success and determine if the July 23, 2015 request for partial release of the reclamation permit was approvable. Based on the conditions observed during the inspection the 5.50 Acres requested to be released has been granted. The site was graded exceptionally well and the reclaimed slopes tie into the adjacent undisturbed slopes in a very natural looking way. All reclaimed slopes appear to be no steeper than the required 3H:1V.

Noxious weeds appeared to be under control and visibly dead. There were some kochia present, but is considered a pioneer species and is not out of control.

Photos that show the conditions observed during the inspection are included at the end of this report.
