COLORADO DIVISION OF RECLAMATION, MINING AND SAFETY
MINERALS PROGRAM INSPECTION REPORT
PHONE: (303) 866-3567

MINE NAME: Western Sugar Project	MINE/PROSPECTING ID#: M-2010-049	MINERAL: Gravel and sand	COUNTY: Weld
INSPECTION TYPE: Preoperation Inspection	INSPECTOR(S): Peter S. Hays	INSP. DATE: February 19, 2016	INSP. TIME: 09:00
OPERATOR: Varra Companies, Inc.	OPERATOR REPRESENTATIVE: Brad Janes, Garrett Varra	TYPE OF OPERATION: 112c - Construction Regular Operation

OBSERVATIONS

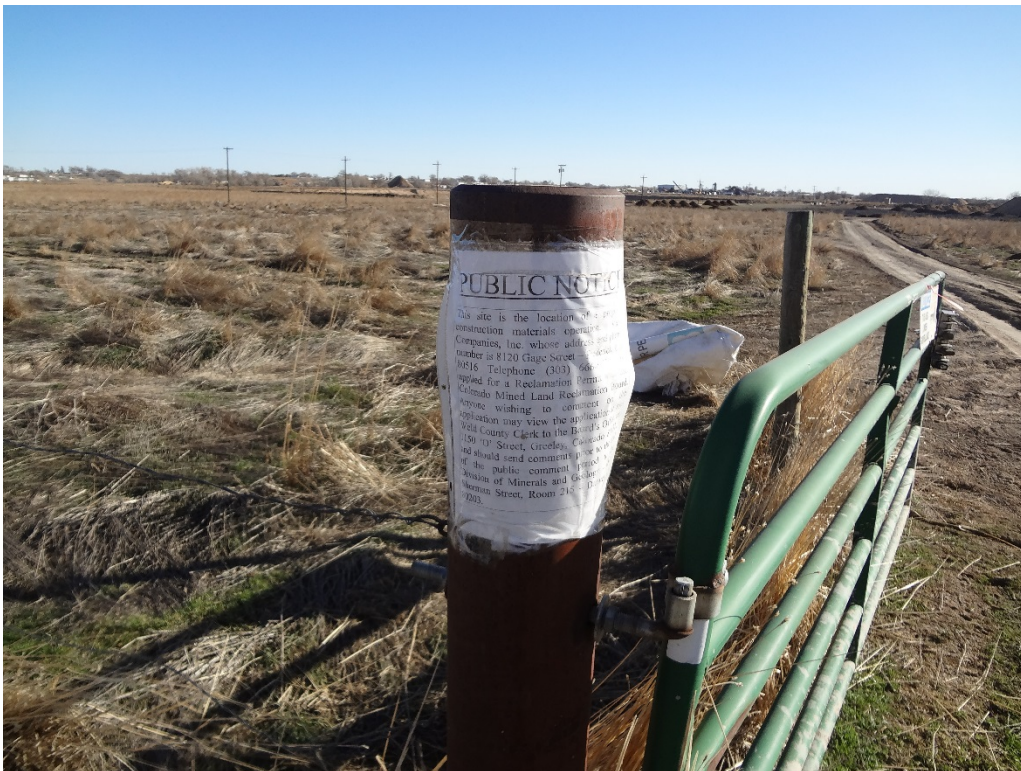
Western Sugar AM-01 Notice sign at Ash St. entrance

The 112c construction materials permit amendment application (AM-01) was received by the Division on December 8, 2015. The application was deemed complete on December 16, 2015. The current decision due date is March 15, 2016. The Applicant published public notice as required by Rule 1.6.2(d) for four consecutive weeks. The public comment period for the application ended on February 4, 2016 according to the Operator. The Division has not received the proof of newspaper publication from the Operator to verify the end of public comment date. No objections were received by the Division. The Division mailed the Applicant the amendment application adequacy letter on February 5, 2016. The notice sign was observed at the entrance gate during the inspection as required by Rule 1.6.2(b).

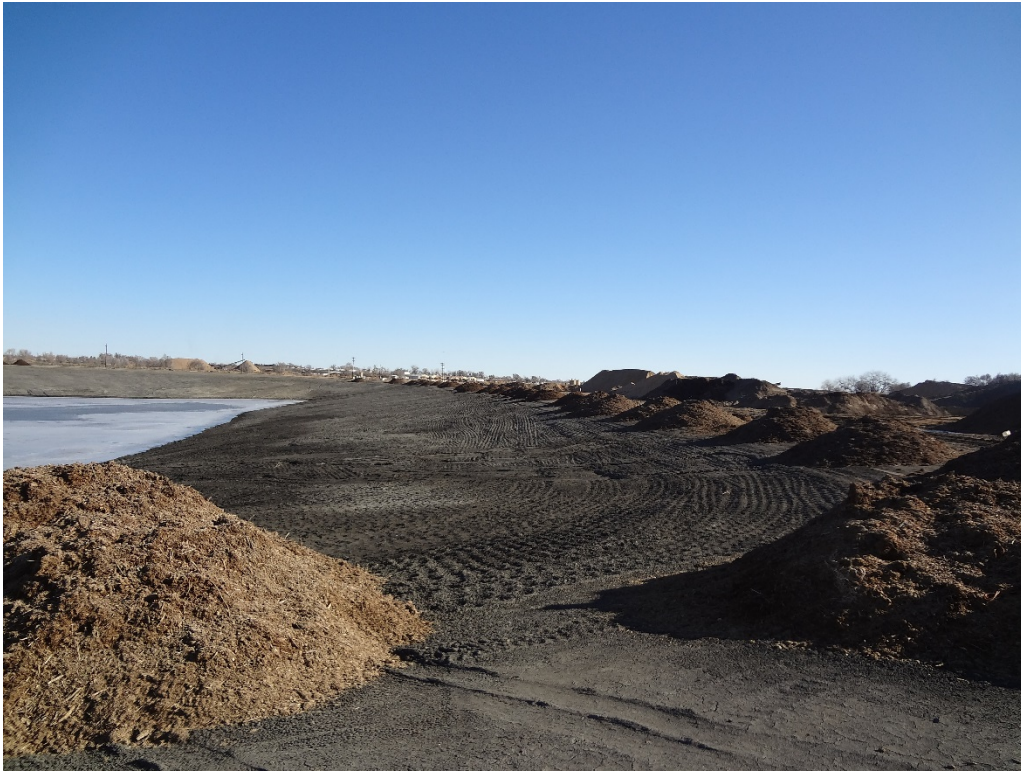
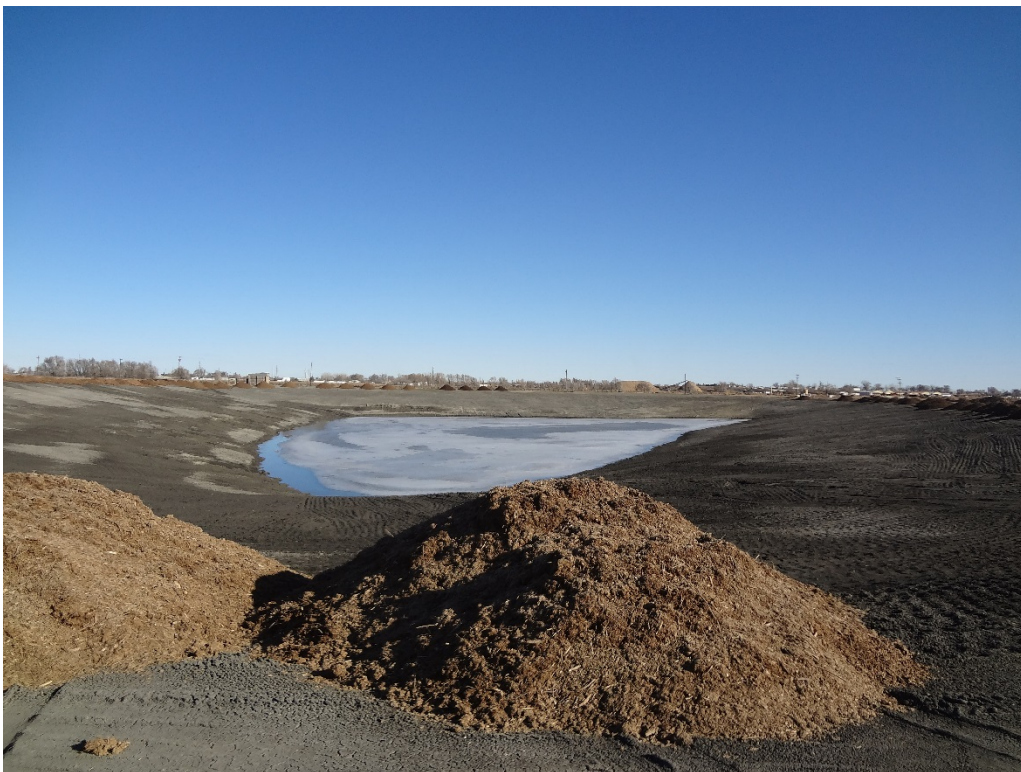
Looking NE from SW corner of Tract B

Mining excavation in Tract B is complete and reclamation is progressing. The Operator stated the clay liner for the Tract is complete, but the required SEO testing has not been completed. The reclaimed slopes appeared to be 4H:1V or flatter and appeared stable. No erosion features were observed. Stockpiles of topsoil amended with manure were observed around the perimeter of the Tract. The approved Reclamation Plan states six (6) inches of topsoil will be replaced at the site. The plan does not mention the amending of onsite topsoil with manure. The Applicant must revise the Reclamation Plan as part of the amendment application to address the manure amendment.

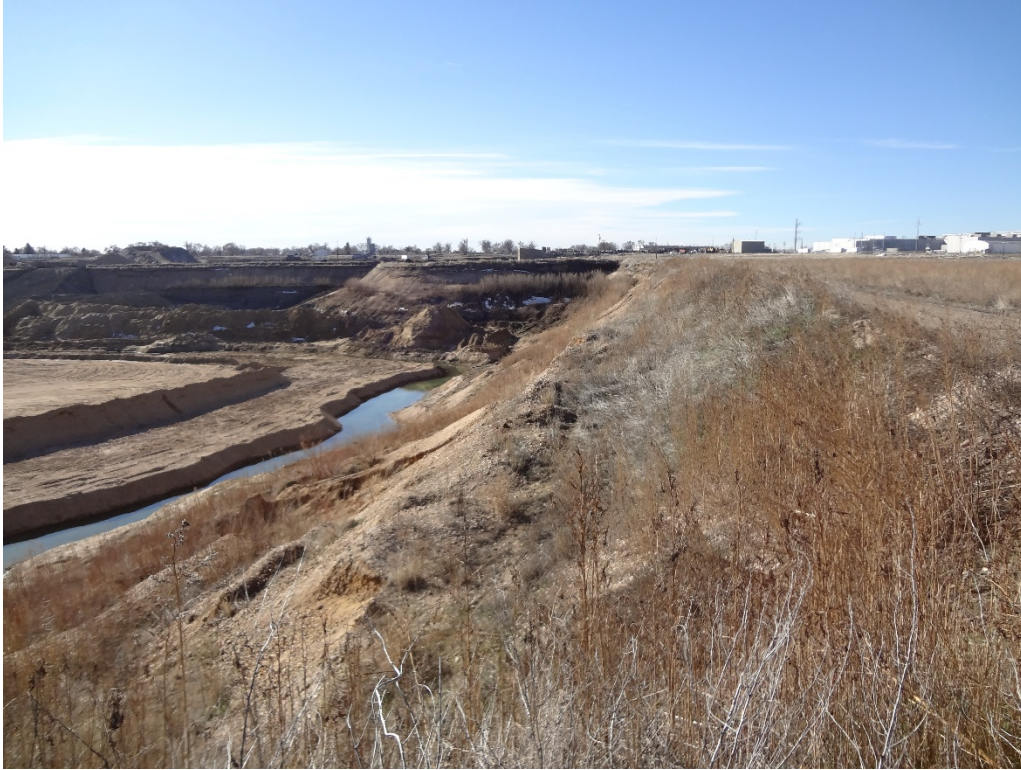
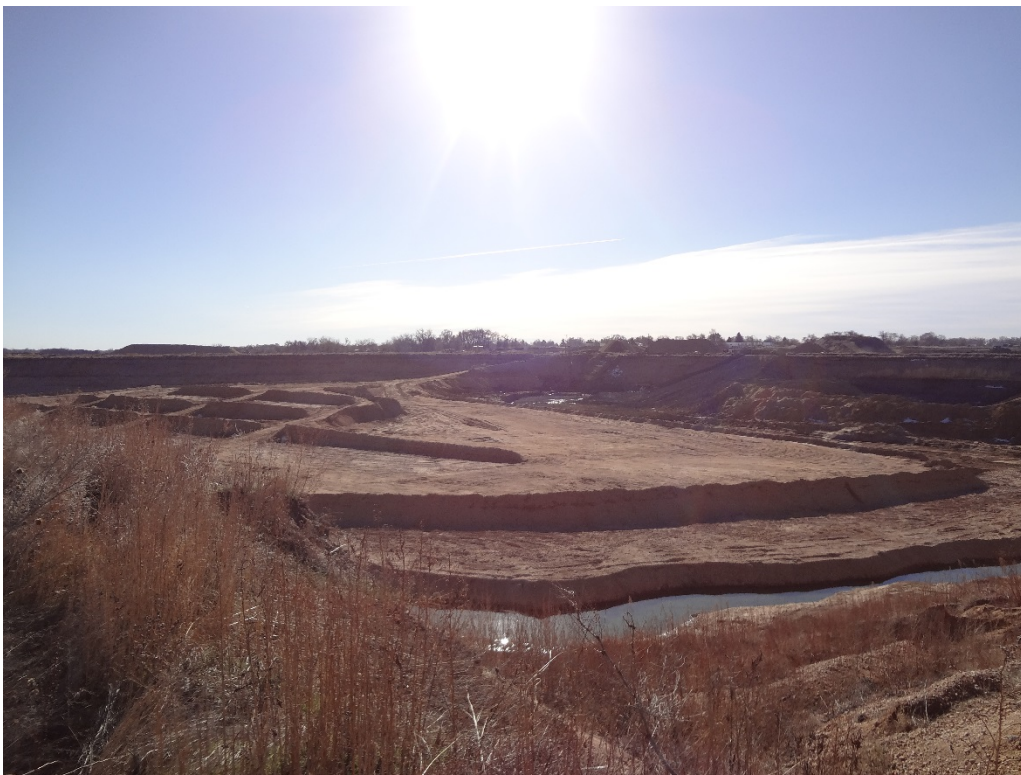
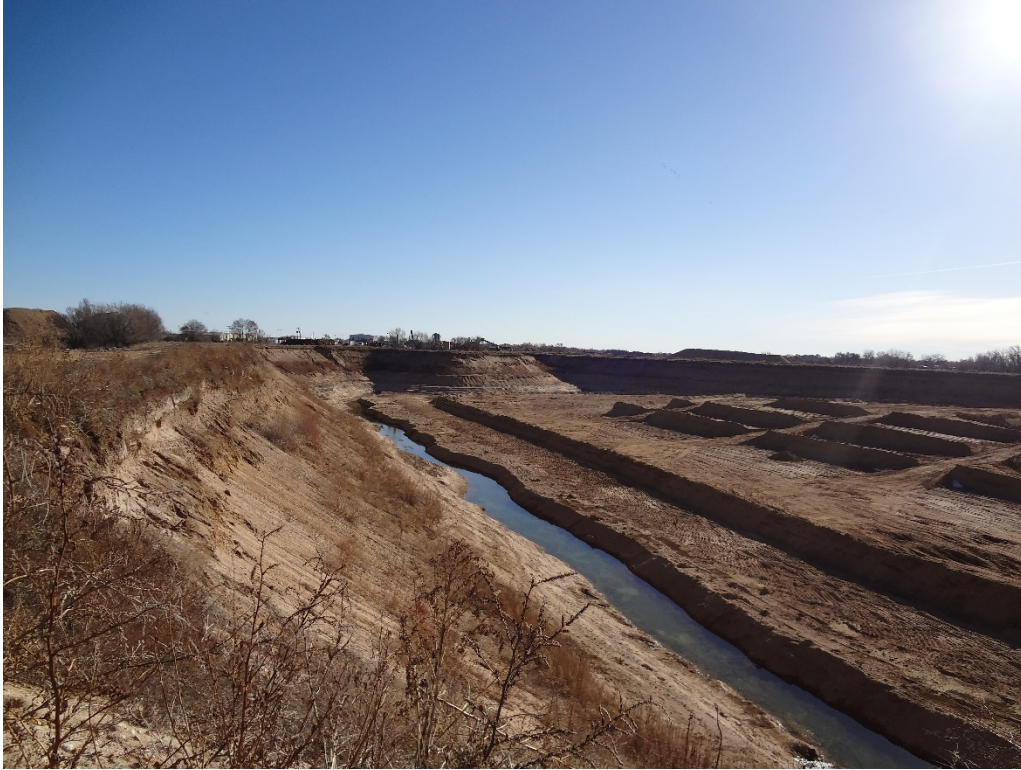
Looking south from NW corner of Tract C

Mining excavation was occurring in Tracts C and D. The tracts were being dewatered and the perimeter slopes appeared to be 1.5H:1V. The excavation in Tract D appeared to be close to completion. The Operator estimates approximately 5 years of material remain in Tracts A, C and D, based on current sales.

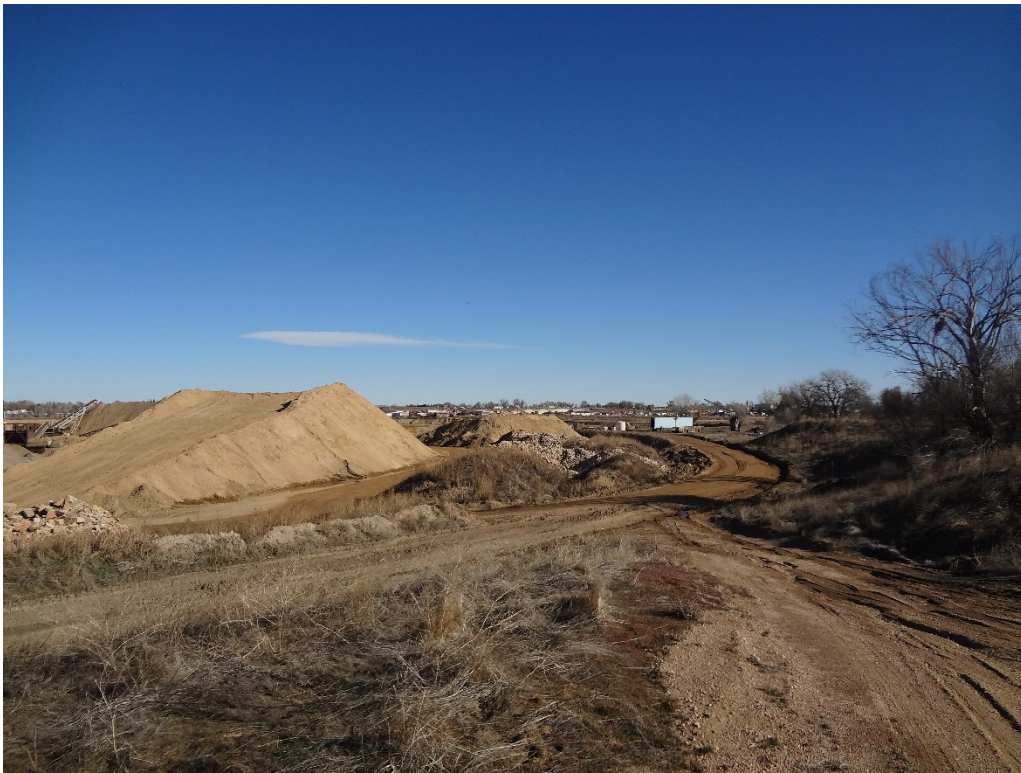
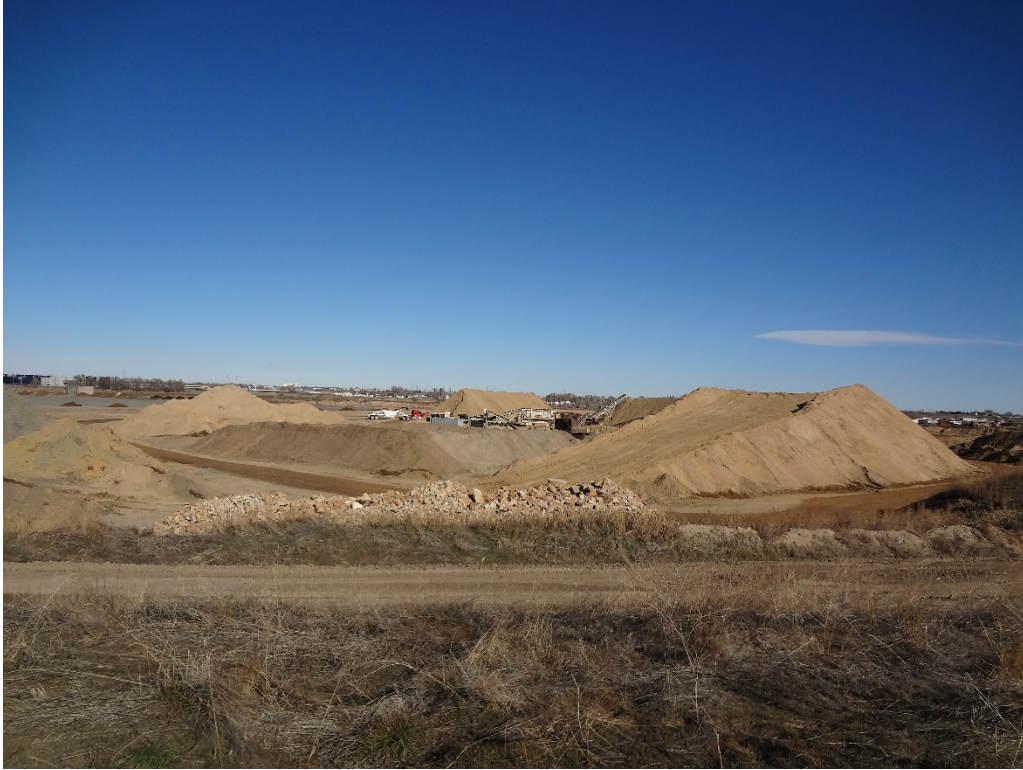
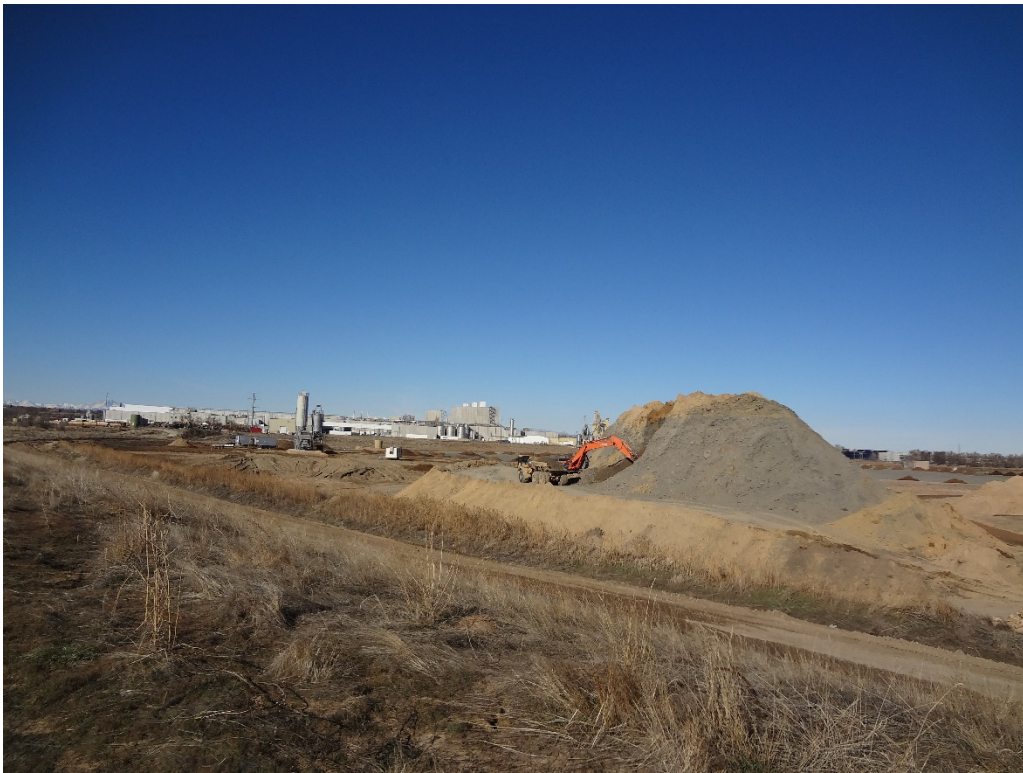
Looking NE from south side of Tract A

Tract A contained the processing plant and product stockpiles. A portable concrete batch plant was being assembled in the southwest corner of the Tract. The Operator must provide the Division with a copy of the approved Weld County Building permit for the batch plant. A concrete foundation was constructed for the batch plant. The amendment application must address the financial warranty implications associated with the removal of the foundation as part of the financial warranty estimate for the amendment application.
