**COLORADO DIVISION OF RECLAMATION, MINING AND SAFETY**  
**MINERALS PROGRAM INSPECTION REPORT**  
**PHONE: (303) 866-3567**

<b>MINE NAME:</b> Hitch Rack Ranch	<b>MINE/PROSPECTING ID#:</b> P-2014-016	<b>MINERAL:</b> Granite, granite gneiss	<b>COUNTY:</b> El Paso
<b>INSPECTION TYPE:</b> Monitoring	<b>INSPECTOR(S):</b> Timothy A. Cazier	<b>INSP. DATE:</b> April 12, 2016	<b>INSP. TIME:</b> 15:30
<b>OPERATOR:</b> Transit Mix Concrete Co.	<b>OPERATOR REPRESENTATIVE:</b> Jerry Schnabel	<b>TYPE OF OPERATION:</b> ME - Mineral Exploration

**INSPECTION TOPIC:** Revegetation

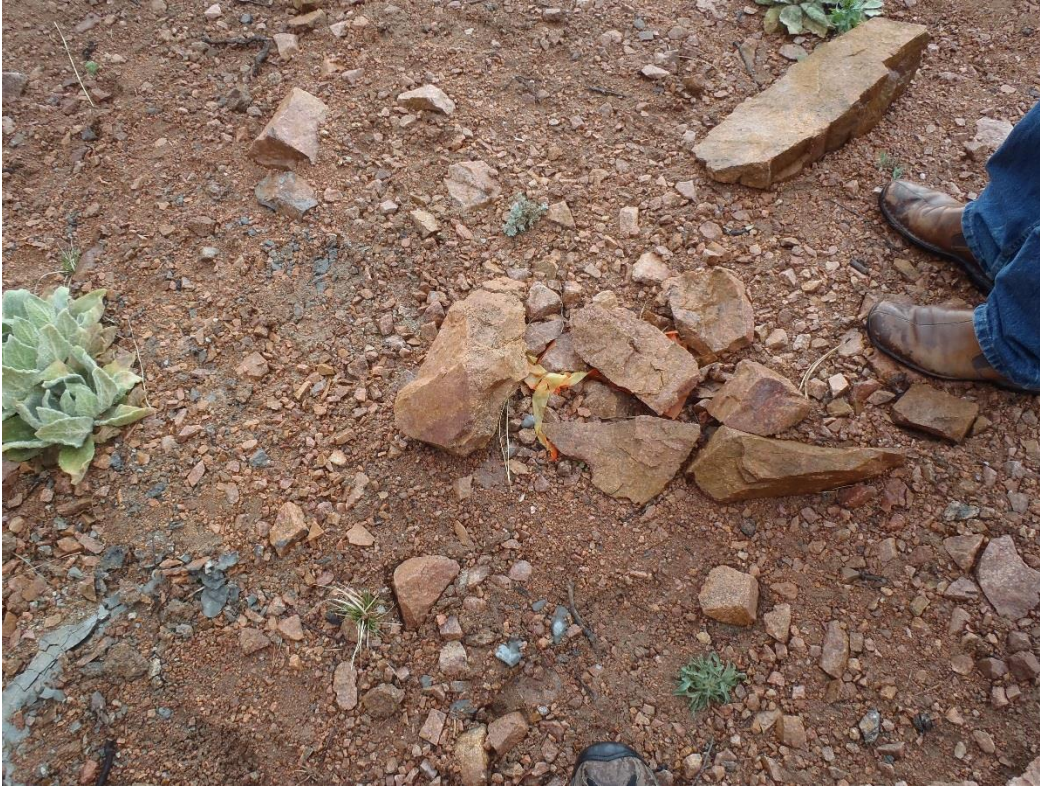
The Division does not require a posted sign for NOIs. All prospecting equipment (drill rig, dozer, skid steer) had been removed from the site. The borehole (B-1) observed during the previous inspection (see **Photo 1**) as well as the first borehole (see **Photo 2**) from the NOI modification (HC001-15) appeared to be sealed at the surface. Mr. Schnabel indicated all the boreholes were dry (which is supported by the logs submitted for the initial/pre-MD-01 drilling program. As such, only the surface is required to be sealed. Weather (potential for lightning) prevented the inspection of other drill pads.

Photo 1. Borehole B-1 appeared to be sealed

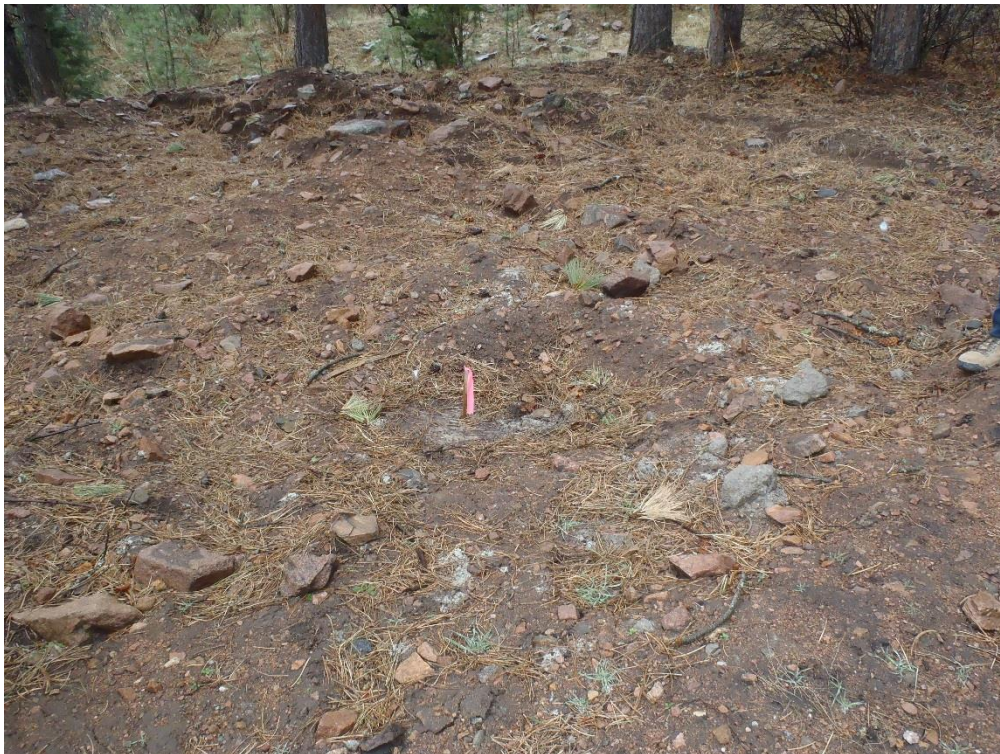
Photo 2. Borehole HC001-15 appeared to be sealed (looking south).

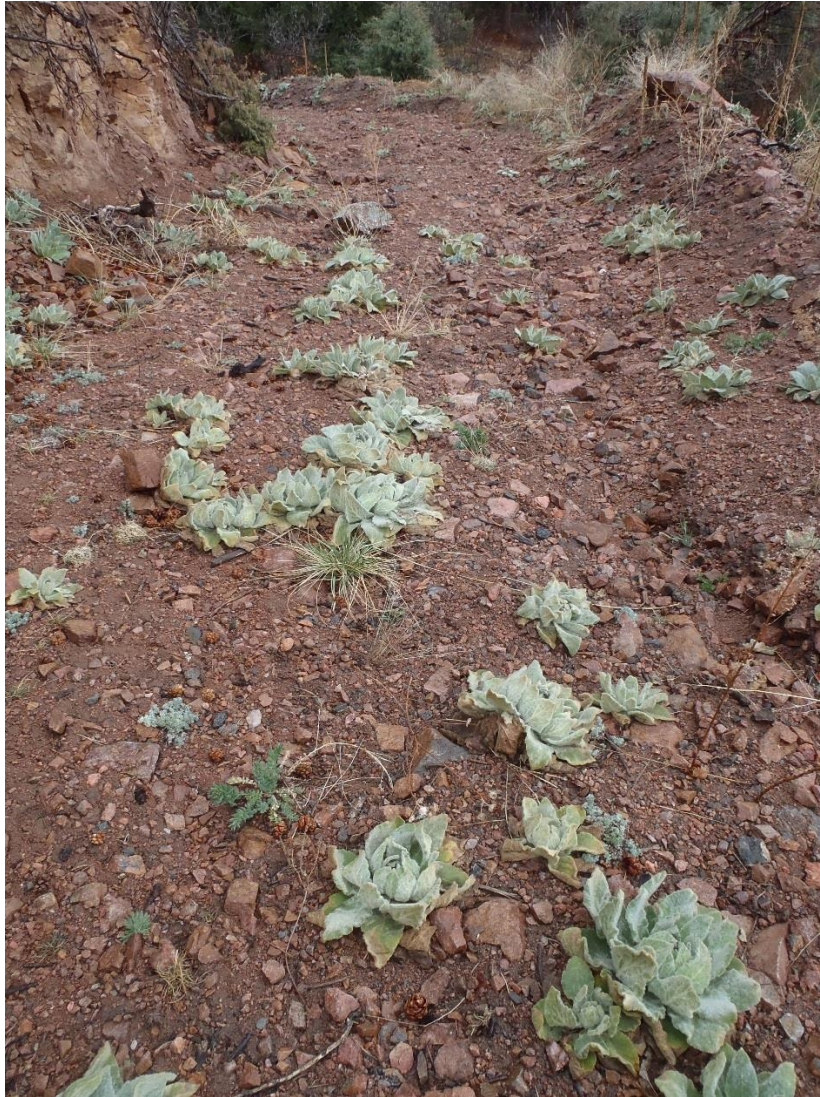
**PROBLEM/POSSIBLE VIOLATION:** Problem: There are state-listed noxious weeds (notably common mullein) present on site. This is a problem for failure to employ weed control methods for state listed noxious weed species within the permitted area, and to reduce the spread of weeds to nearby areas as required by Section 3.1.10 (6) of the rule.

Revegetation is proposed for the drill pads and new roads, but had not been initiated at the time of the inspection. A significant number of new common mullein were observed on this drill road (see **Photo 3**). **The amount of mullein observed is cited as a problem on page 1 of this report.**

Photo 3. Common Mullein on B-1 Drill Road.

**CORRECTIVE ACTIONS:** The prospector shall develop a weed control and management plan in accordance with Section 3.1.10 (6) of the Rule. This plan should be developed in consultation with the county extension agency, or weed control district office and should include specific control measures to be applied, a schedule for when control measures will be applied and a post-treatment monitoring plan. This weed control plan shall be submitted to the Division as an NOI Modification to the approved plan with the appropriate NOI Modification fee of \$108.00 by the corrective action date.

The prospector is required to submit a modification to the NOI to incorporate a weed control plan as indicated on page 1 of this report.
