MINERALS PROGRAM INSPECTION REPORT**PHONE: (303) 866-3567**

MINE NAME: Rowe Gravel	MINE/PROSPECTING ID#: M-1999-038	MINERAL: Sand and gravel	COUNTY: La Plata
INSPECTION TYPE: Monitoring	INSPECTOR(S): Lucas J. West	INSP. DATE: September 14, 2016	INSP. TIME: 14:45
OPERATOR: Rowe Gravel	OPERATOR REPRESENTATIVE: Brad Rowe	TYPE OF OPERATION: 110c - Construction Limited Impact

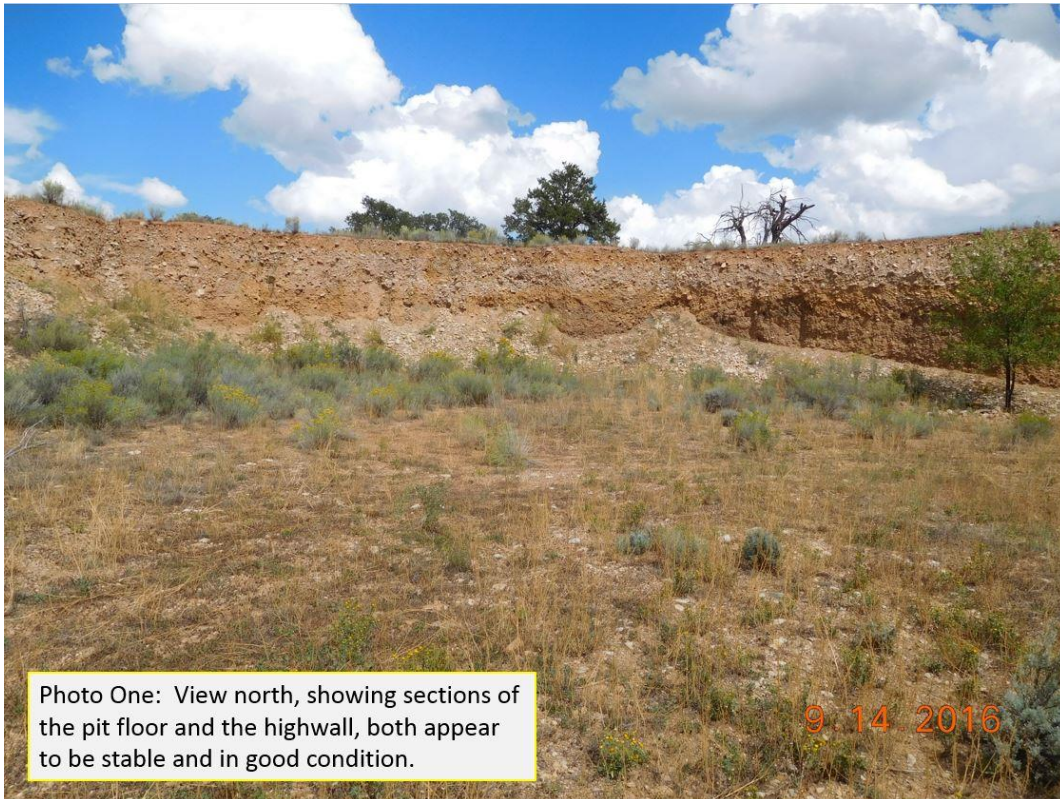
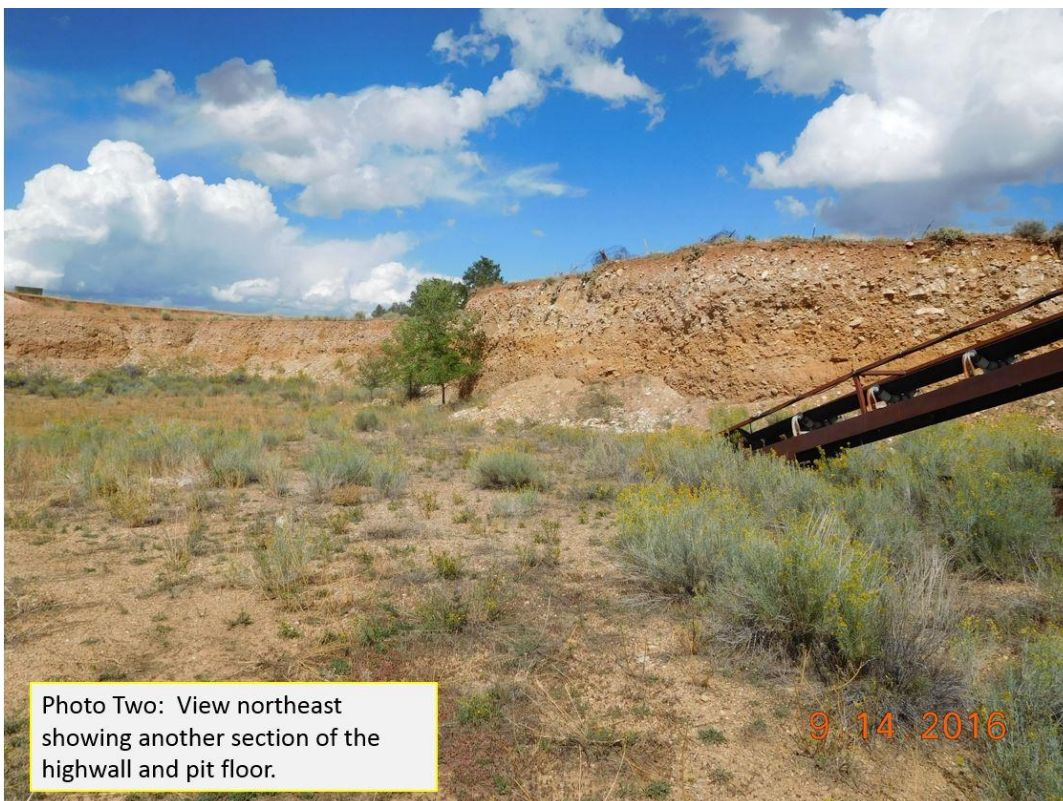
The active mining area consists of a small hole located within the permitted area. The total area of disturbance is approximately 1 acre. The active highwall is approximately 300 linear feet, averaging approximately 15-20 feet tall and appears to be stable and in good condition as seen in photos One and Two. The only equipment observed on site was a screen shown in Photo Three and two small conveyors, shown in Photo Four. The pit floor is well vegetated with volunteer species and very few state listed noxious weeds were noted on site. The pit floor appears to be stable and in good condition. Evidence of chemical treatment of select weeds was observed, and discussions with the operator indicate that weed management is ongoing.

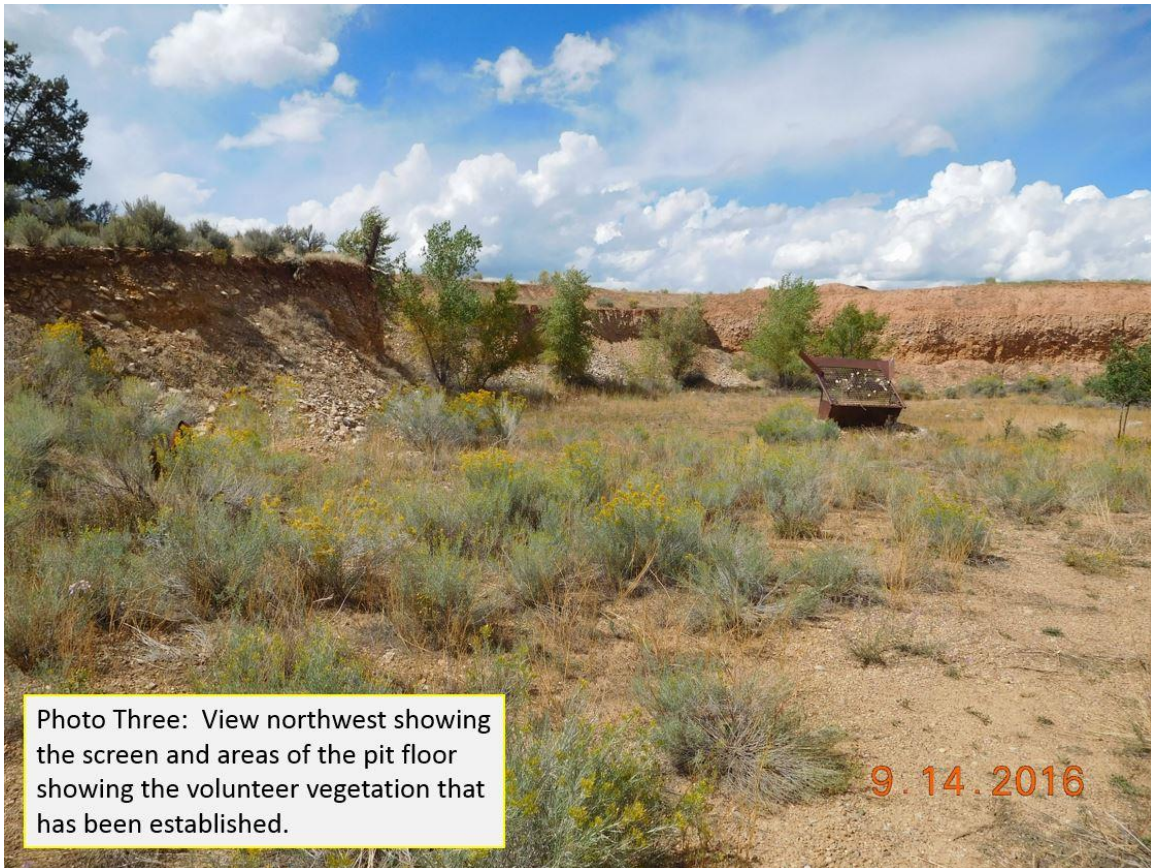
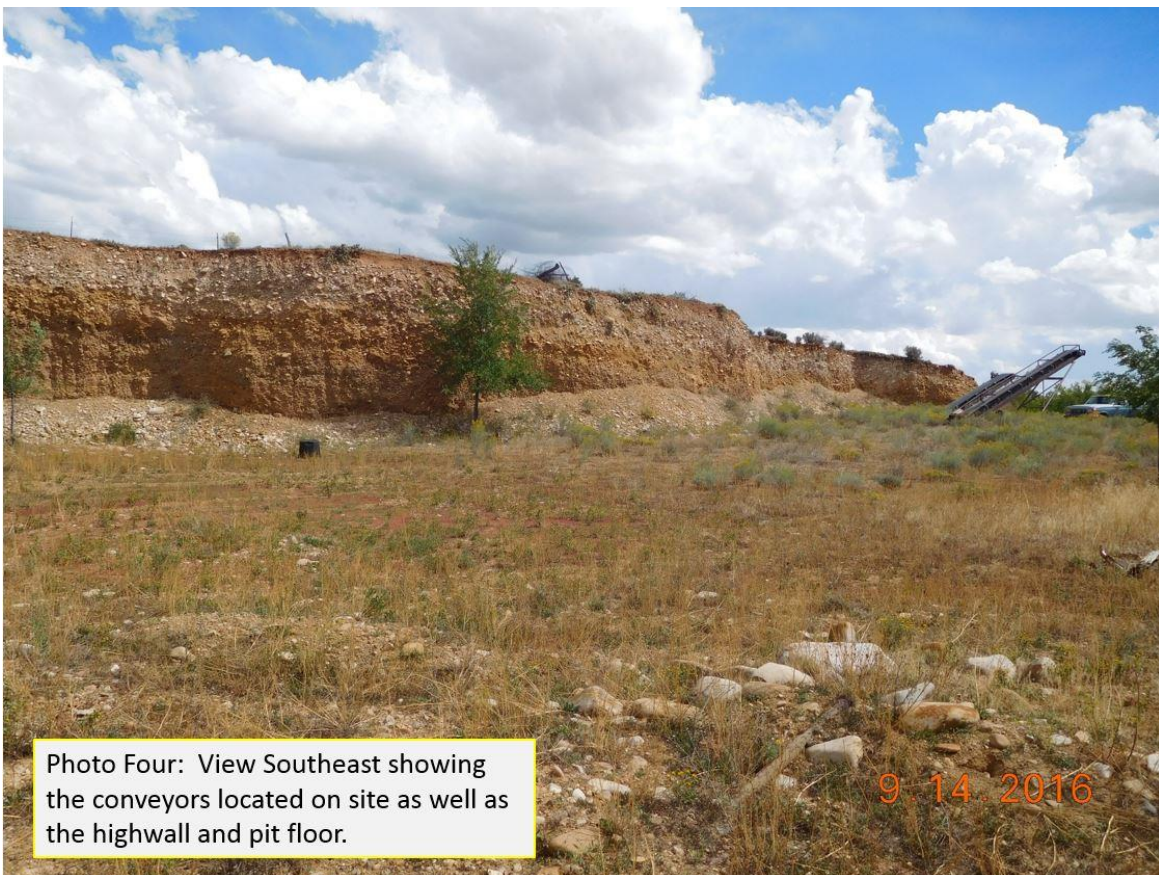
No stockpiles of materials were noted on site, a very small overburden stockpile was observed. The topsoil stockpile was observed and appeared to be in good condition. The site exhibits positive drainage and no erosional features were noted on site. The overall footprint of the site was in good condition and free from trash and debris. The operator is reminded that the corrective actions listed on pages one and two of this report need to be completed no later than Monday November 28, 2016.
