MINERALS PROGRAM INSPECTION REPORT

MINE NAME: Tamarcaz Pit	MINE/PROSPECTING ID#: M-1985-072	MINERAL: Sand and gravel	COUNTY: Gunnison
INSPECTION TYPE: Monitoring	INSPECTOR(S): Dustin M. Czapla	INSP. DATE: September 14, 2016	INSP. TIME: 17:00
OPERATOR: Gunnison County	OPERATOR REPRESENTATIVE: None	TYPE OF OPERATION: 110c - Construction Limited Impact

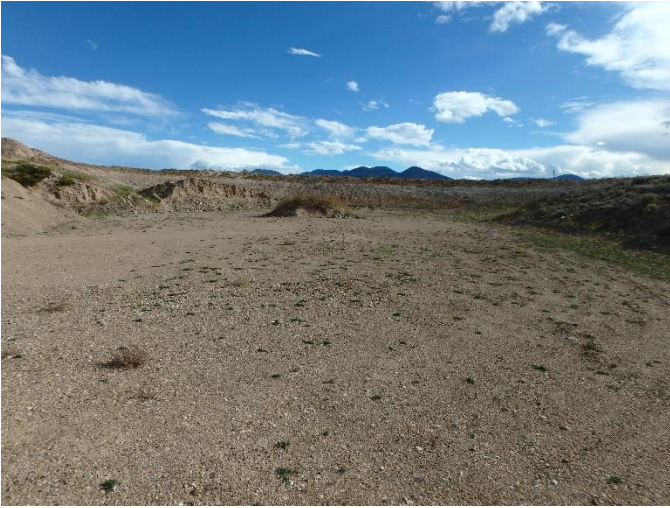
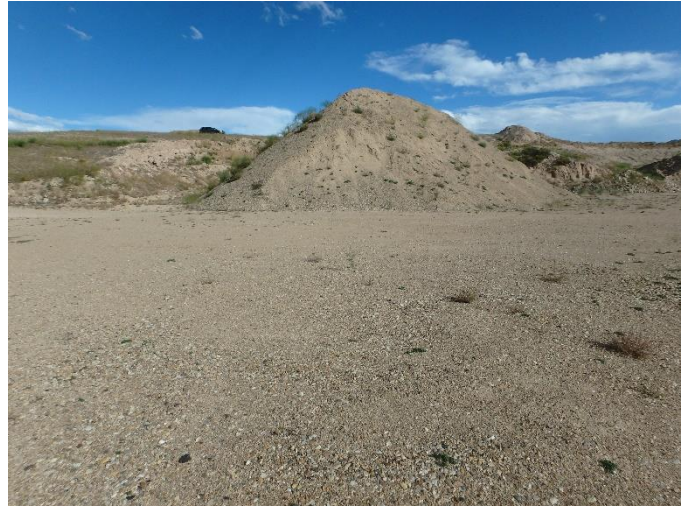
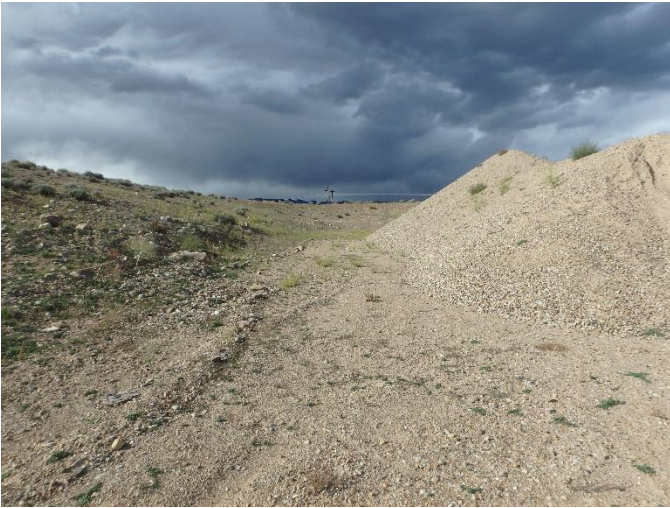
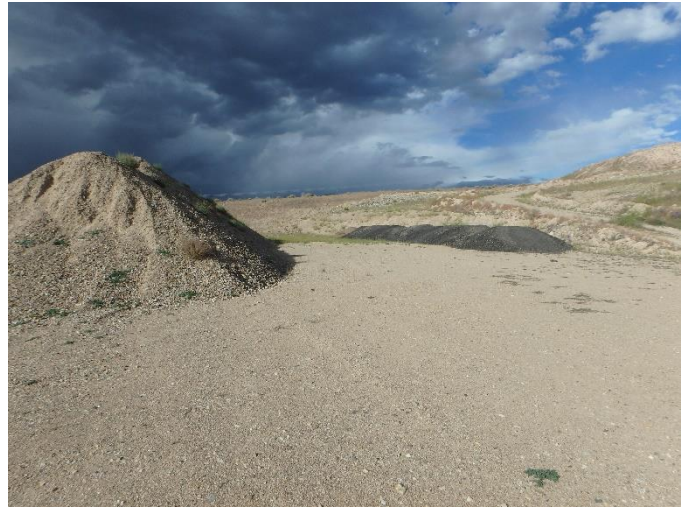
PHOTOGRAPHS

Adequate mine identification signage was not noted at the entrance to the site.

The affected area was marked by fencing that was clearly visible and adequate to delineate the affected area boundary.

Evidence of any recent excavation was not noted. The county typically mines and crushes enough material to last for approximately three years, so active mining/processing is infrequent at this site. Most of the slopes around the pit have been graded to 2H:1V or better. The slopes that have been reseeded show minimal growth at this time. Halogeton and other weeds were noted at the site. The operator should remain diligent in controlling noxious weed species at the site.

Gravel stockpiles were located on the pit floor. Topsoil stockpiles were located at the northeast rim of the pit.

CORRECTIVE ACTIONS: The operator shall, at the entrance of the mine site, post a sign which shall be clearly visible from the access road with the following: the name of the operator, a statement that a reclamation permit for the operation has been issued by the Colorado Mined Land Reclamation Board; and the permit number. The operator shall submit photo documentation that a proper sign has been posted by the corrective action date.
