MINERALS PROGRAM INSPECTION REPORT

MINE NAME: Glen Johnston Site 1	MINE/PROSPECTING ID#: M-1982-044	MINERAL: Sand and gravel	COUNTY: Teller
INSPECTION TYPE: Monitoring	INSPECTOR(S): Timothy A. Cazier	INSP. DATE: July 7, 2015	INSP. TIME: 09:15
OPERATOR: Jerry Johnston	OPERATOR REPRESENTATIVE: Jerry Johnston	TYPE OF OPERATION: 110c - Construction Limited Impact

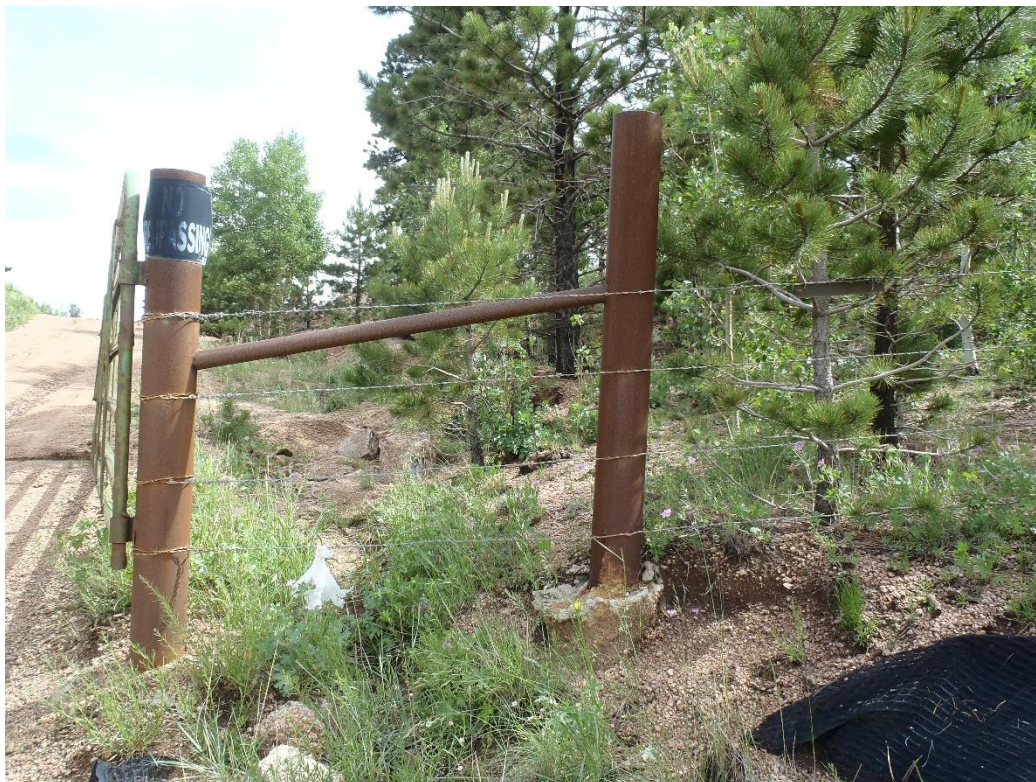
Markers & Boundary – A mine sign was not displayed at the site entrance (see **Photo 1**). Mr. Johnston indicated the sign had recently fallen down. **The missing permit sign is cited as a problem on page 2 of this report.** The permit boundary appeared to be adequately marked with fencing and other markers.

Photo 1. Site entrance without permit identification sign.

CORRECTIVE ACTIONS: The operator shall, at the entrance of the mine site, post a sign which shall be clearly visible from the access road with the following: the name of the operator, a statement that a reclamation permit for the operation has been issued by the Colorado Mined Land Reclamation Board; and the permit number. The operator shall submit photo documentation that a proper sign has been posted by the corrective action date.

1. The Operator must post a permit sign at the site entrance and provide the Division with photographic evidence of the posting by the Corrective Action Due Date shown on page 2 of this report. The sign shall include the following information as a minimum:
 - a. the name of the Operator;
 - b. a statement indicating "A reclamation permit for the operation has been issued by the Colorado Mined Land Reclamation Board; and
 - c. the permit number.
2. The Division recommends treating the Mullein before it becomes a problem.
3. A surety increase letter for and additional \$4,380 will be sent on or near September 13, 2016.
4. Please contact the Division if you intend to increase the permit area.

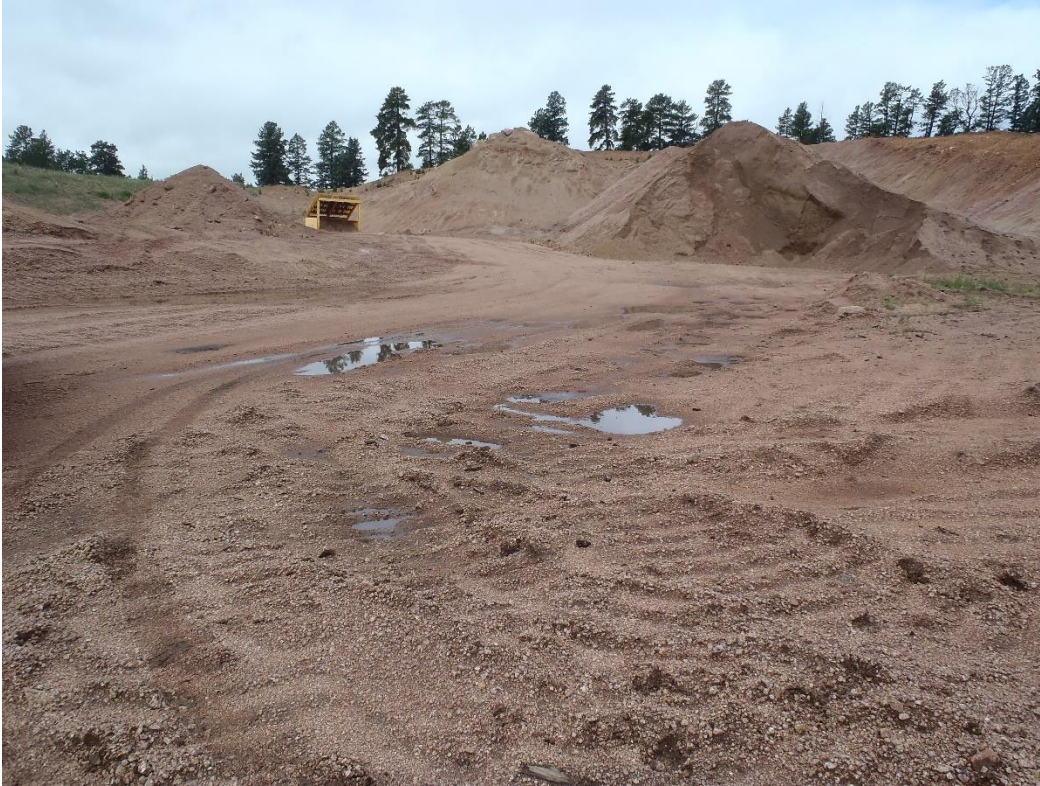
Mining Plan – A screen was observed (see **Photo 2**) and several stockpiles of product (see **Photo 3**). Mr. Johnston indicated topsoil stockpiles were on the east side of the site (see **Photo 3**) and more was available offsite on some of his other property. Highwalls appeared to be about 2H:1V or flatter. Mining appeared to be in compliance with the approved mine plan. Mr. Johnston indicated an interest in increasing the size of the permit to 9.9 acres. I explained that would require an amendment to the permit and explained the process.

Photo 2. Screen and product stockpiles (looking SW).

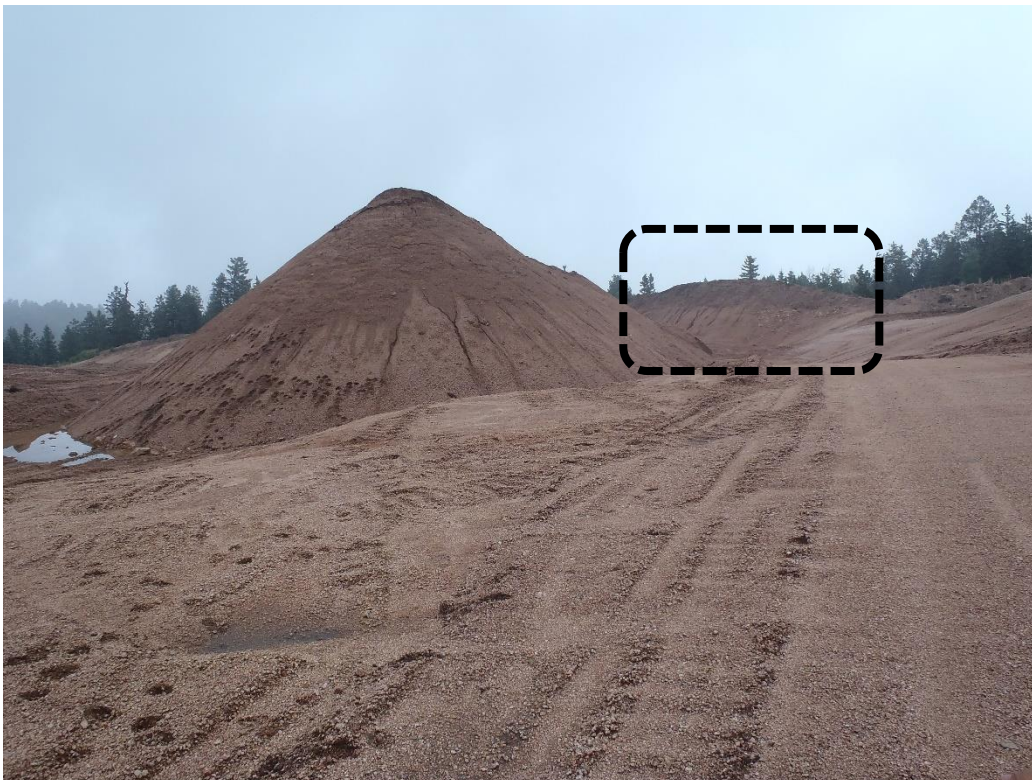
Photo 3. Product stockpile and topsoil stockpile, circled (looking east).

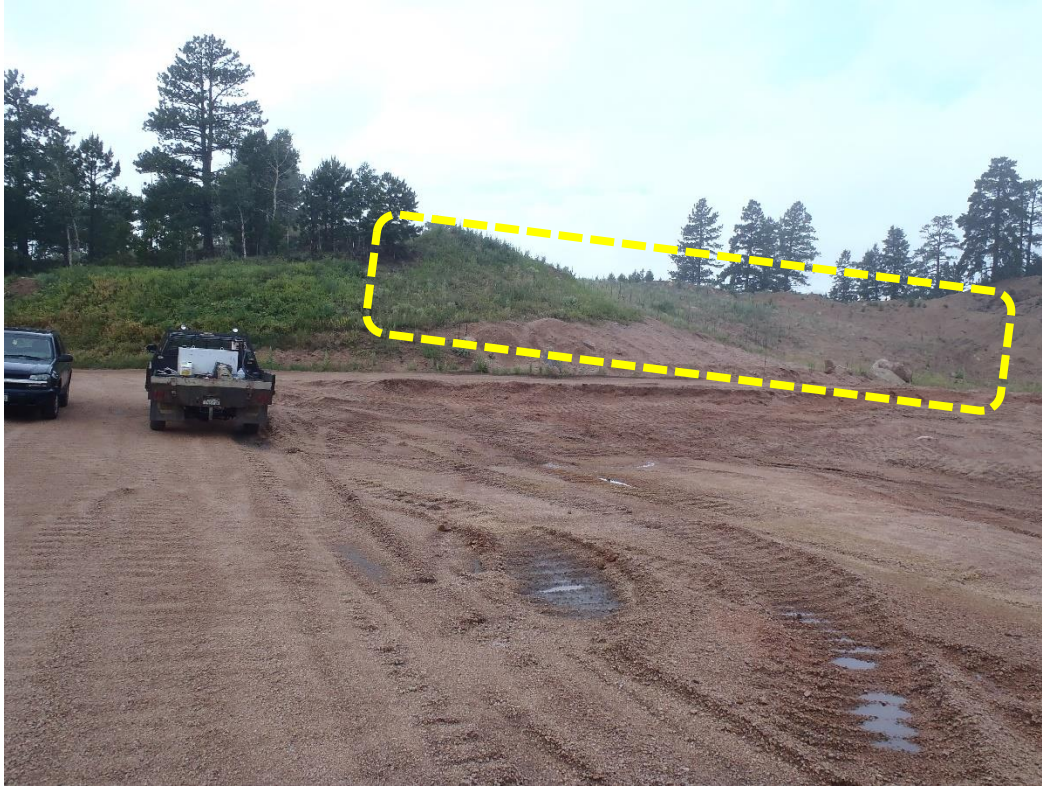
Reclamation – No reclamation had been initiated on site. However, the north facing slope in the southwest corner of the site shows signs of self-revegetation (see **Photo 4**).

Photo 4. SW corner of site showing signs of self-revegetation (looking SW).
