MINERALS PROGRAM INSPECTION REPORT PHONE: (303) 866-3567

MINE NAME:	MINE/PROSPECTING ID#:	MINERAL:	COUNTY:
Houchin Gravel Pit	M-1980-249	Sand and gravel	El Paso
INSPECTION TYPE:	INSPECTOR(S):	INSP. DATE:	INSP. TIME:
Monitoring	Timothy A. Cazier	March 16, 2016	09:50
OPERATOR:	OPERATOR REPRESENTATIVE:	TYPE OF OPERA	TION:
Charles W Houchin	Curt Houchin	110c - Construction	Limited Impact
REASON FOR INSPECTION:	BOND CALCULATION TYPE:	BOND AMOUNT:	
Normal I&E Program	Complete Bond	\$3,500.00	
DATE OF COMPLAINT:	POST INSP. CONTACTS:	JOINT INSP. AGE	NCY:
NA	None	None	
WEATHER:	INSPECTOR'S SIGNATURE:	SIGNATURE DAT	'E:
Windy	Thim AC-	February 10, 2017

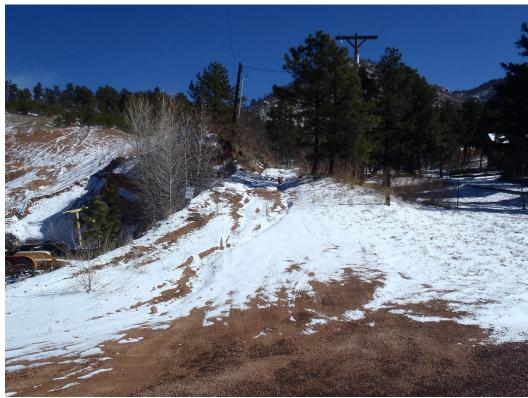
PROBLEM/POSSIBLE VIOLATION: Problem: No utility structures agreement for the powerline and/or phone line on the east side of the pit.

<u>Availability of Records</u>: Annual fees are paid through February 2017. There are no open infractions. However, in the three previous inspection reports (from inspections on 10/28/2011, 10/7/2005, and 10/3/2000) the Division has requested a letter from the utility company that owns the power pole and/or phone line (see **Photo** 1) on the crest of the east highwall. The following is an excerpt from the previous inspection report:

"During the last inspection (10/7/2005), the Division had notified the operator to submit a notarized agreement between the operator and the persons having an interest in the structures that the operator provide a compensation agreement for any damage to structures within 200 feet in accordance with Rule 6.4.19(a) for the power pole and the phone line along the north east side of the permit and affected area To date the Division has not received the agreement."

The Division has no record of having received the requested notarized agreement. The lack of agreement is cited as a Problem on page 1 of this report.

Photo 1. Power and/or phone poles (looking NE).

CORRECTIVE ACTIONS: Within 60 days of this report the Operator must submit a notarized letter on utility letterhead or agreement in accordance with Rule 6.4.19 addressing the potential for damage to the powerline and/or phone line.

CORRECTIVE ACTION DUE DATE: 4/11/17

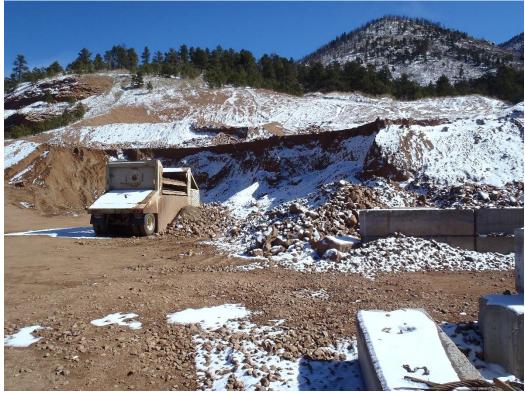
<u>Gen. Compliance with Mine Plan</u>: The operation appeared to be in compliance with the approved mine plan. The pit highwall was benched (see **Photo 2**). Google Earth was used to measure the disturbed area, which was estimated to be approximately 3 acres.

Photo 2. Benched highwall (looking NE).

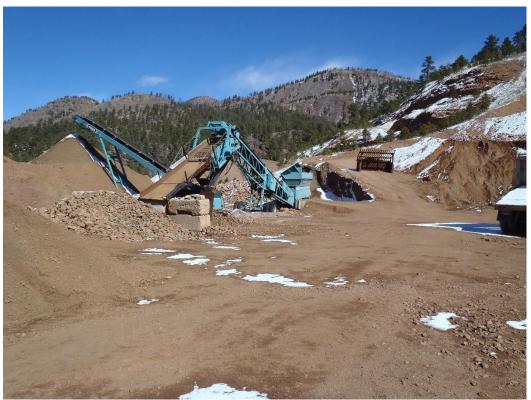
Support Facilities On-site: A screen and conveyor were observed on site (see Photo 3).

Photo 3. Screen & conveyor.

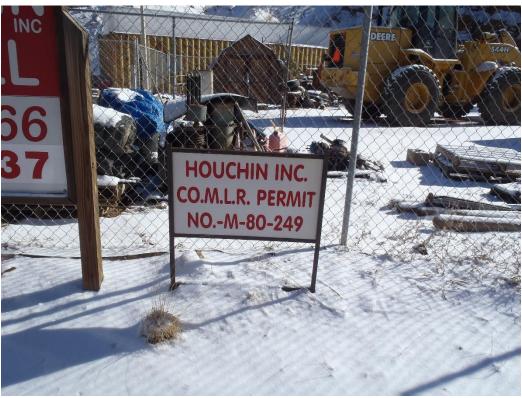
<u>Signs and Markers</u>: The permit sign was properly posted (see **Photo 4**) and boundary markers were observed to delineate the permit boundary.

Photo 4. Permit sign.
