MINERALS PROGRAM INSPECTION REPORT
PHONE: (303) 866-3567

MINE NAME: Canon City East Pit	MINE/PROSPECTING ID#: M-1977-559	MINERAL: Sand and gravel	COUNTY: Fremont
INSPECTION TYPE: Surety-Related Inspection	INSPECTOR(S): Timothy A. Cazier	INSP. DATE: February 16, 2017	INSP. TIME: 11:35
OPERATOR: VALCO, Inc.	OPERATOR REPRESENTATIVE: Tom Brubaker, Steve Lindner	TYPE OF OPERATION: 112c - Construction Regular Operation	
REASON FOR INSPECTION: Surety Related	BOND CALCULATION TYPE: Complete Bond	BOND AMOUNT: \$45,500.00	
DATE OF COMPLAINT: NA	POST INSP. CONTACTS: None	JOINT INSP. AGENCY: None	
WEATHER: Clear	INSPECTOR'S SIGNATURE:

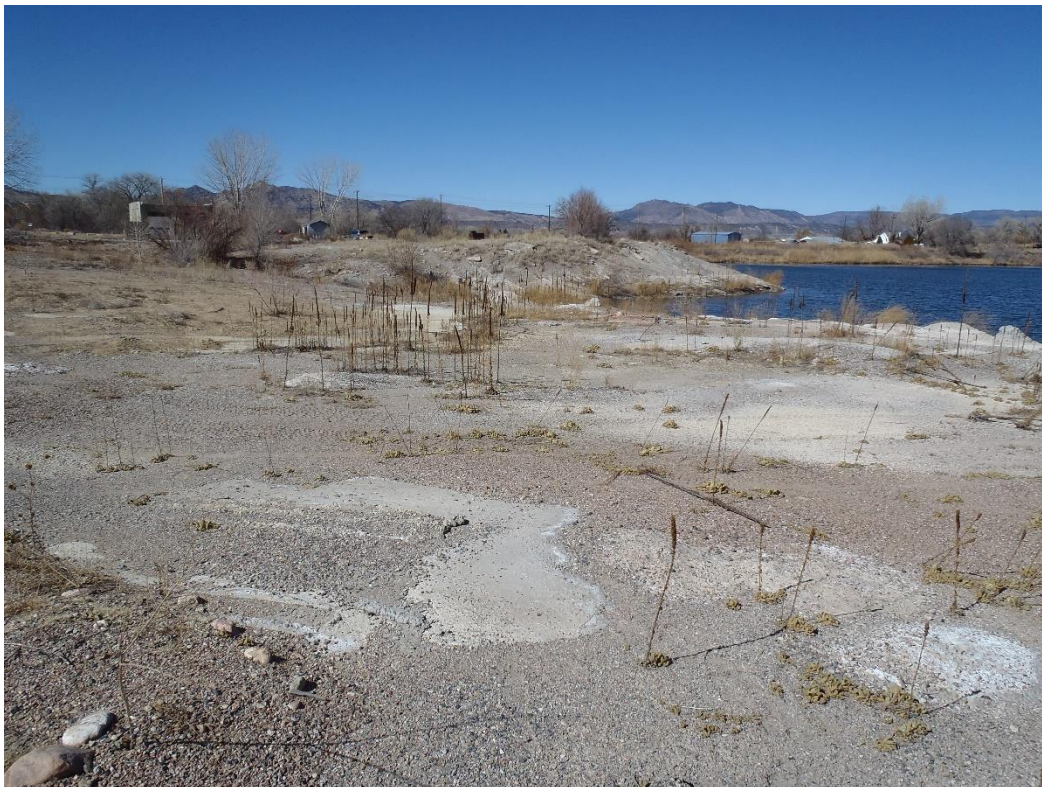
Backfilling and Grading: During the inspection, representatives from South Forty stated they had investigated pit run material in the vicinity of the concrete dump area (East Parcel, see **Photo 1**) and determined sufficient quantities were available to regrade the area and cover the concrete dump area prior to placing topsoil, but after the concrete drilling program is completed for drainage.

Photo 1. Concrete dump area, East Parcel (looking north).

Excess Spoil and Dev. Waste: There are no overburden piles to remove. However the slash pile (mostly downed russian olive trees needs to be removed) near the concrete dump area does need to be removed.

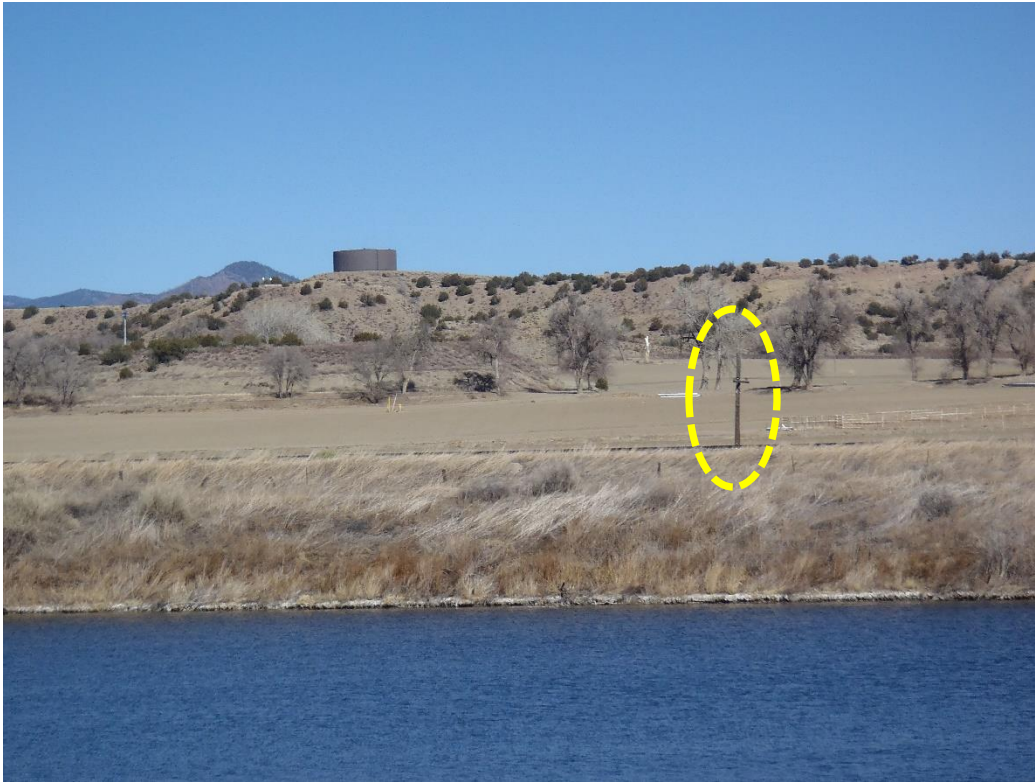
Off-site Damage: The mined area appeared to be confined to within the permit boundary. All structures agreements for SO-01 were accounted for. Additional communication lines (not covered by the submitted UPPR agreement) along the railroad on the east side of the east parcel were noted (see **Photo 2**). South Forty Recreation submitted a revised structure agreement to the DRMS via email on February 23, 2017 to cover this discrepancy.

Photo 2. Communication lines along the railroad.

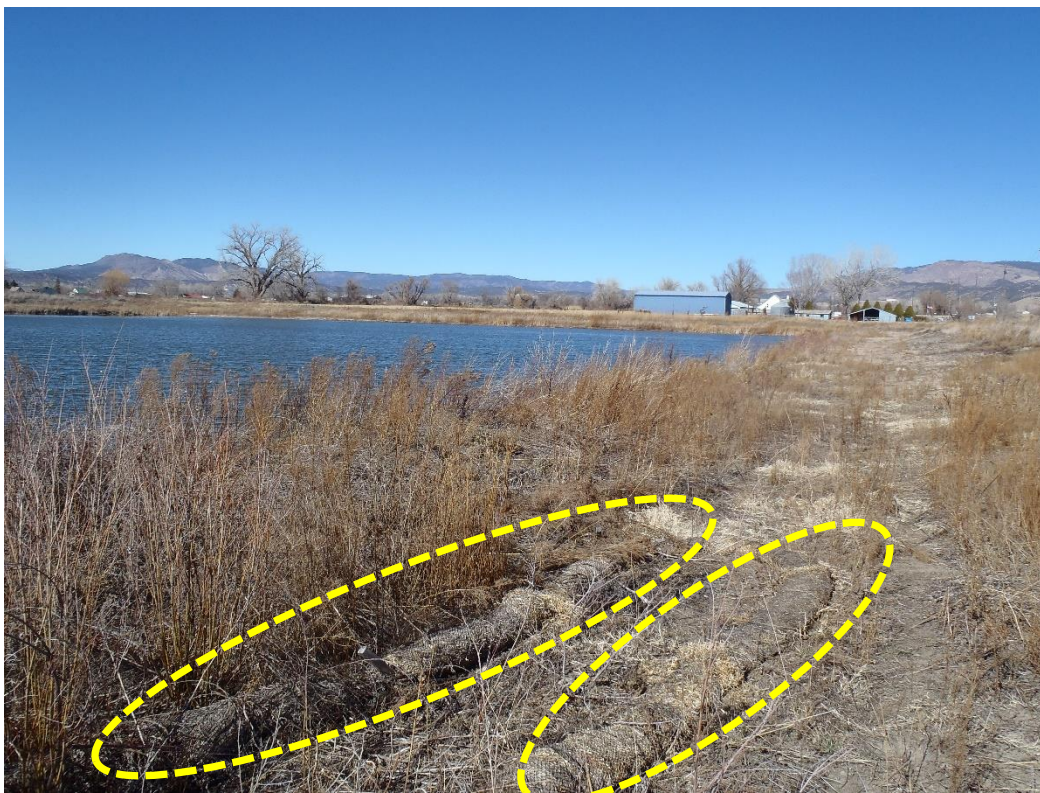
Sediment Control: No erosion problems were observed. However, straw wattles were observed on the east side of the west parcel (see **Photo 3**). Site representatives thought these wattles were left over from recent repair work done on the sewer line that runs between the west pit lake and MacKenzie Ave. Subsequent to this inspection, photographic evidence of the removal of these straw wattles was received by the DRMS.

Photo 3. Straw wattles were observed on the east side of the west parcel.

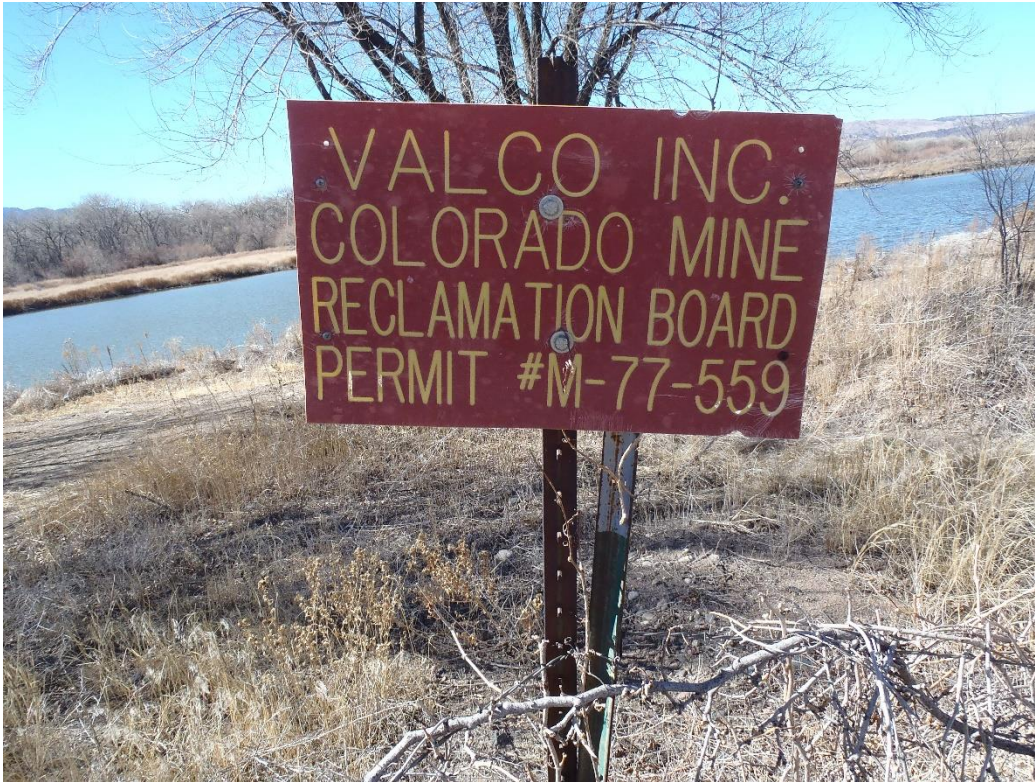
Signs and Markers: The permit sign was properly posted (see **Photo 4**). It must remain posted until final release of reclamation liability. However, the name should be changed on the sign after SO-01 is approved by the DRMS.

Photo 4. Permit sign (west side of MacKenzie Ave.).
