## MINERALS PROGRAM INSPECTION REPORT

<b>MINE NAME:</b> Grizzly Ridge Pit	<b>MINE/PROSPECTING ID#:</b> M-1984-152	<b>MINERAL:</b> Sand and gravel	<b>COUNTY:</b> Montrose
<b>INSPECTION TYPE:</b> Monitoring	<b>INSPECTOR(S):</b> Dustin M. Czaplá	<b>INSP. DATE:</b> March 9, 2017	<b>INSP. TIME:</b> 10:00
<b>OPERATOR:</b> Montrose County	<b>OPERATOR REPRESENTATIVE:</b> None	<b>TYPE OF OPERATION:</b> 110c - Construction Limited Impact	
<b>REASON FOR INSPECTION:</b> Normal I&E Program	<b>BOND CALCULATION TYPE:</b> NA	<b>BOND AMOUNT:</b> \$0.00	
<b>DATE OF COMPLAINT:</b> NA	<b>POST INSP. CONTACTS:</b> None	<b>JOINT INSP. AGENCY:</b> None	
<b>WEATHER:</b> Clear	<b>INSPECTOR'S SIGNATURE:</b>

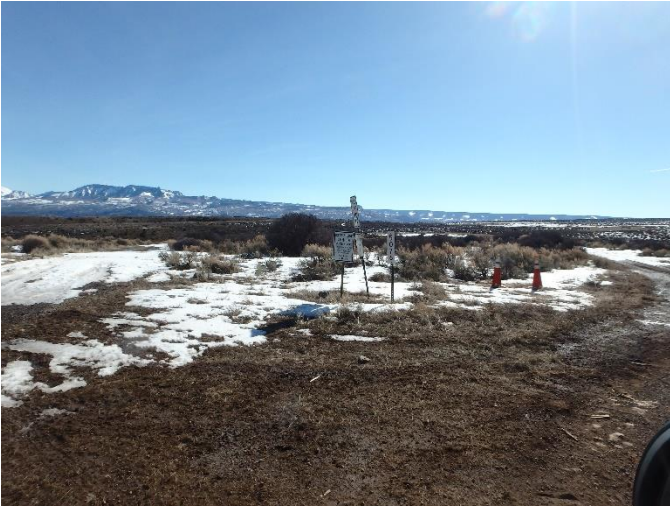
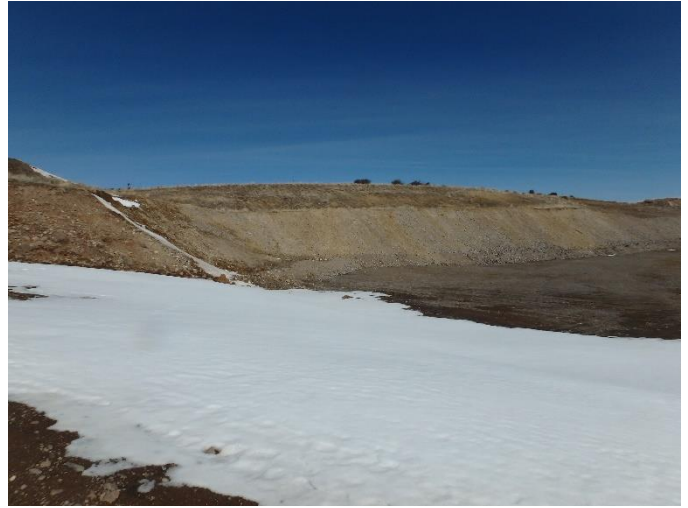
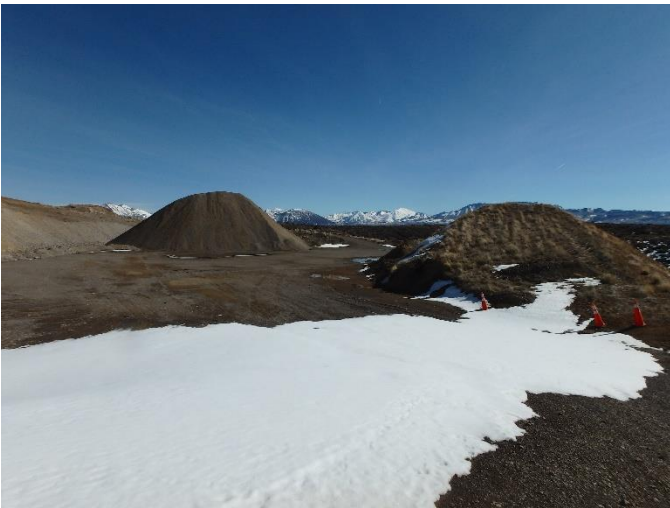
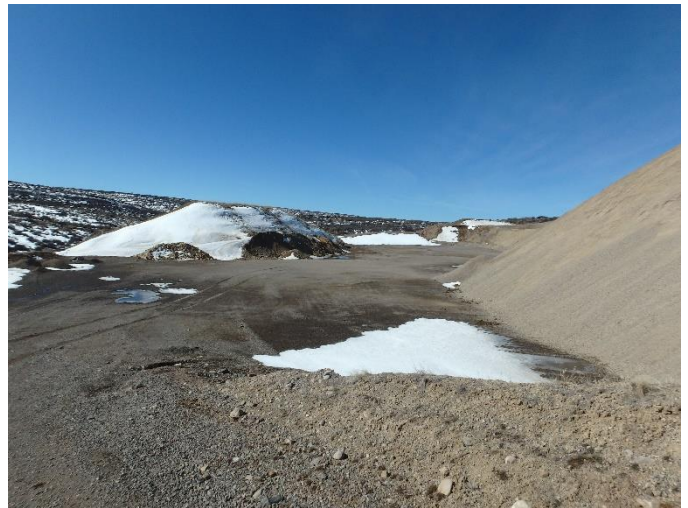
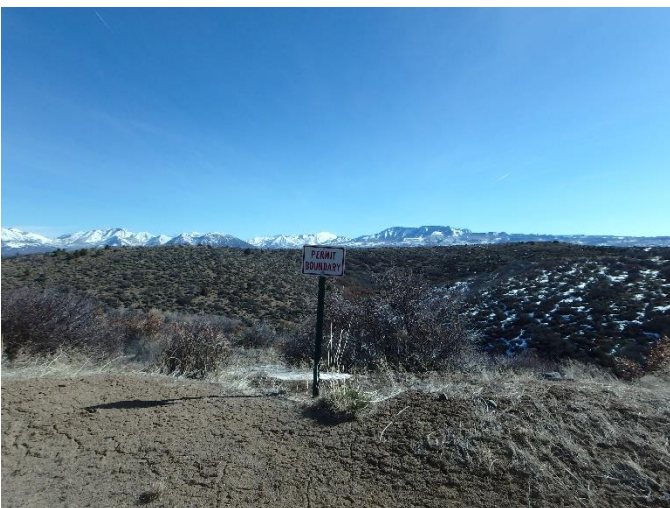
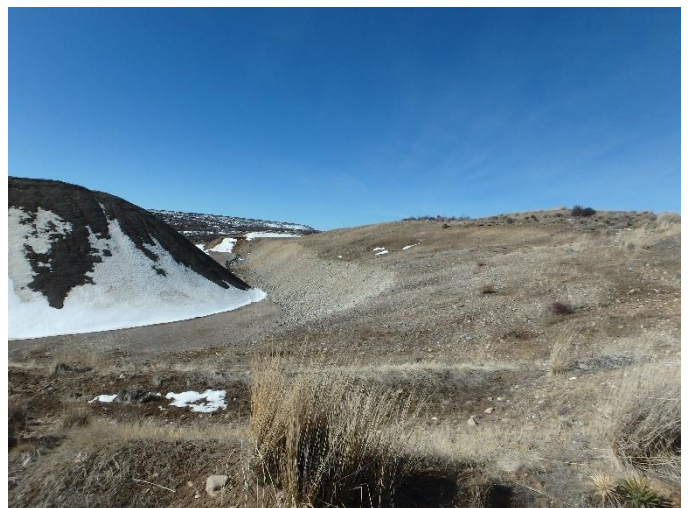
## PHOTOGRAPHS

There was no mining activity occurring or personnel at the site during this inspection. The site is well maintained. The mine face was left at an approximate 2H:1V slope. No rilling was observed on the slope. A stockpile of gravel was located on the pit floor. Adequate topsoil was stockpiled on the south side of the mine bench. The stockpile was stabilized with adequate vegetation. Noxious weeds were not observed.
