MINERALS PROGRAM INSPECTION REPORT**PHONE: (303) 866-3567**

MINE NAME: Montgomery Pit	MINE/PROSPECTING ID#: M-1986-104	MINERAL: Sand and gravel	COUNTY: Eagle
INSPECTION TYPE: Monitoring	INSPECTOR(S): Travis H. Marshall	INSP. DATE: April 13, 2017	INSP. TIME: 11:00
OPERATOR: Oldcastle SW Group, Inc. dba B & B Excavat	OPERATOR REPRESENTATIVE: Chip Bair	TYPE OF OPERATION: 112c - Construction Regular Operation

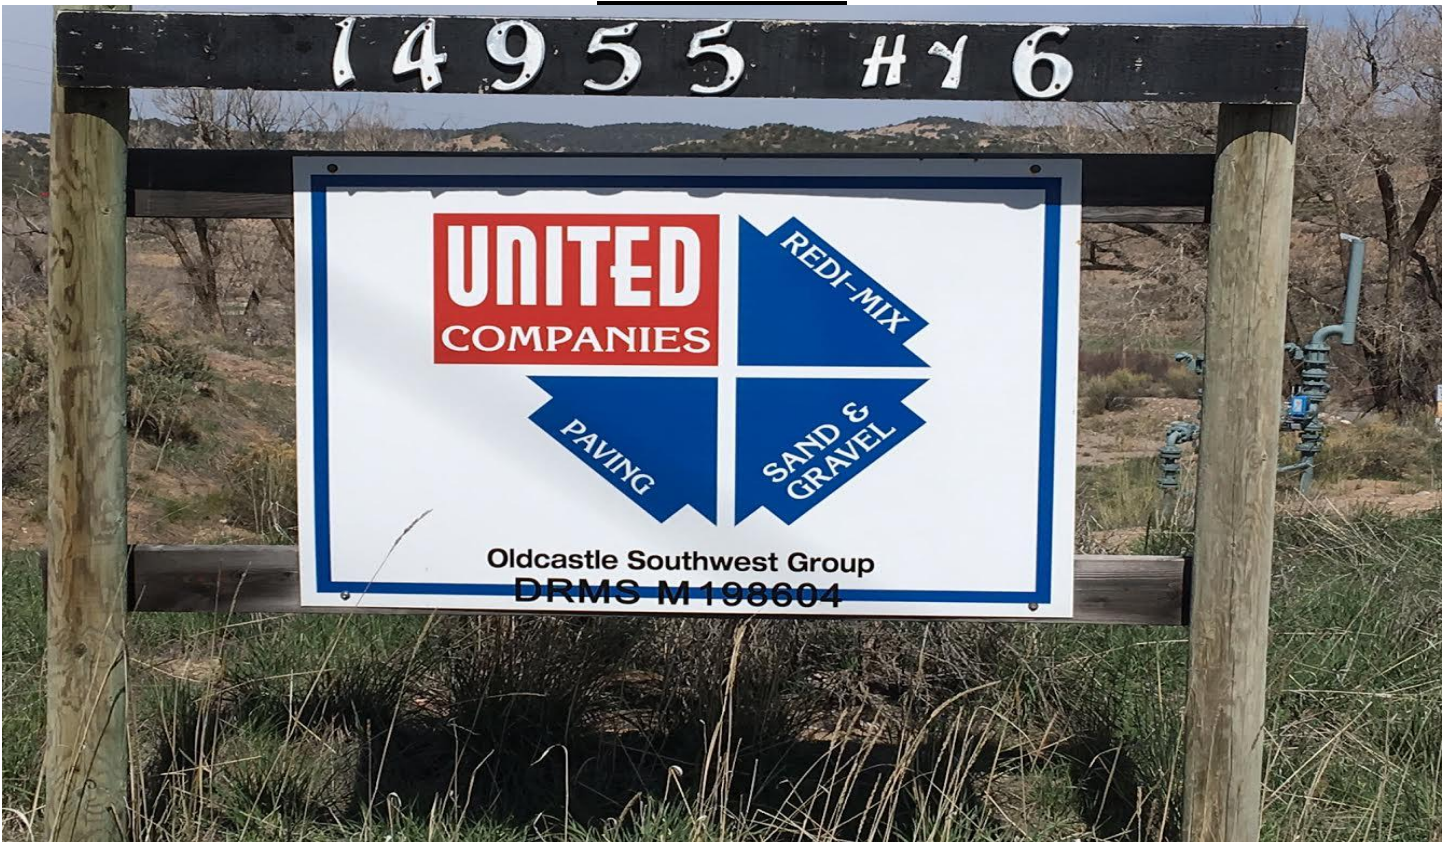
PROBLEM/POSSIBLE VIOLATION: Problem: The mine identification sign was posted at the entrance of the mine site but it was lacking the correct permit number. This is a problem for failure to post a mine identification sign as required by Section 3.1.12(1) of the rule.

The mine identification sign and the affected area boundary markers are in place but the sign is displaying an incomplete permit number. Also another sign observed at the site had the permit number for the Chambers Pit (M-1980-136). In order to be in compliance with Rule 3.1.12 the operator must fix the permit number on the sign located at the entrance and remove the incorrect permit number located on the sign that is located past the main entrance to the site. Please supply photo-documentation that displays the corrected signs. The permit boundaries are comprised of fences and posts that are easily identifiable around the entire perimeter of the mine.

Sign with incomplete permit number, should read M-1986-104.

CORRECTIVE ACTIONS: The operator shall amend the sign with the correct permit number. The operator shall submit photo documentation that a proper sign has been posted by the corrective action date.

CORRECTIVE ACTION DUE DATE: 5/31/17

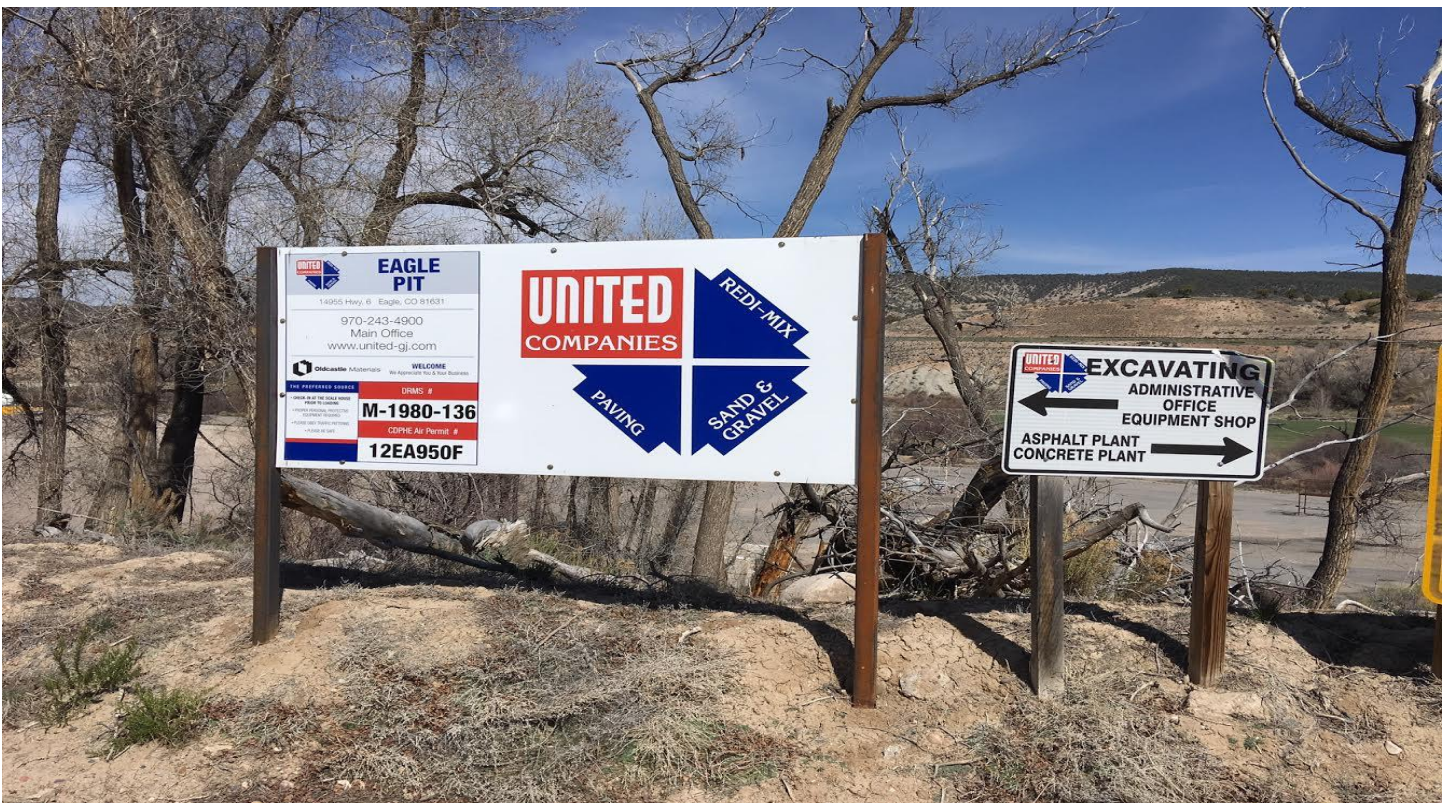
Sign with Chambers Pit permit number.

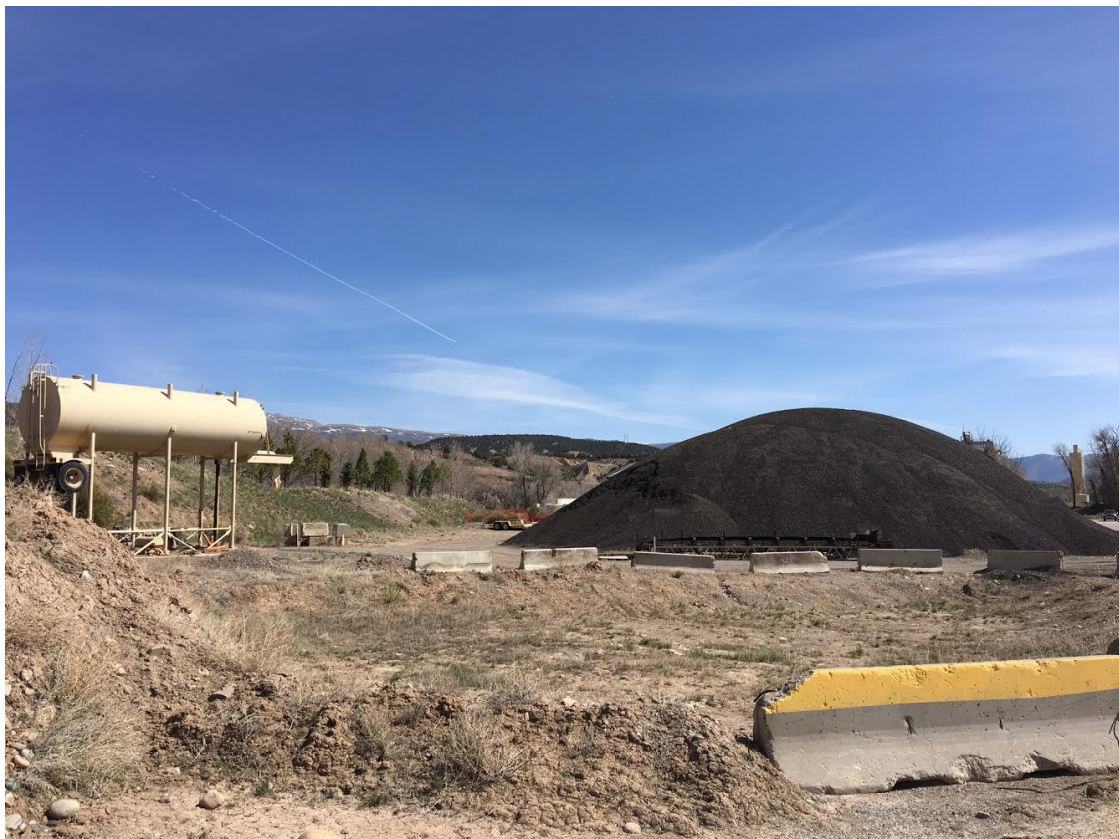
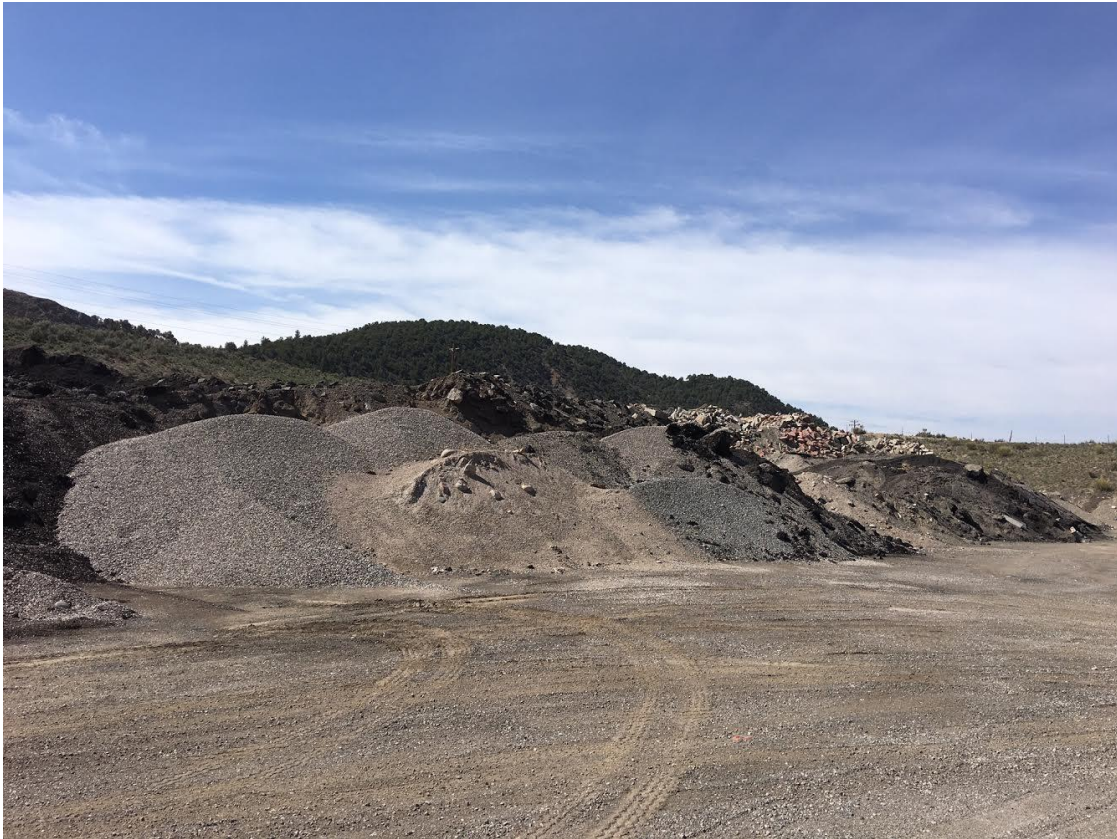
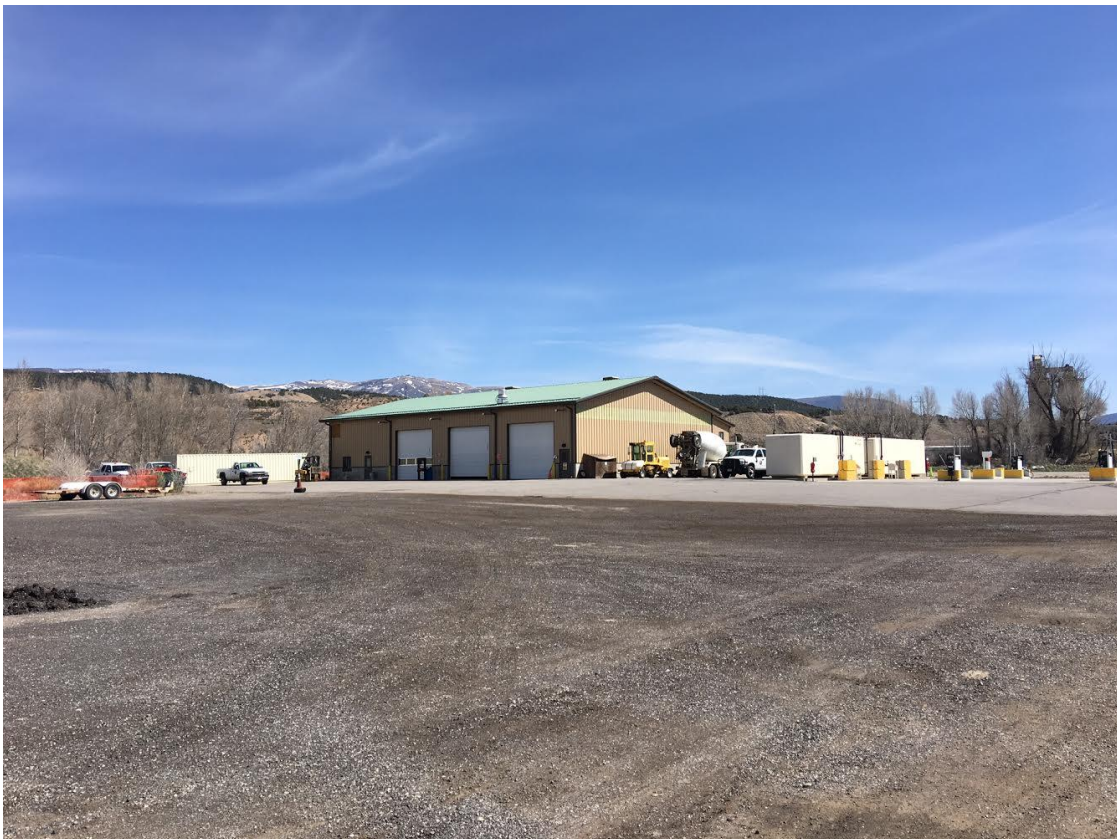
The pit is currently mined out but is active as an office, a concrete plant, heavy equipment storage and construction material stockpiling. Various pieces of heavy equipment were observed within the permit area. Most of the slopes within the permit area had been reclaimed to slopes that appeared to be no steeper than 2H:1V. All slopes appeared to be stable and adequately vegetated. No evidence of major storm water erosion was observed during the inspection.

Stockpiles of used concrete and asphalt ready for recycling were observed at the crusher stockpile area of the mine during the inspection.
