MINERALS PROGRAM INSPECTION REPORT**PHONE: (303) 866-3567**

MINE NAME: Bear Ranch Gravel Mine	MINE/PROSPECTING ID#: M-2013-002	MINERAL: Sand and gravel	COUNTY: Gunnison
INSPECTION TYPE: Monitoring	INSPECTOR(S): Dustin M. Czapla	INSP. DATE: July 24, 2017	INSP. TIME: 12:30
OPERATOR: Bear Ranch LLC	OPERATOR REPRESENTATIVE: None	TYPE OF OPERATION: 110c - Construction Limited Impact

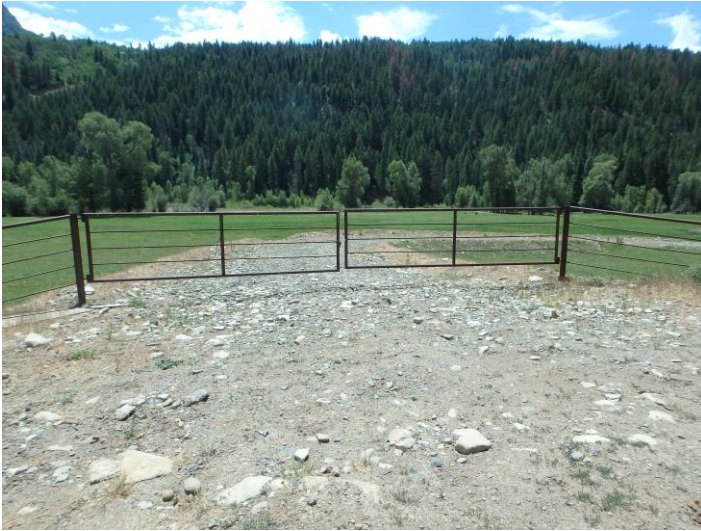
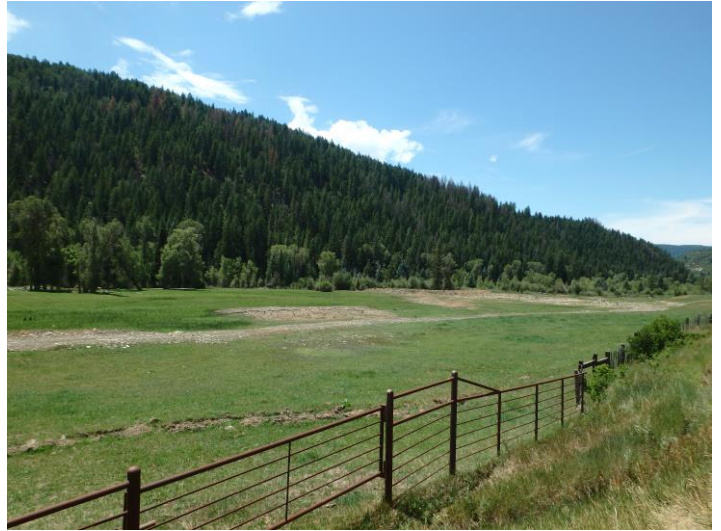
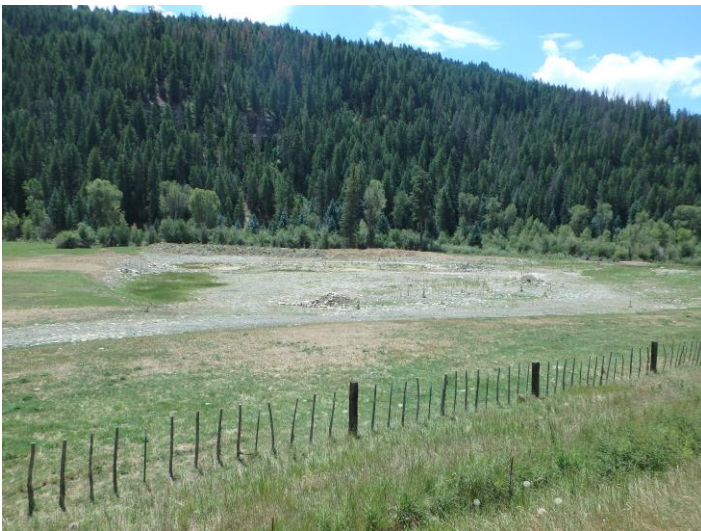
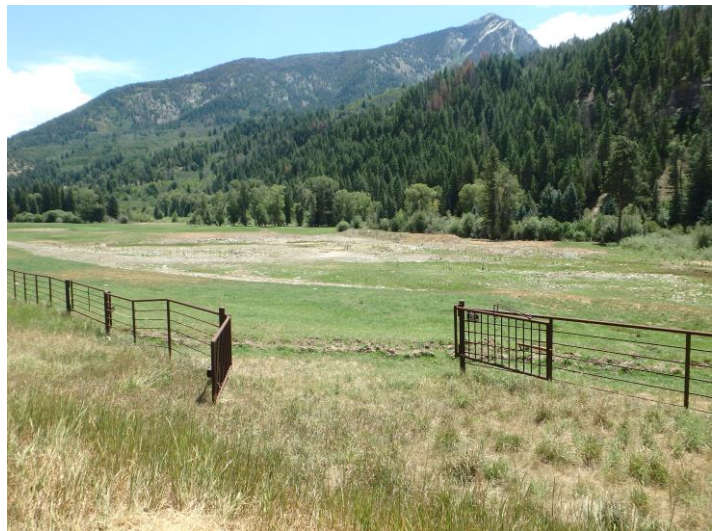
PHOTOGRAPHS

Adequate mine identification signage was not noted at the entrance to the site. This has been noted above as a problem.

The affected area was marked by fencing and posts that were clearly visible and adequate to delineate the affected area boundary. The current disturbance covers approximately three acres within the 9.9 acre permit area. The pit has been excavated to a depth of approximately three feet with side slopes at roughly 3H:1V. Topsoil has been pushed into a berm on the south side of the excavated pit.

Common mullein, a state listed noxious weed, was noted throughout the site. This has been noted as a problem.

CORRECTIVE ACTIONS: Implement approved weed control plan and provide proof to the Division that this has been done. If a weed control plan is not already in place, the operator shall develop a weed control and management plan in accordance with Section 3.1.10 (6) of the Rule. This plan should be developed in consultation with the county extension agency, or weed control district office and should include specific control measures to be applied, a schedule for when control measures will be applied and a post-treatment monitoring plan. This weed control plan shall be submitted to the Division as a Technical Revision to the approved plan with the appropriate Technical Revision fee of \$216.00 by the corrective action date.

CORRECTIVE ACTIONS: The operator shall, at the entrance of the mine site, post a sign which shall be clearly visible from the access road with the following: the name of the operator, a statement that a reclamation permit for the operation has been issued by the Colorado Mined Land Reclamation Board; and the permit number. The operator shall submit photo documentation that a proper sign has been posted by the corrective action date.
