Snowcap Coal Company, Inc. / Roadside Portals Mine Bond Release Inspection  
(Phase III, SL-10)

Colorado Division of Reclamation, Mining and Safety (DRMS) Permit ID # C-1981-041

April 24, 2017

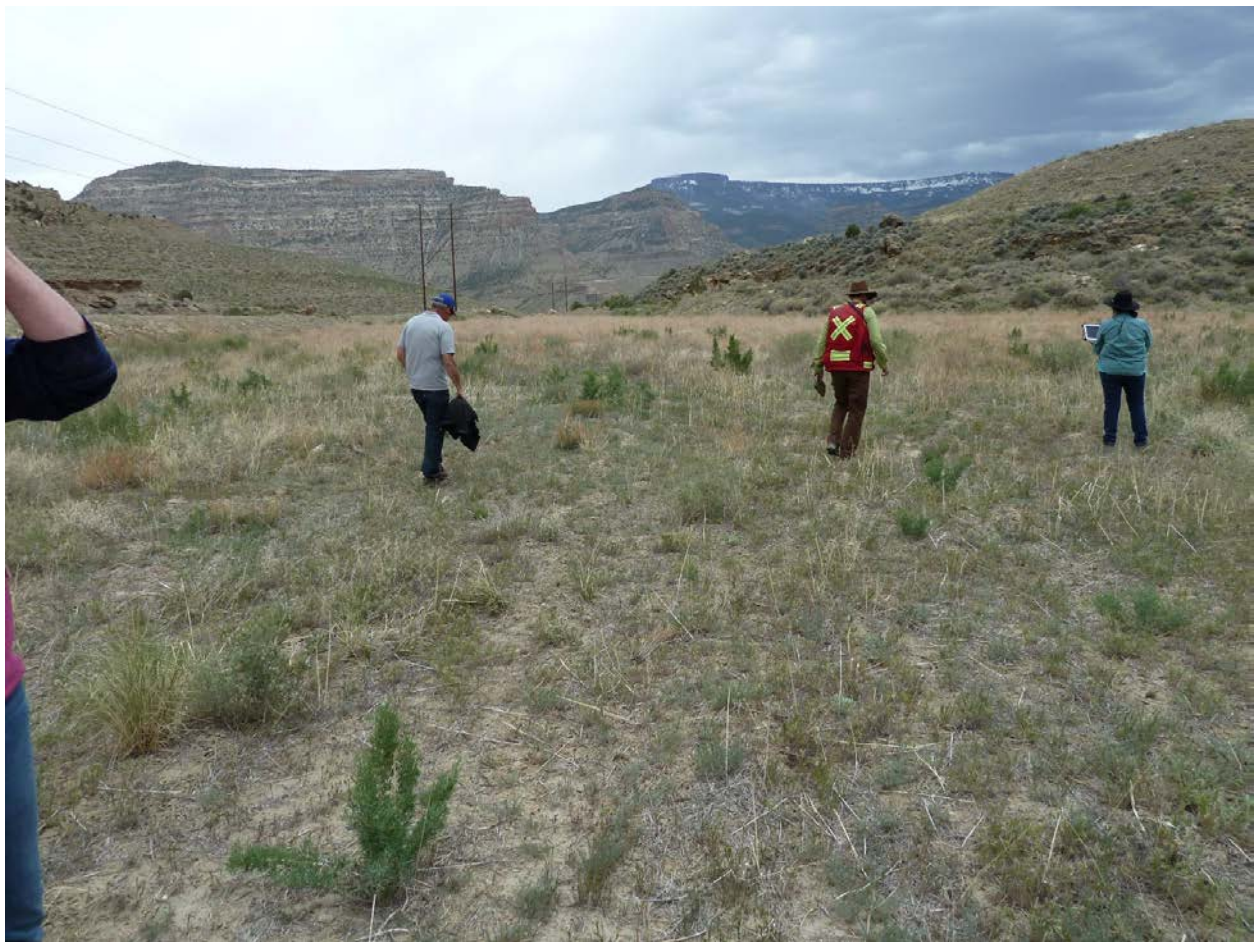
The inspection began on the afternoon of April 24, 2017 with the participants meeting at the mine site. The lands under consideration for this bond release are in the process of becoming an indoor / outdoor shooting complex. We first visited the former Pond 11 area. Within this area, the Vegetation is adequate for an industrial Phase III bond release. Some noxious weeds were present (e.g. cheatgrass), but desirable perennial shrubs, forbs, and grasses are abundant (Figure 1).

Figure 1 - Pond 11 reclamation with desirable shrubs, forbs, and grasses present.

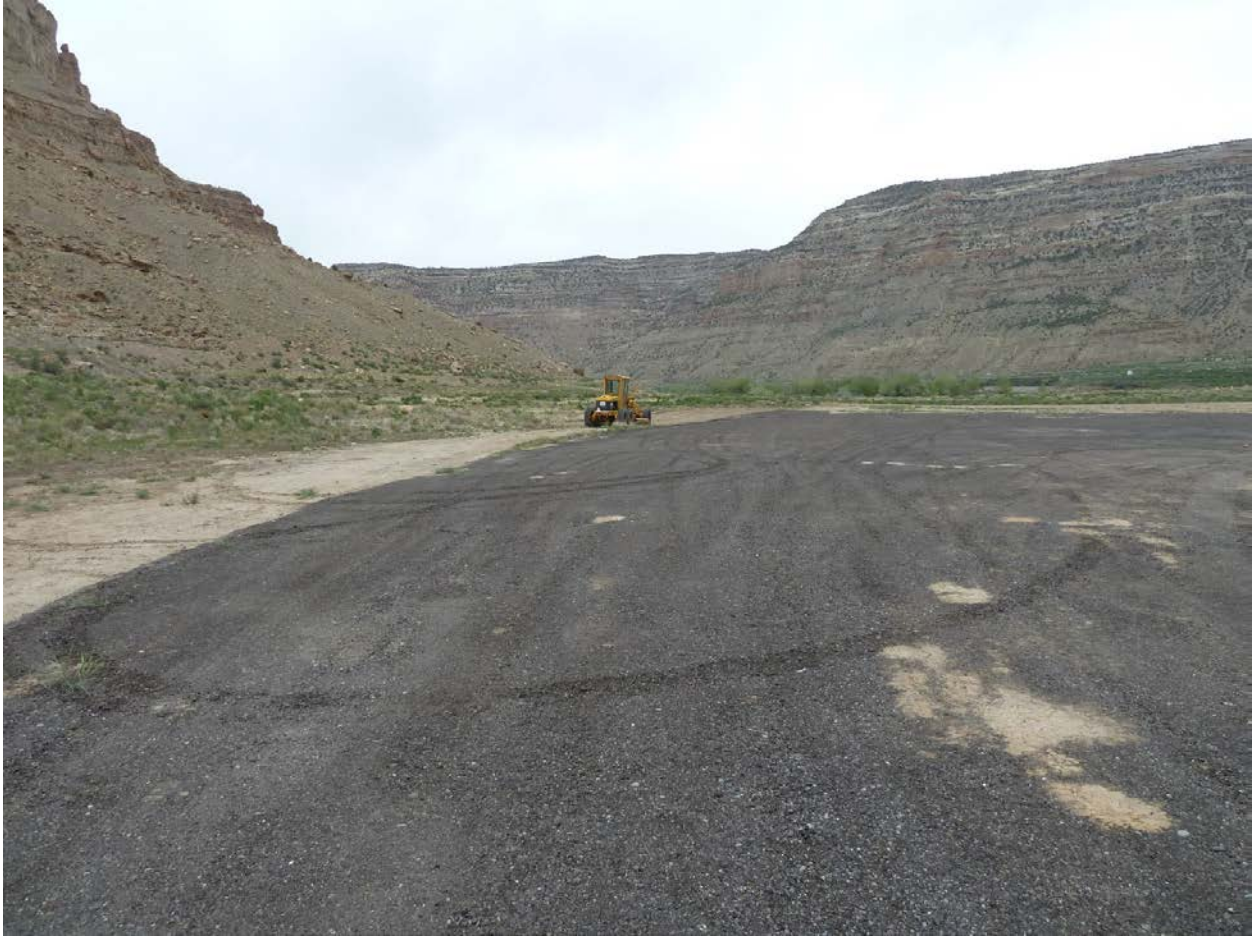
We continued to Substation G, which was in the process of being converted to a gravel parking

lot. This section of the bond release area was level and no issues were noted (Figure 2). This area is adequate for an industrial Phase III bond release.

Figure 2 - Parking lot construction at the former Substation G site.

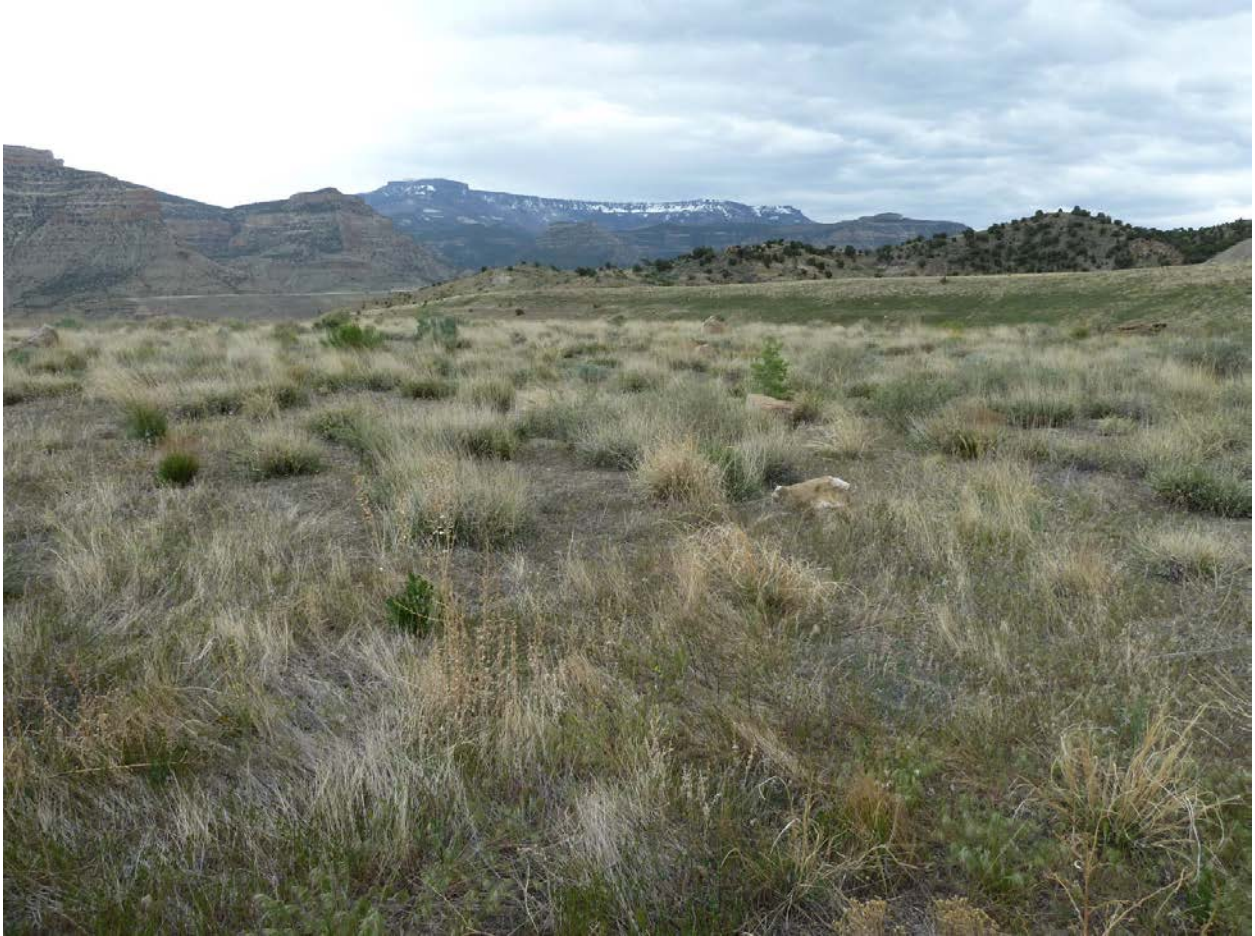
Finally, we travelled to CDRA #1 where this site was well vegetated with desirable perennials, and is adequate for an industrial Phase III bond release (Figure 3).

Figure 3 - Desirable plant species present and abundant at the CDRA #1 site.
