MINERALS PROGRAM INSPECTION REPORT
PHONE: (303) 866-3567

MINE NAME: CBC Gravel Pit	MINE/PROSPECTING ID#: M-2009-030	MINERAL: Gravel and sand	COUNTY: Dolores
INSPECTION TYPE: Monitoring	INSPECTOR(S): Lucas J. West	INSP. DATE: August 22, 2017	INSP. TIME: 14:30
OPERATOR: Coal Bed Creek Construction, Inc.	OPERATOR REPRESENTATIVE: David Cressler	TYPE OF OPERATION: 110c - Construction Limited Impact	
REASON FOR INSPECTION: Normal I&E Program	BOND CALCULATION TYPE: Complete Bond	BOND AMOUNT: \$10,166.62	
DATE OF COMPLAINT: NA	POST INSP. CONTACTS: None	JOINT INSP. AGENCY: None	
WEATHER: Clear	INSPECTOR'S SIGNATURE:

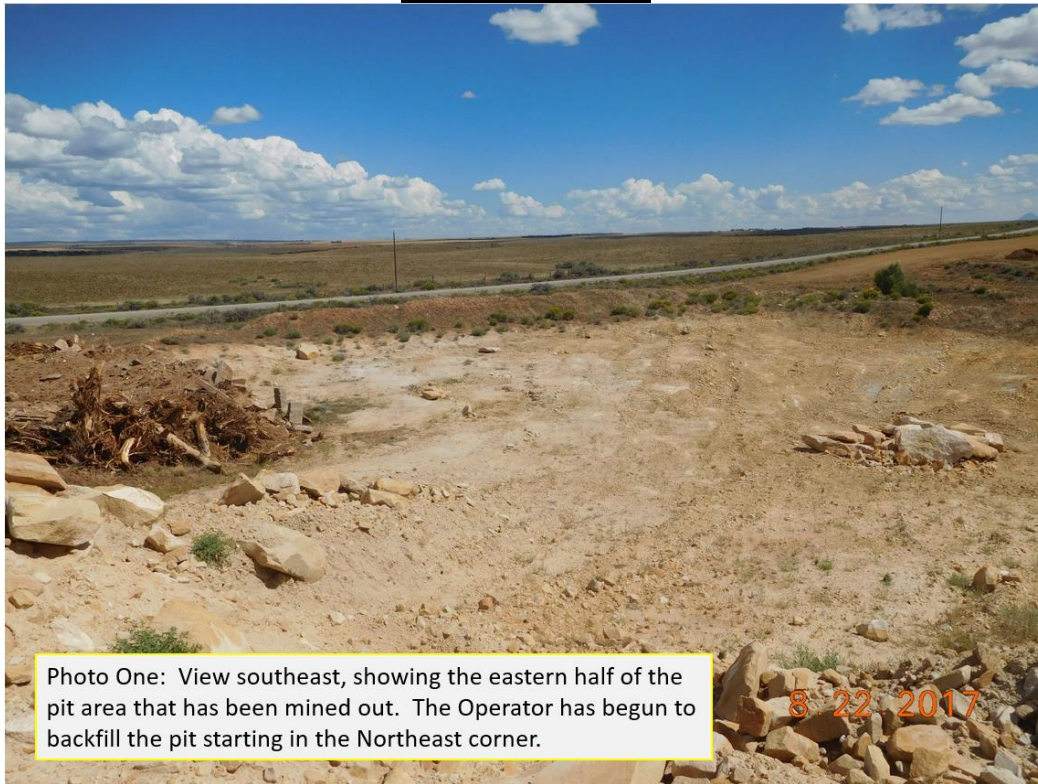
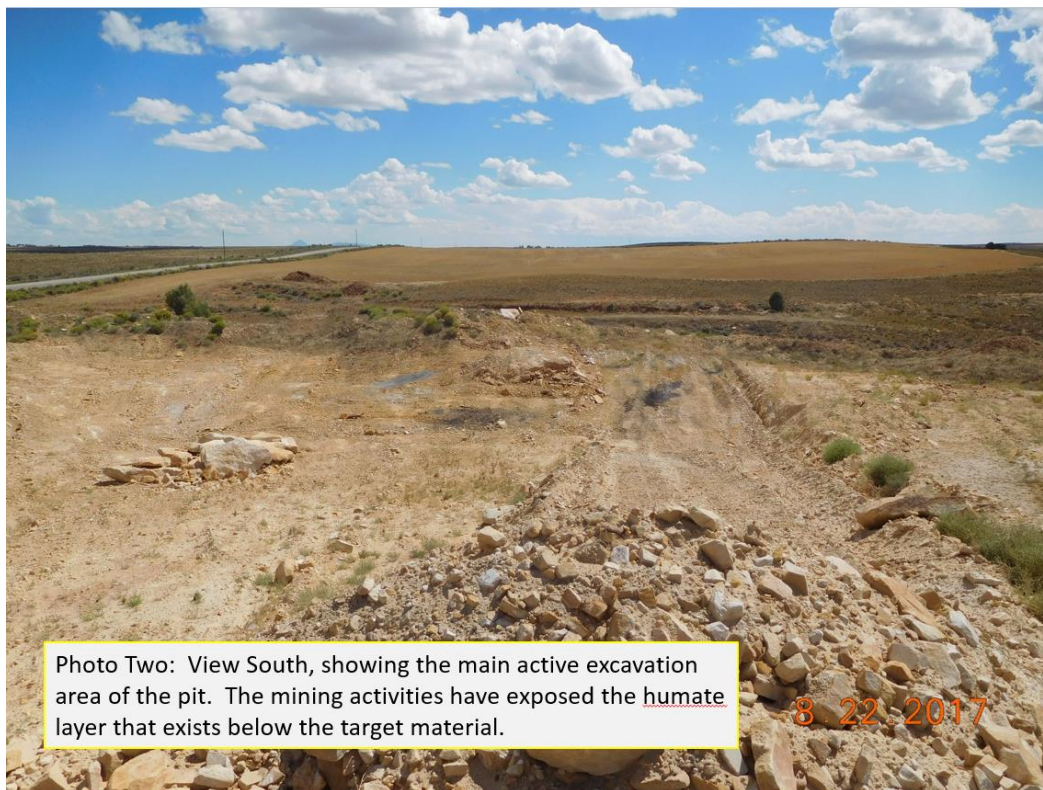
The proper mine identification signage was posted at the entrance to the site, and the permit boundaries were clearly marked with a series of earthen berms. Several pieces of equipment including a loader, dozer, and crusher were on site however they were not active during the inspection. The main pit area which can be seen in Photos One and Two, appears to be stable and in good condition. The pit appears to be free draining and showed no signs of significant erosion during the inspection. Mining activities are progressing to the west, and the next section has been stripped. Several stockpiles of materials are located within the permitted area, including topsoil around the edges of the pit, overburden and useable materials. All stockpiles that were observed appeared to be stable and showed no signs of erosion, settling or slumping.

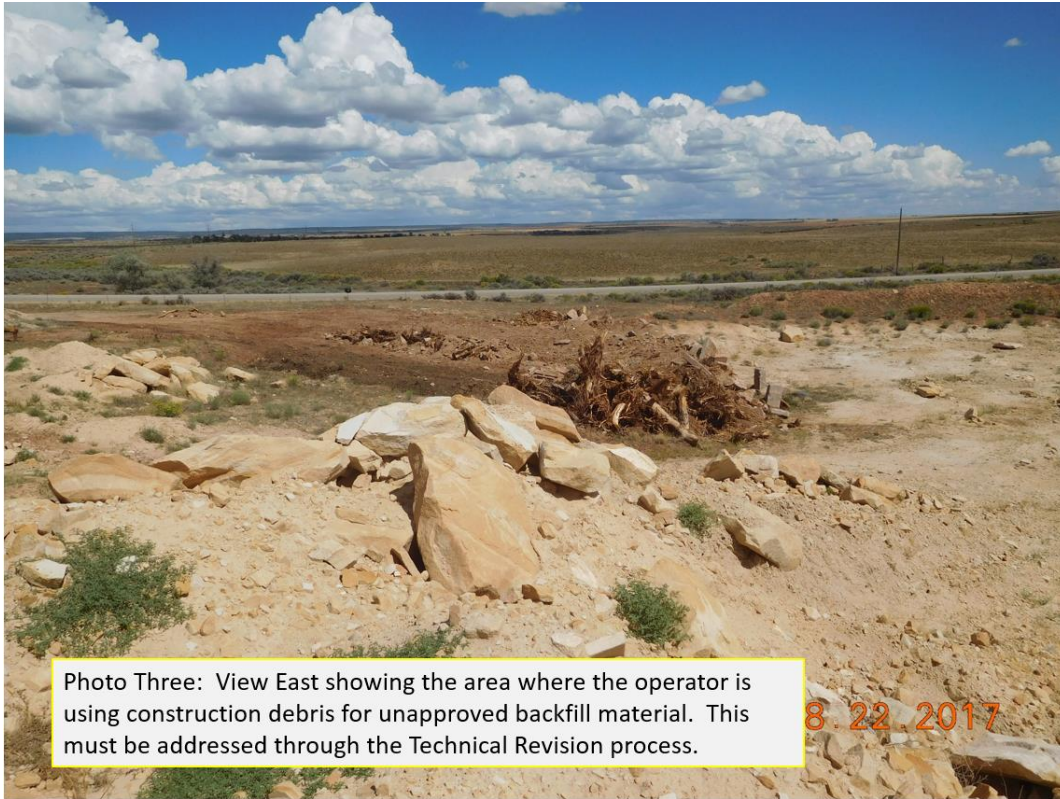
In the previously mined area of the pit, the Operator has begun to use offsite fill material to backfill the open pit. The material includes broken up concrete and construction debris and can be seen in Photo Three. The importation of offsite fill has not been approved by the Division. To allow for the importation of offsite fill material the operator must submit a Technical Revision with a signed affidavit, stating that the fill is, in fact, inert and addressing all requirements pursuant to Rule 3.1.5(9), which describes the intended use of inert/off-site fill by the corrective action date. The affidavit should list the materials to be imported, and commit to burying the material a minimum of three feet below final grade, with all protruding rebar or structural elements having been removed. The Technical Revision cover sheet is enclosed with this report, should be filled out and submitted to the Division's Denver office with the signed affidavit as well as the required fee of \$216.00 within 60 days of the date of this letter. All elements of the Technical Revision should be received by the Division no later than **Tuesday October 31, 2017**. If the Operator has any questions about the required Technical Revision, please feel free to contact me. Also, note that during the inspection, a large pile of brush, tree limbs and wooded debris was noted in the previously mined area. This material will not be approved for use as backfill material as over time the organic material will decay and could cause subsidence features to develop. However if this material is burned, the ashes may be disposed of in the pit area.
