**COLORADO**Division of Reclamation,  
Mining and Safety

**MINERALS PROGRAM INSPECTION REPORT****PHONE: (303) 866-3567**

<b>MINE NAME:</b> Loloff Mine	<b>MINE/PROSPECTING ID#:</b> M-1985-112	<b>MINERAL:</b> Sand and gravel	<b>COUNTY:</b> Weld
<b>INSPECTION TYPE:</b> Monitoring	<b>INSPECTOR(S):</b> Peter S. Hays	<b>INSP. DATE:</b> October 11, 2017	<b>INSP. TIME:</b> 09:30
<b>OPERATOR:</b> Loloff Construction, Inc.	<b>OPERATOR REPRESENTATIVE:</b> Kelly Hodge	<b>TYPE OF OPERATION:</b> 112c - Construction Regular Operation

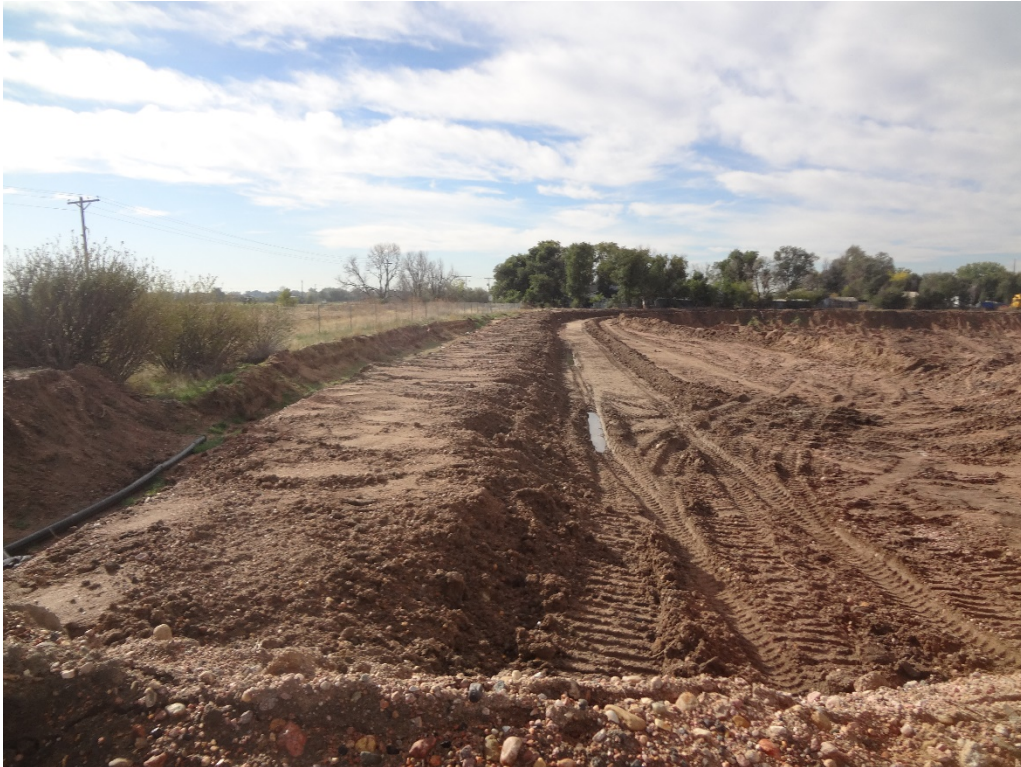
View of the completed slurry wall cap in the southeast corner of the Loloff Pit looking south from the entrance

The Division does not dictate the timeline for the installation of slurry walls at mine sites. The decision of when to install a slurry wall is the Operator's decision to make based the operational requirements of the mine. The slurry wall design and specifications for the Loloff Mine were approved by the Division on July 18, 2016. The Operator stated the lower portion of the slurry wall was completed two months ago. The top of the slurry wall was observed around the perimeter of the site during the inspection. The upper clay liner portion of the slurry wall will be installed by the Operator in the near future. The slurry wall leak test is scheduled to begin ten days from the date of this inspection according to the Operator.

The Division considers the complaint (CT-09) resolved due to the installation of the lower portion of the slurry wall and the on-going operation of the Loloff Mine in accordance with the approved Mining and Reclamation Plans.

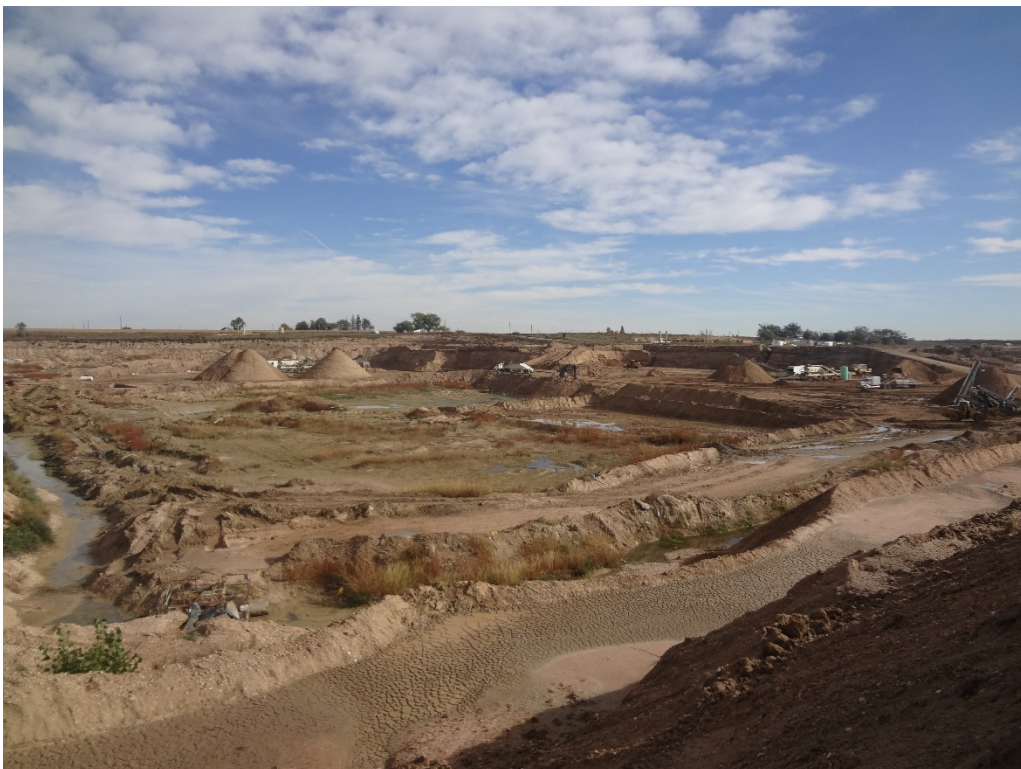
View of the Loloff Pit from the southwest corner of the site looking northeast

The extraction of sand and gravel from the site is progressing in accordance with the approved Mine Plan. Mining excavation was observed in the former location of the processing plant during the inspection. The Operator estimated mining will be complete and the perimeter slopes will be graded to the approved 3H:1V grade by the spring of 2018.

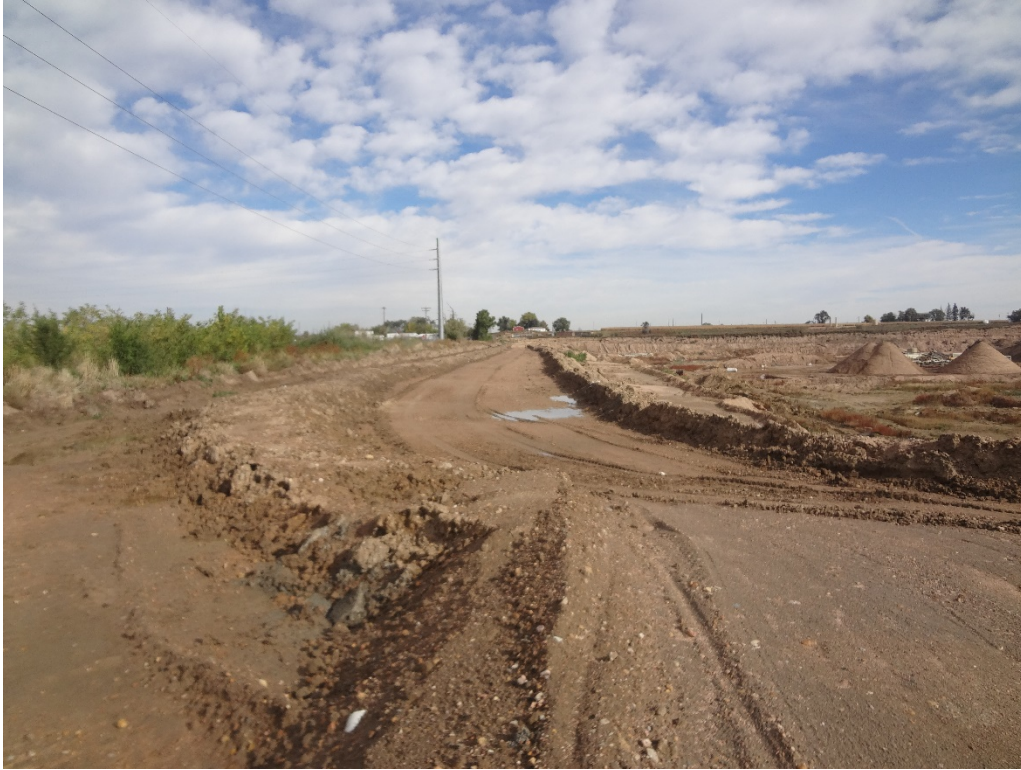
View of the completed slurry wall cap along the west side of the Loloff Pit looking north from the southwest corner of the site

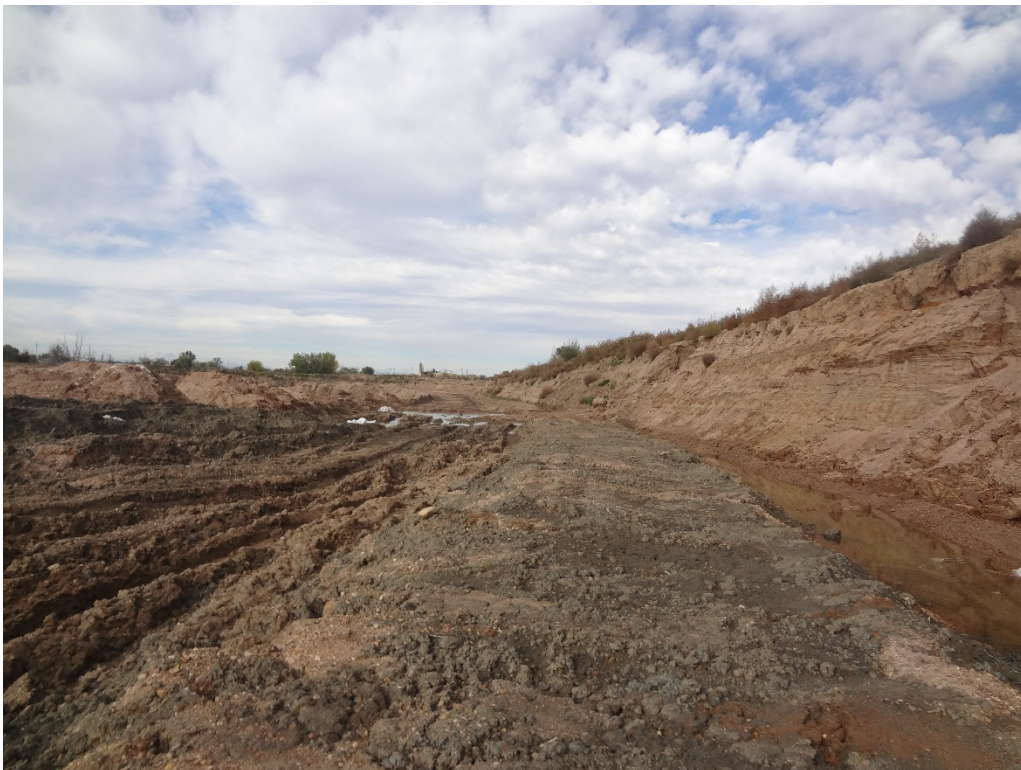
View of the completed slurry wall cap along the north side of the Loloff Pit looking west

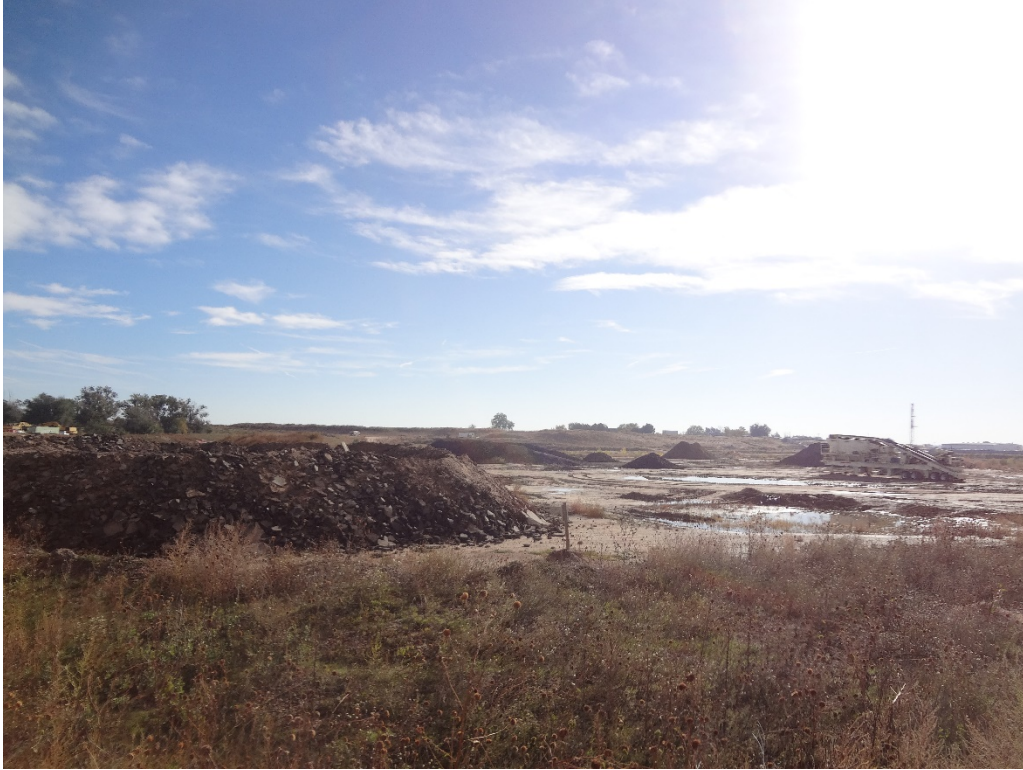
View of asphalt stockpile (near) and milling stockpiles (far) at the Derr Pit looking west from the office

The Derr Pit located east of the Loloff Mine was inspected to observe the stockpiled material at the site. Stockpiles of recycled asphalt products and concrete were observed at Derr Pit. The importation and temporary stockpiling of these materials is acceptable under the Division's Rule and Regulations. The Operator stated the asphalt millings would be rescreened and the asphalt and concrete stockpiles would be reprocessed to produce a sellable product in the future. The Operator confirmed all stockpiled imported material will be removed from the site and the site is in compliance with Weld County requirements for the stockpiles. An Air Pollution Emissions Notice (APEN) permit, which regulates dust emission from processing plants will be required for the material processing under the jurisdiction of the Colorado Department of Public Health and Environment. The Operator stated they are aware of the requirement to obtain an APEN prior to reprocessing the materials at the site.

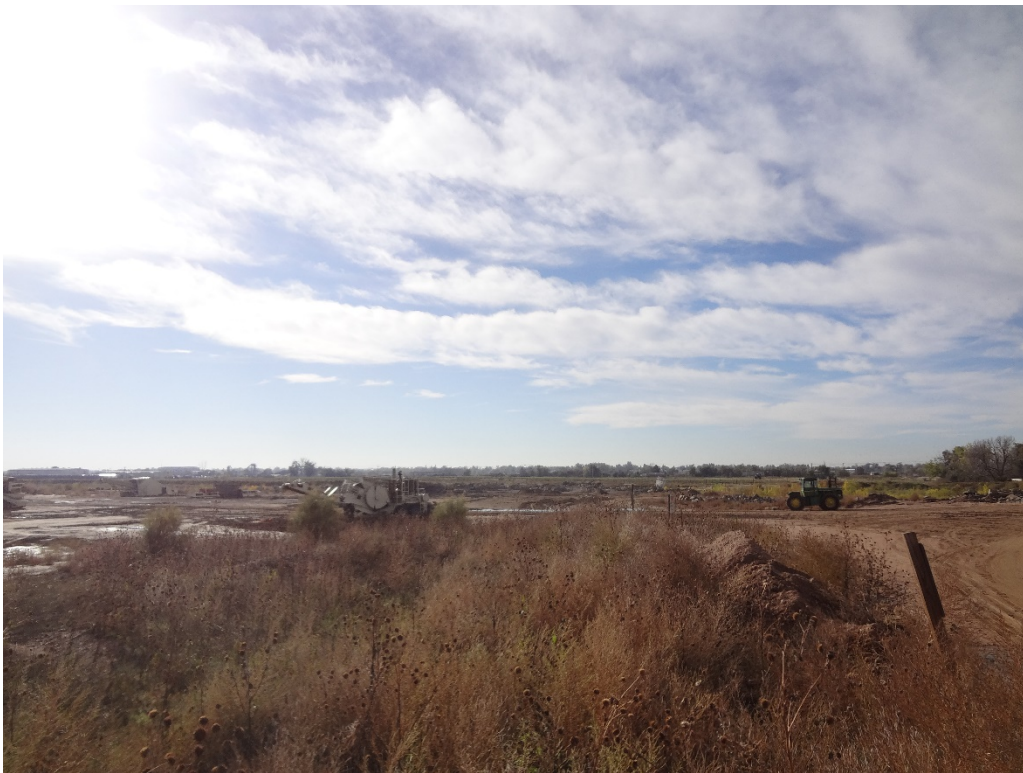
View of concrete stockpiles in the southern portion of the Derr Pit looking south from the office
