***RE: Rifle Quarry, Permit No. M-1985-038, Surety Reduction Request (SR-2), Approval***

**MINERALS PROGRAM INSPECTION REPORT**  
**PHONE: (303) 866-3567**

<b>MINE NAME:</b> Rifle Quarry	<b>MINE/PROSPECTING ID#:</b> M-1985-038	<b>MINERAL:</b> Limestone (general)	<b>COUNTY:</b> Garfield
<b>INSPECTION TYPE:</b> Monitoring	<b>INSPECTOR(S):</b> Amy C. Yeldell	<b>INSP. DATE:</b> November 9, 2017	<b>INSP. TIME:</b> 08:00
<b>OPERATOR:</b> Pete Lien & Sons, Inc.	<b>OPERATOR REPRESENTATIVE:</b> None	<b>TYPE OF OPERATION:</b> 112c - Construction Regular Operation	
<b>REASON FOR INSPECTION:</b> Normal I&E Program	<b>BOND CALCULATION TYPE:</b> Complete Bond	<b>BOND AMOUNT:</b> \$53,640.00	
<b>DATE OF COMPLAINT:</b> NA	<b>POST INSP. CONTACTS:</b> None	<b>JOINT INSP. AGENCY:</b> None	
<b>WEATHER:</b> Clear	<b>INSPECTOR'S SIGNATURE:</b>

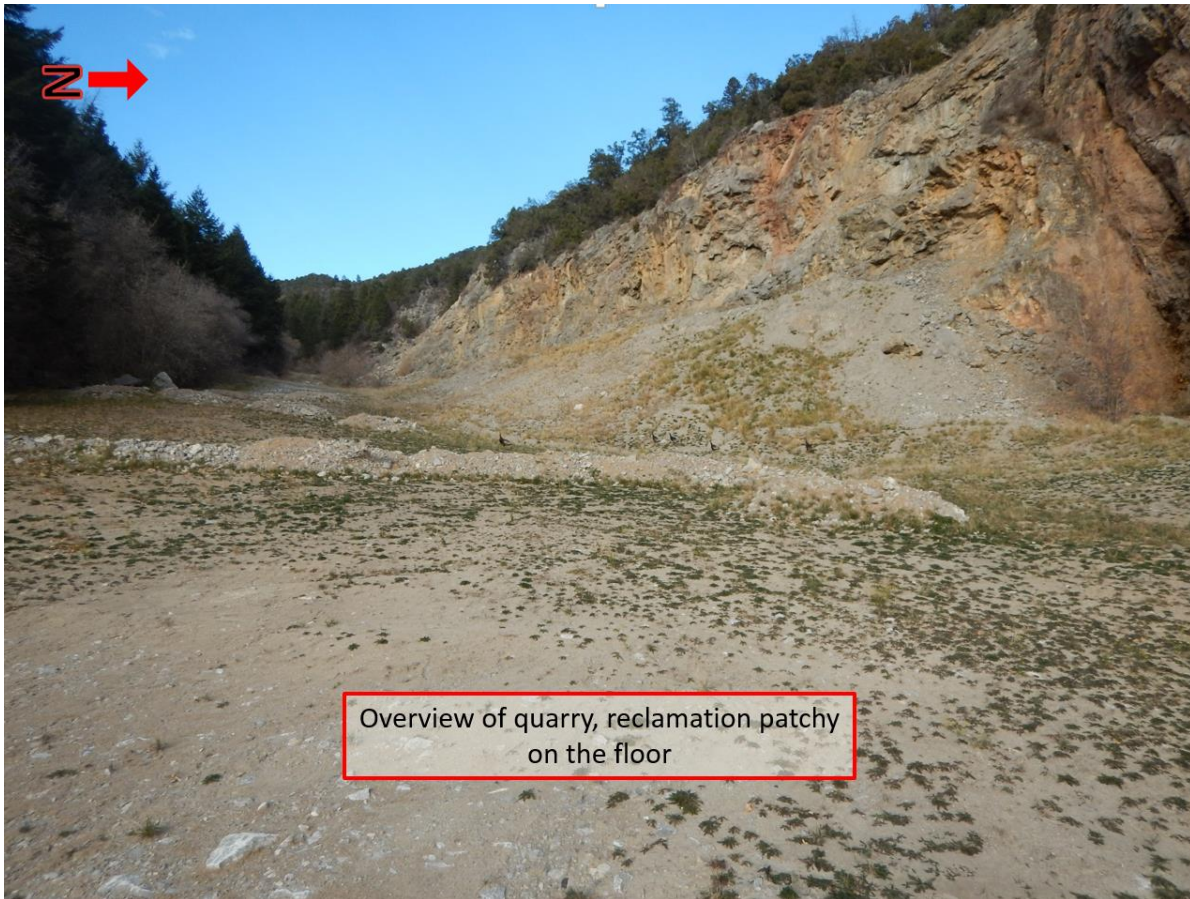
Overview of quarry, reclamation patchy  
on the floor

Vegetation along the access road is sparse. The ruts remain void of vegetation but the other areas are growing well. Additionally some areas appear to be compacted or lack the necessary growth medium to support vegetation. If additional vegetation does not establish in the spring of 2018 the operator should conduct secondary seeding. Spot seeding measures should be employed to avoid disturbing already established areas.

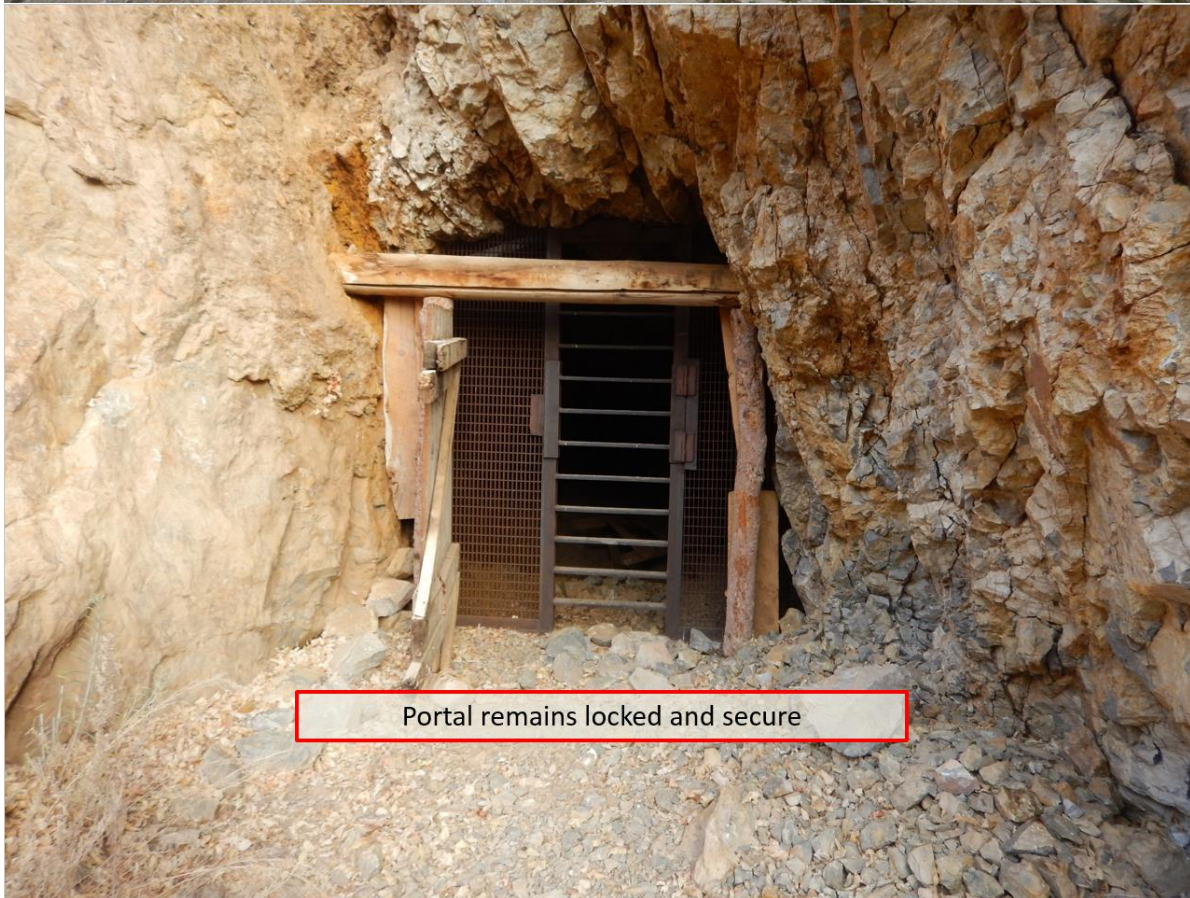
The portals on site remain secured.

Portal remains locked and secure
