## June Inspection Follow-Up

## Tech Memo

**Subject:** 2017 SE ECOSA Seep

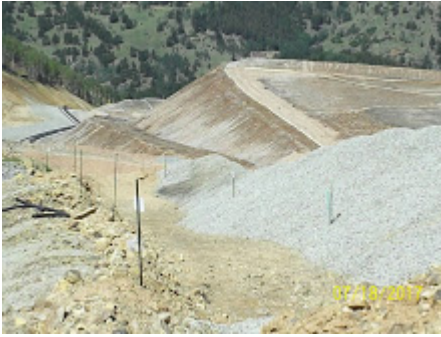
**100\_0178.jpg**  
328K

1. The Edge of Liner signs have been posted in the requested location. See JPG's 100\_0178 and 100\_0176.
2. The sampling program approved in TR 82 and TR 83 was overlooked in Q1. Q2 samples have been taken, results have not been received yet.

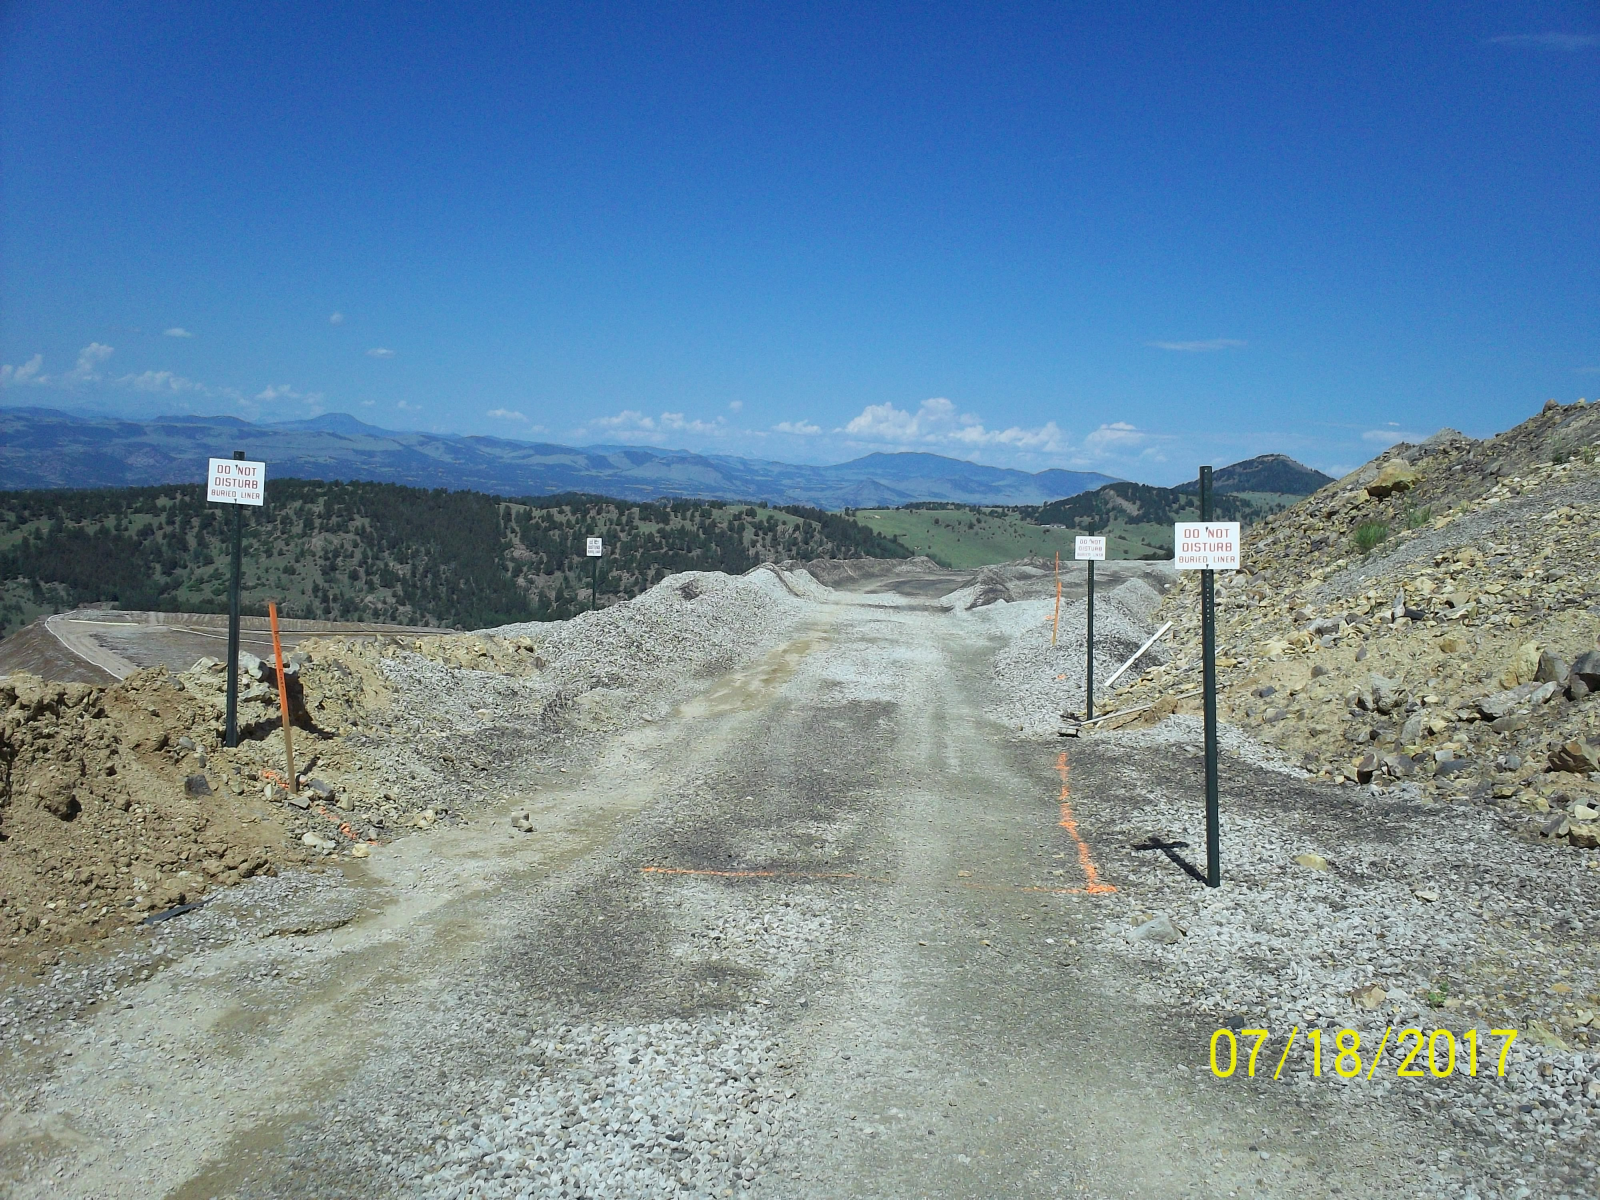
DO NOT  
DISTURB  
BURIED LINER

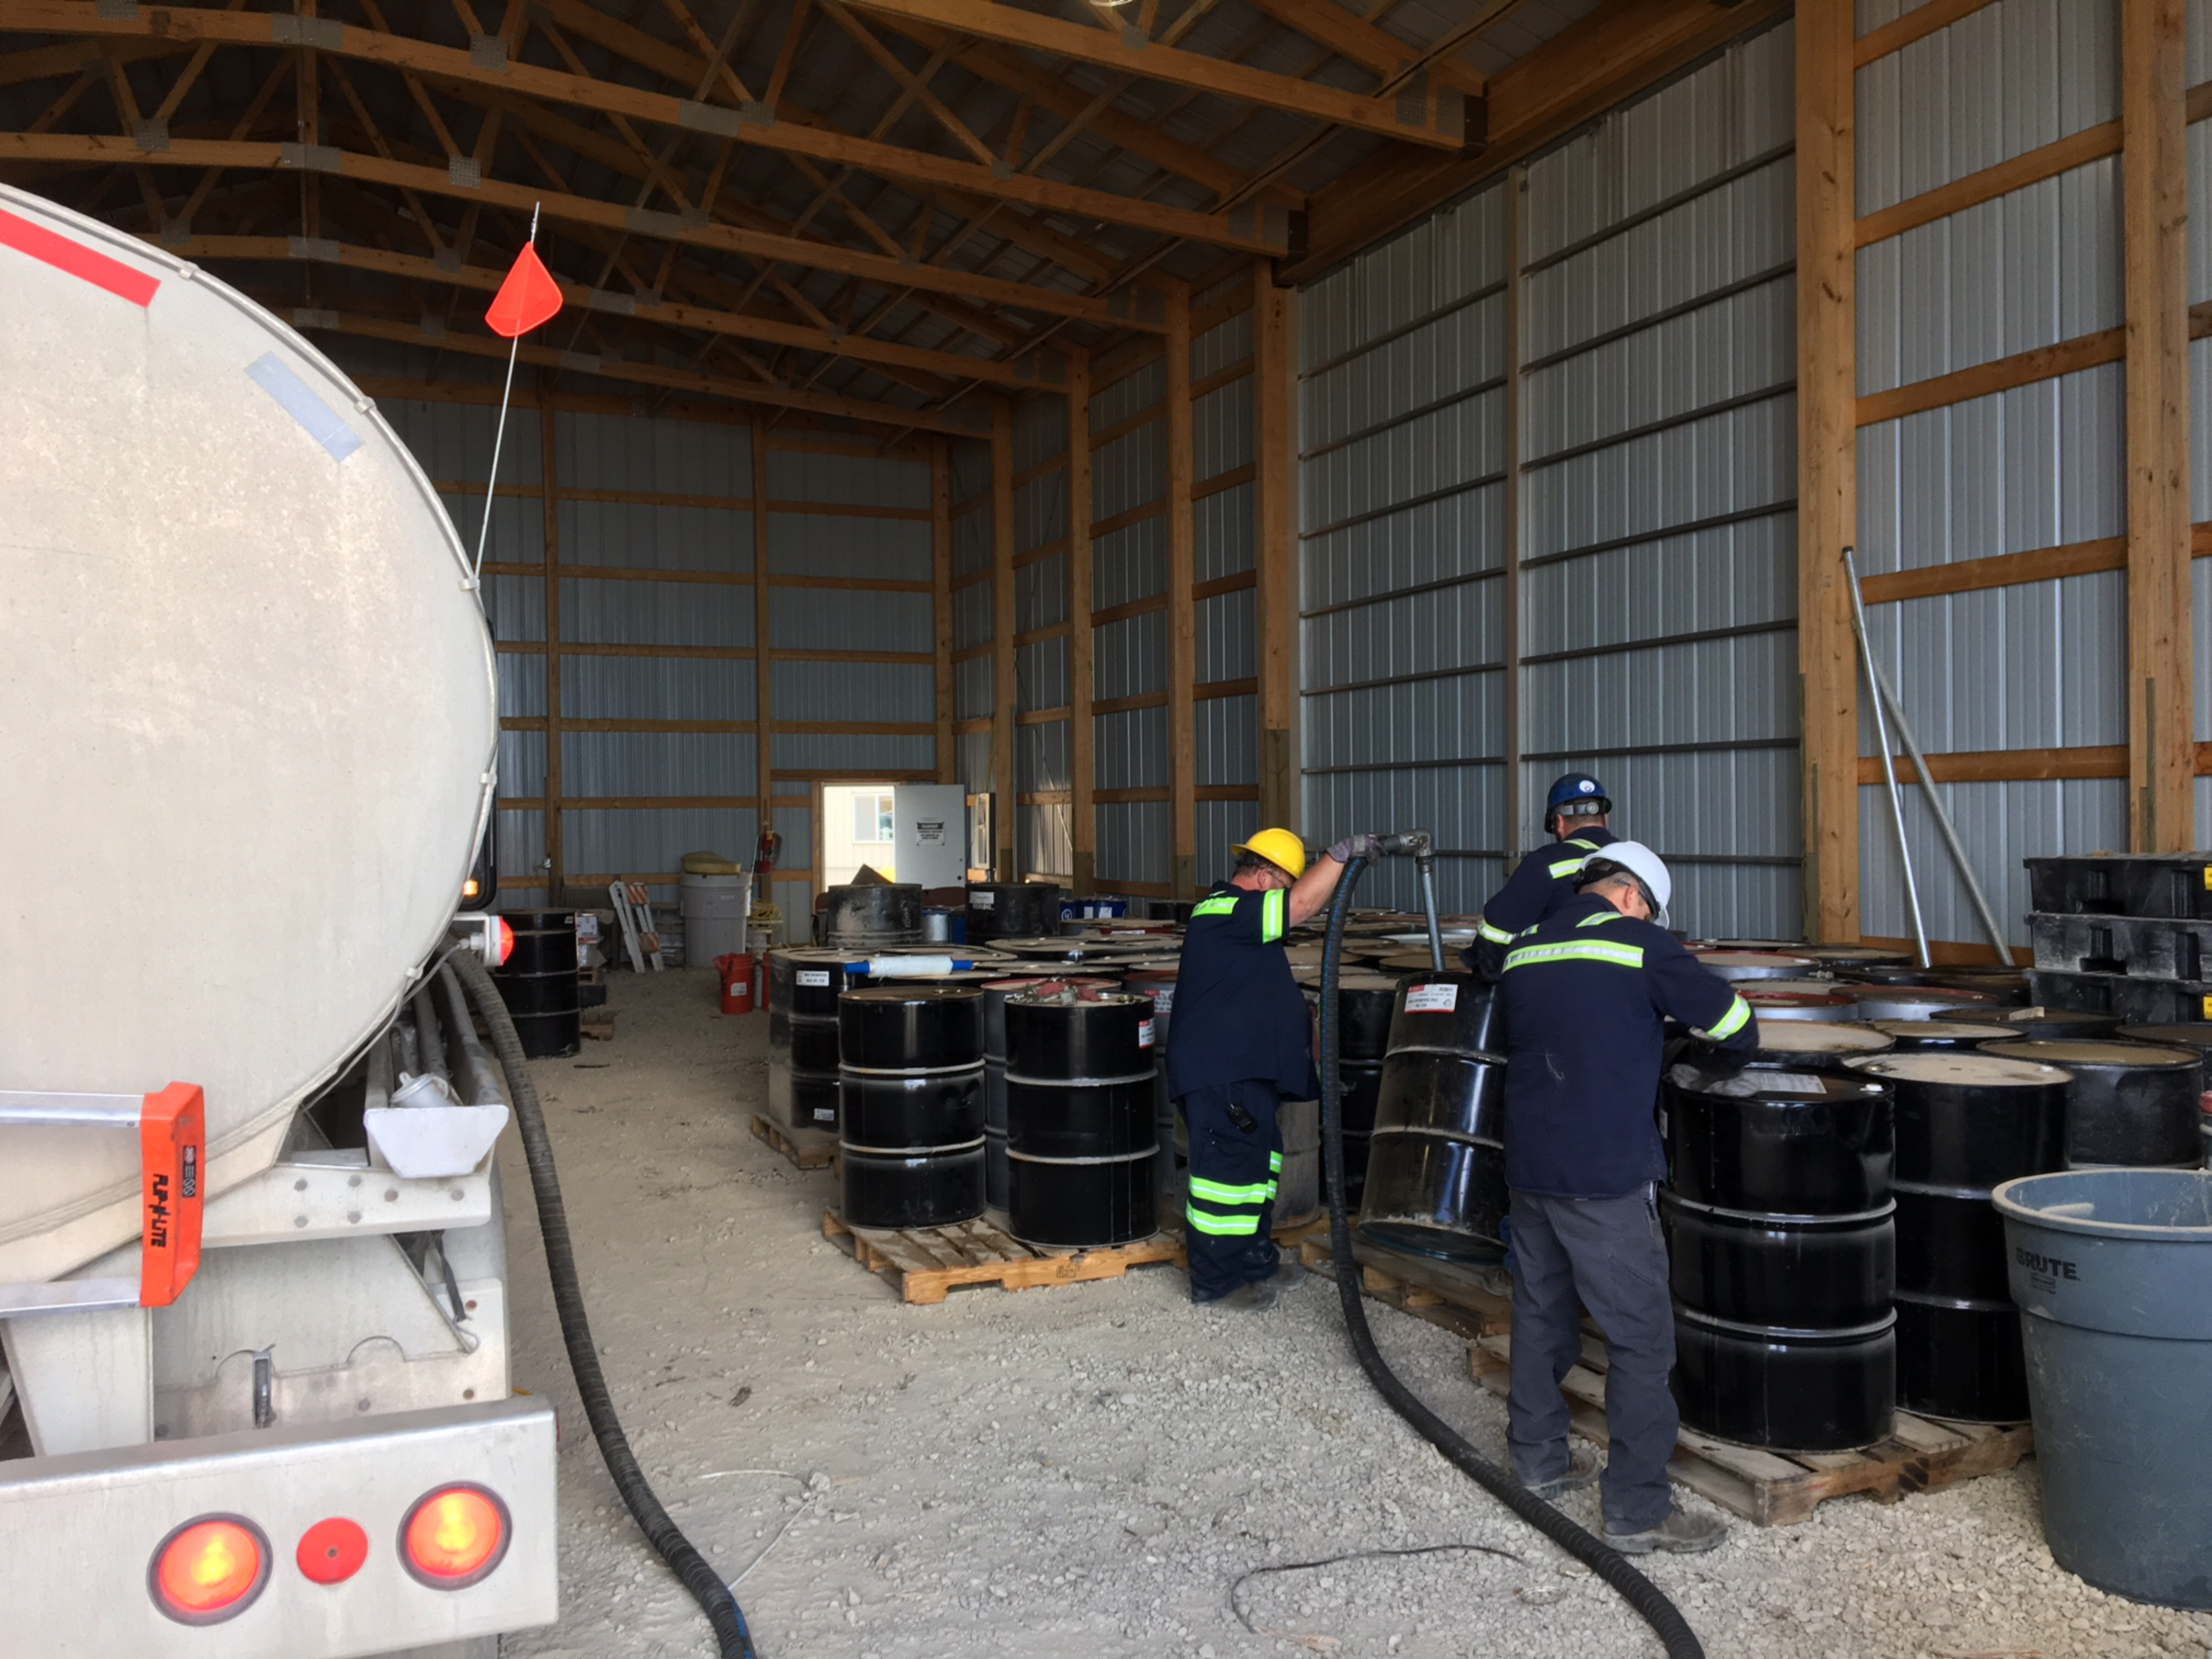
During the June 2017 DRMS inspection, the inspector observed water on the south-southeast side of the East Cresson Overburden Storage Area (ECOSA) between the toe berm containing the facility, and the facility itself (Photo 1.). Subsequently on June 21, 2017 the location of the observed water was inspected by CC&V site personnel and water samples collected. From this inspection it was determined that the water at this location is likely being generated from a seep at the contact between the native ground and the placed overburden.

The seep observed on the south-southeast side of the ECOSA facility between the toe berm and the facility is likely meteoric water which has infiltrated into the waste rock facility and is re-emerging to the surface at this location. Elevation differences between the seep observed in 2016 (the result of the pipeline failure) and the seep identified in June of 2017 demonstrate that the sources of water between the two seeps are distinct. Figure 1 depicts the locations of the 2016 pipeline failure seep, and the seep identified in June of 2017. The seep is entirely contained within the ECOSA toe berm and is evident only between the North and South areas identified on Figure 1. The seep water was not observed past this location and is believed to seep into the ground. The flow of the water is too low to effectively obtain a flow measurement.

In conclusion, an ephemeral seep has been observed on the ECOSA. It is located entirely on the diatreme and requires no active management at this time. The seep is being actively monitored to ensure the conditions do not change and there is no discharge from the immediate area.

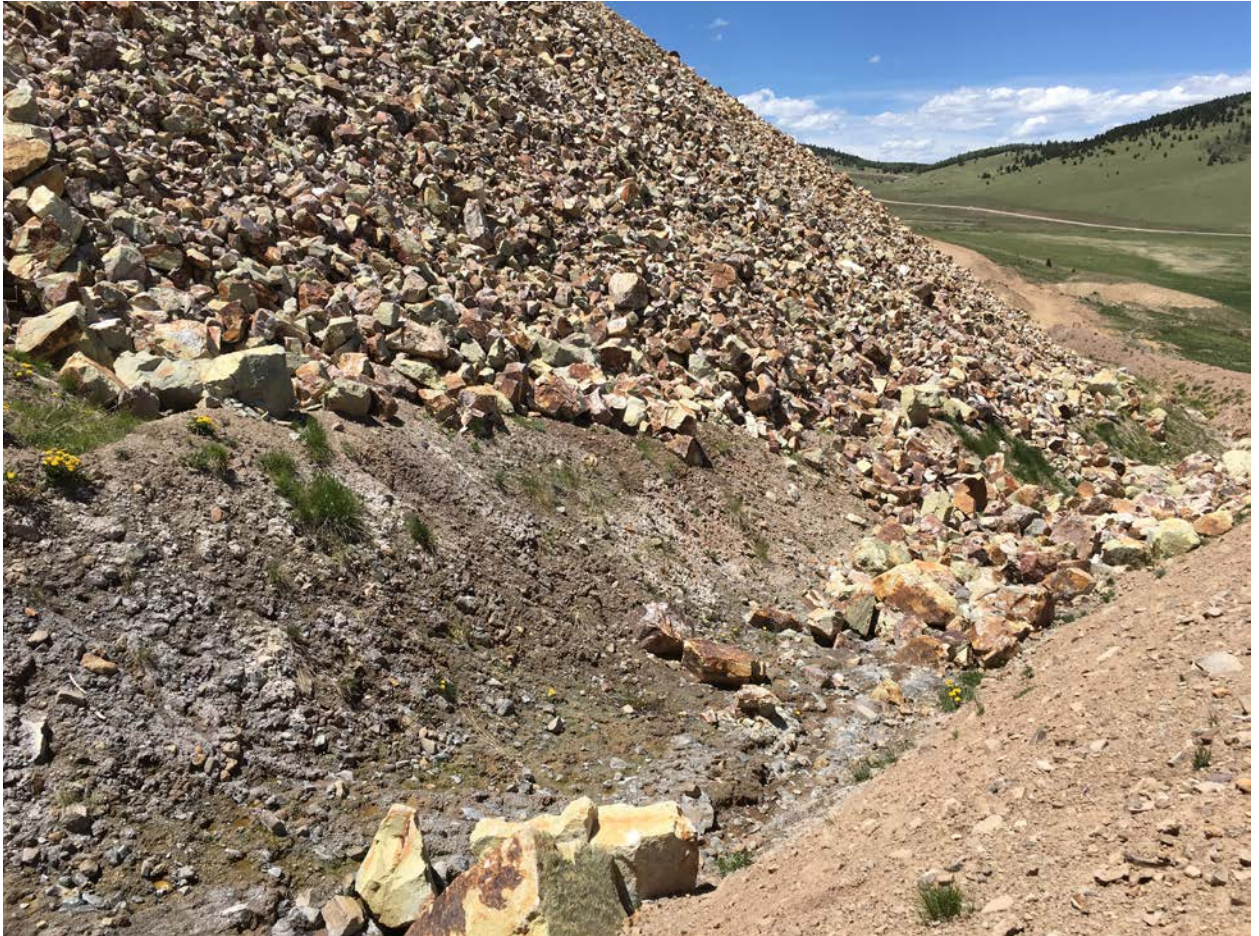
Photo 1. Seep identified at toe of ECOSA 15 June 2017. Photo looking northeast at south-southeast side of the ECOSA.
