RE: Virginia Acres, Permit No. M-1990-021, Unresolved Problem(s) Noted in a Past Inspection Report

MINERALS PROGRAM INSPECTION REPORT
PHONE: (303) 866-3567

MINE NAME: Virginia Acres	MINE/PROSPECTING ID#: M-1990-021	MINERAL: Sand and gravel	COUNTY: Mesa
INSPECTION TYPE: Monitoring	INSPECTOR(S): Stephanie J. Mitchell	INSP. DATE: November 16, 2017	INSP. TIME: 13:00
OPERATOR: Oldcastle SW Group, Inc. dba United Compas County	OPERATOR REPRESENTATIVE: Jason Burkey	TYPE OF OPERATION: 112c - Construction Regular Operation

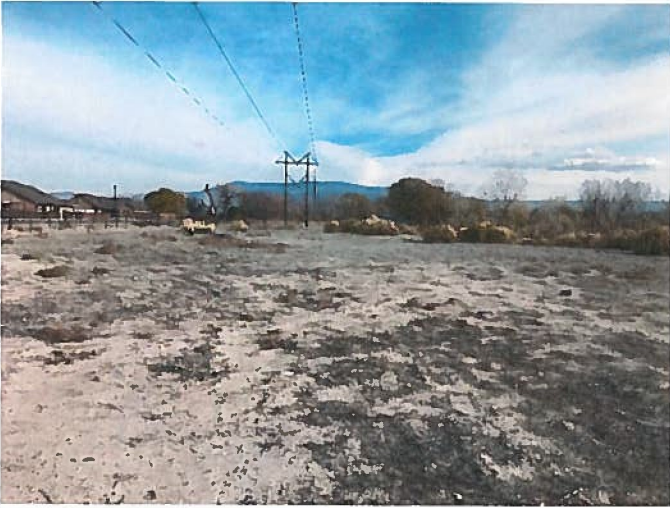
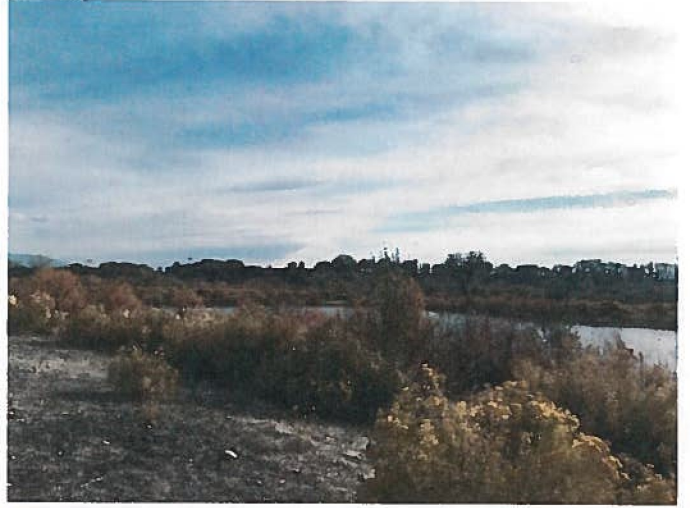
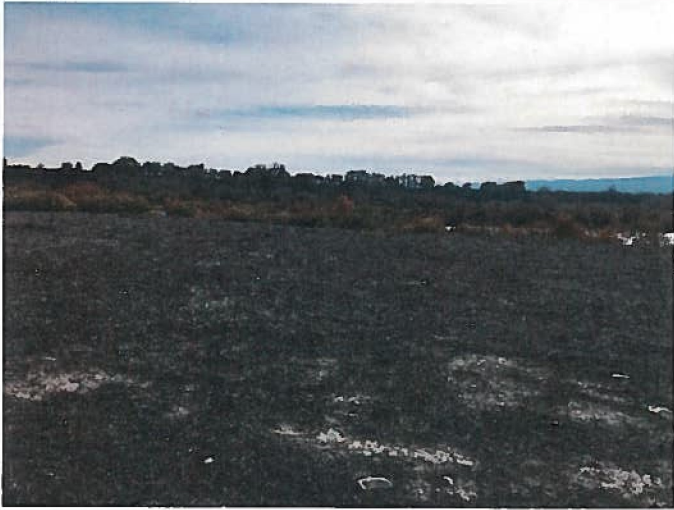
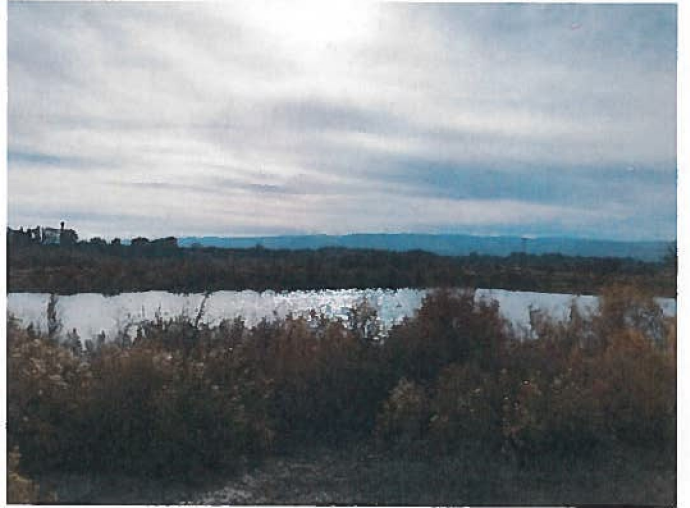
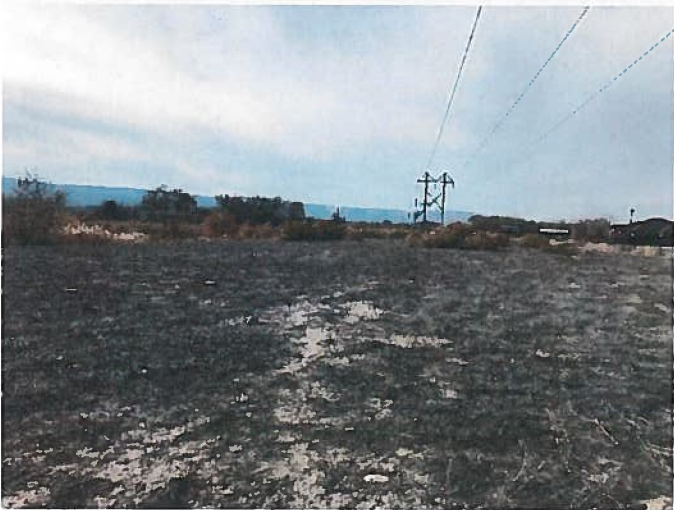
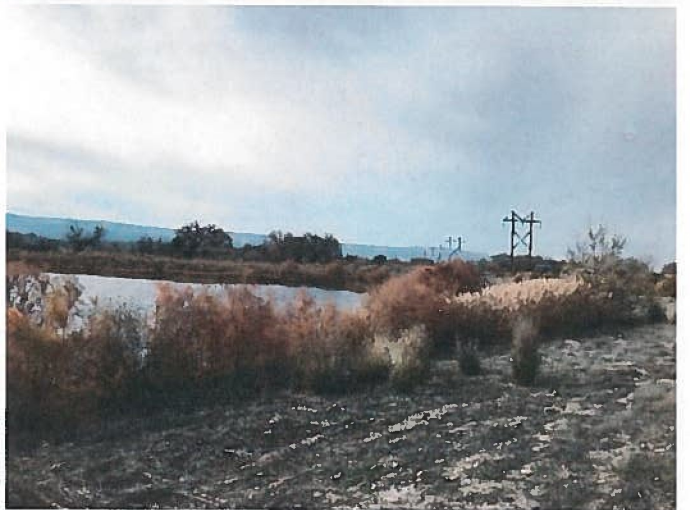
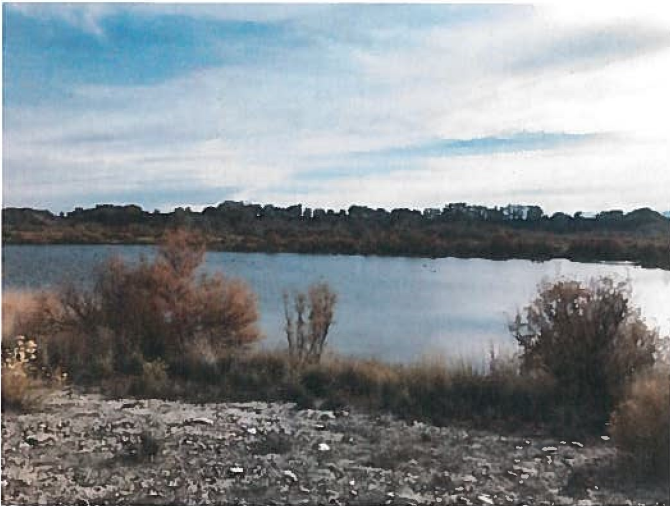
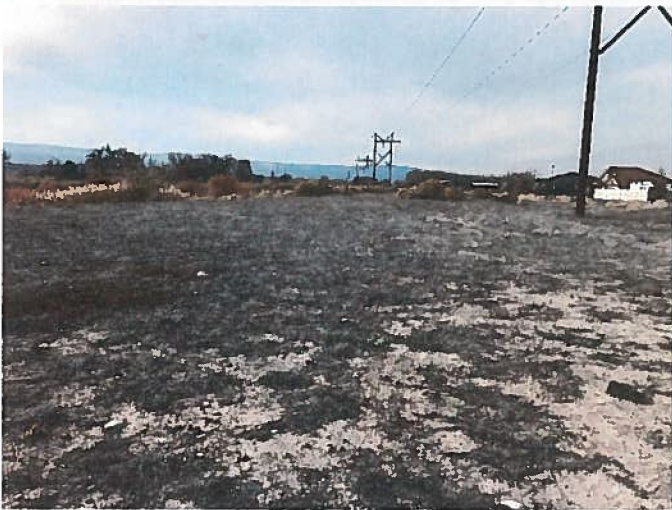
PHOTOGRAPHS

This is a 17.7 acre 112c operation. Mining is complete and the Operator has completed reclaiming the site with some revegetation success in except for the area located near the entrance of the pit- northern portion of the permit area. This area only has Rabbit Brush sparsely established. The perimeter side slopes of the pit have been graded to a 3:1 horizontal to vertical ratio. All pond slopes are successfully reclaimed. The post mining land use is Recreation. The south portion of the permit area consists of several ponds reclaimed for wildlife habitat. The ponds are adjacent to the Colorado Riverfront Trail.

Virginia Acres has been problematic for revegetation establishment in an area less than 3 acres. United Companies has submitted several Technical Revisions to the Division changing seed mixes in 2010 and 2014.

At this point the Division suggests submitting another Technical Revision to include soil testing. There could be an imbalance in nutrients to secure revegetation efforts, such as high salinity or nitrogen. This is noted as a problem at the beginning of this inspection report. Please submit a Technical Revision to the Division by February 15, 2018 to include soil test results and an approach to rectify the growth medium with additional soil amendments.
