**COLORADO**Division of Reclamation,  
Mining and Safety

**MINERALS PROGRAM INSPECTION REPORT****PHONE: (303) 866-3567**

<b>MINE NAME:</b> North River Gravel Pit Extension	<b>MINE/PROSPECTING ID#:</b> M-1999-007	<b>MINERAL:</b> Gravel	<b>COUNTY:</b> Rio Blanco
<b>INSPECTION TYPE:</b> Monitoring	<b>INSPECTOR(S):</b> Travis H. Marshall	<b>INSP. DATE:</b> April 17, 2018	<b>INSP. TIME:</b> 10:15
<b>OPERATOR:</b> George T. Weldon Construction, LLC	<b>OPERATOR REPRESENTATIVE:</b> Mike T. Weldon	<b>TYPE OF OPERATION:</b> 110c - Construction Limited Impact

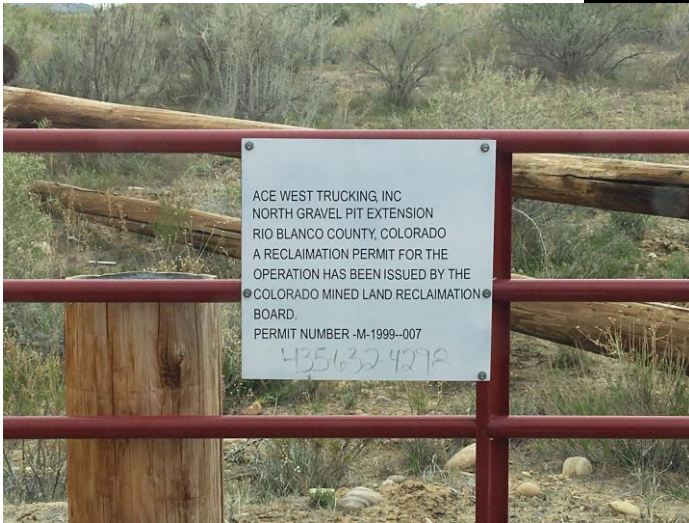
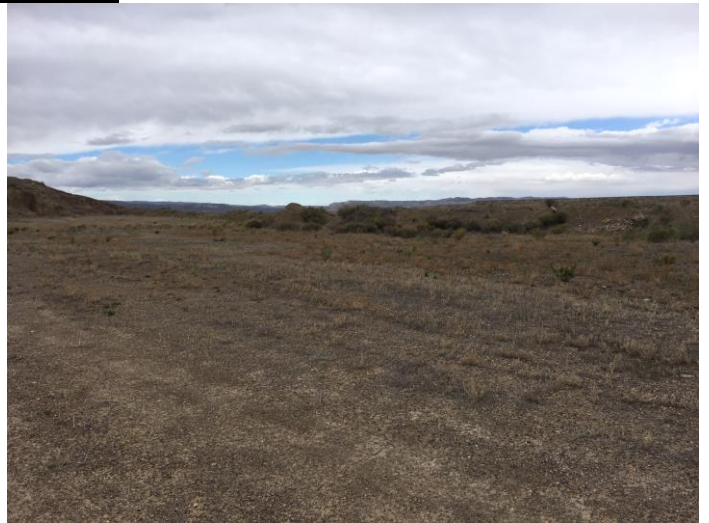
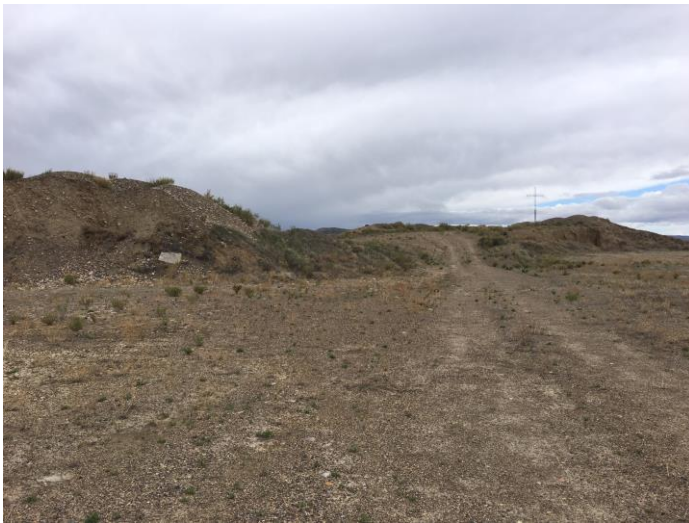
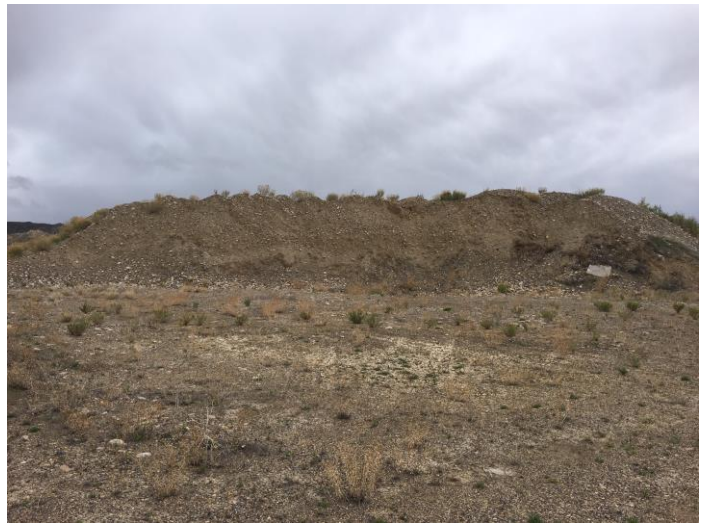
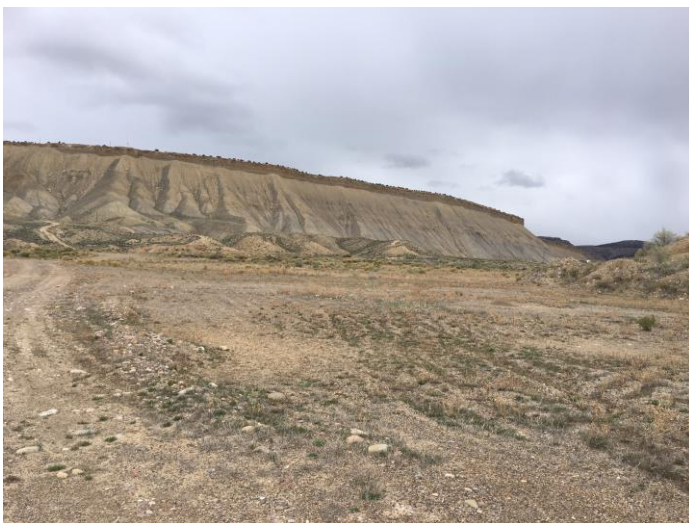
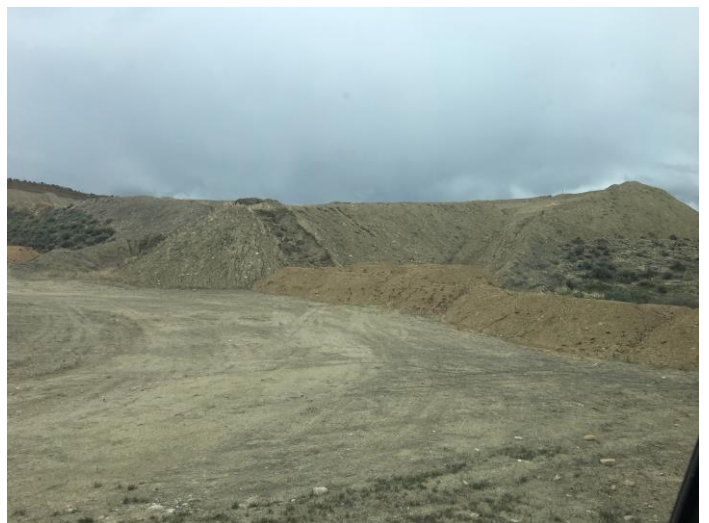
**PHOTOGRAPHS**

The pit was inactive during the inspection and no equipment was observed within the permit area.

Various stockpiles of construction material were observed in the eastern portion of the gravel pit.

The mine consists of only 9.9 permitted acres and the disturbance observed exceeds the 9.9 acres allowed for mining activities. It is not possible to define what disturbance outside of the permit area was recent or pre-law. In order to update the permit the operator must submit a 110c to 112c conversion to expand the permit area to include previously disturbed resources outside of the permit area. The operator may wish to include non-disturbed resources on the property as well. The purpose of the required conversion from a 110c to a 112c is to account for all the surface disturbance on the site and to update the mining and reclamation plans. The current mining and reclamation plans are outdated and the maps originally submitted to the Division are not accurate. **The conversion must be submitted no later than June 22, 2018.**

**INSPECTION TOPIC:** Gen. Compliance With Mine Plan**PROBLEM/POSSIBLE VIOLATION:** Problem: The current mine plan needs to be updated and clarified pursuant to C.R.S. 34-32.5-112 (1)(c)(VI). The operator must provide sufficient information to describe or identify how the operator intends to conduct the operation.**CORRECTIVE ACTIONS:** The operator shall submit a conversion from a 110c to a 112c, with the required \$2,696.00 revision fee, to update and clarify the current approved mine plan to reflect existing and proposed activities by the corrective action date of June 22, 2018.**CORRECTIVE ACTION DUE DATE:** 6/22/18
