**MINERALS PROGRAM INSPECTION REPORT****PHONE: (303) 866-3567**

<b>MINE NAME:</b> Nichols Gravel Pit	<b>MINE/PROSPECTING ID#:</b> M-1981-013	<b>MINERAL:</b> Sand and gravel	<b>COUNTY:</b> Mesa
<b>INSPECTION TYPE:</b> Monitoring	<b>INSPECTOR(S):</b> Amy C. Yeldell	<b>INSP. DATE:</b> May 3, 2018	<b>INSP. TIME:</b> 11:00
<b>OPERATOR:</b> Nichols Gravel Pit, L.L.P.	<b>OPERATOR REPRESENTATIVE:</b> None	<b>TYPE OF OPERATION:</b> 112c - Construction Regular Operation

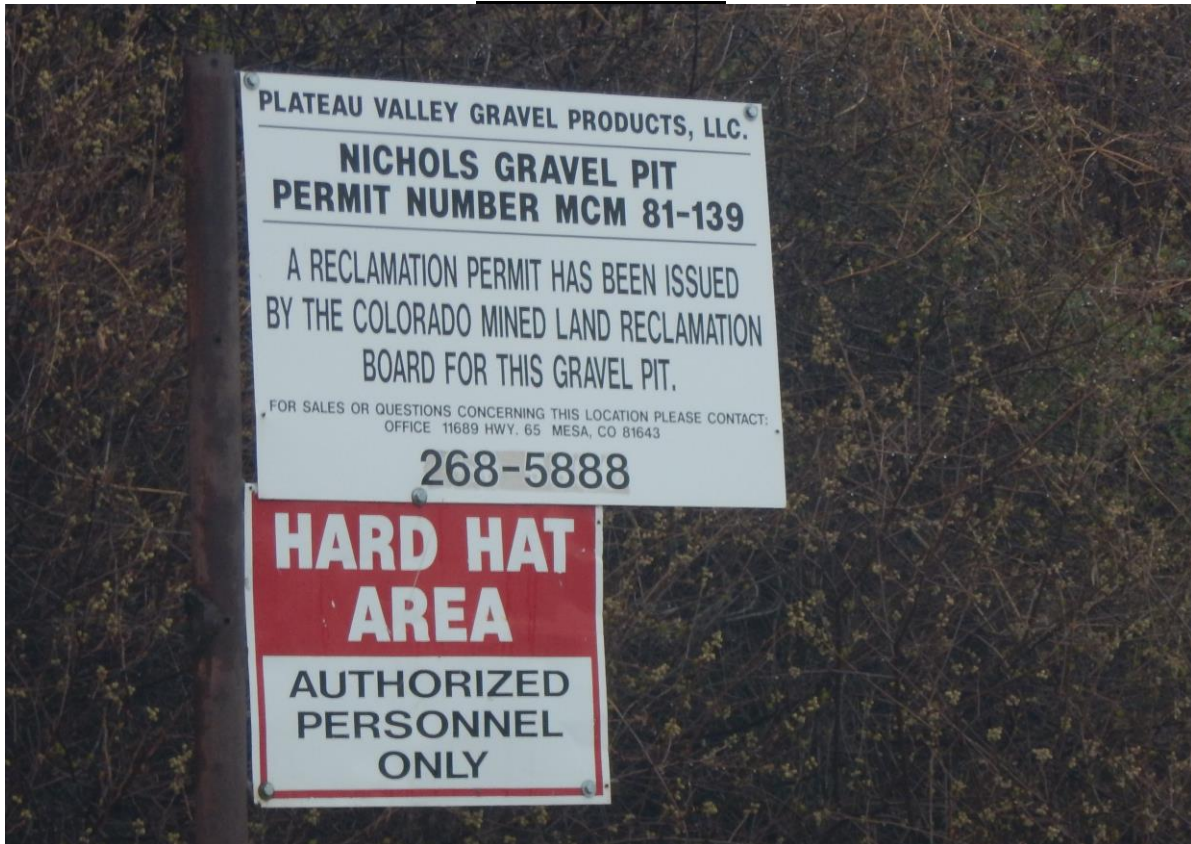
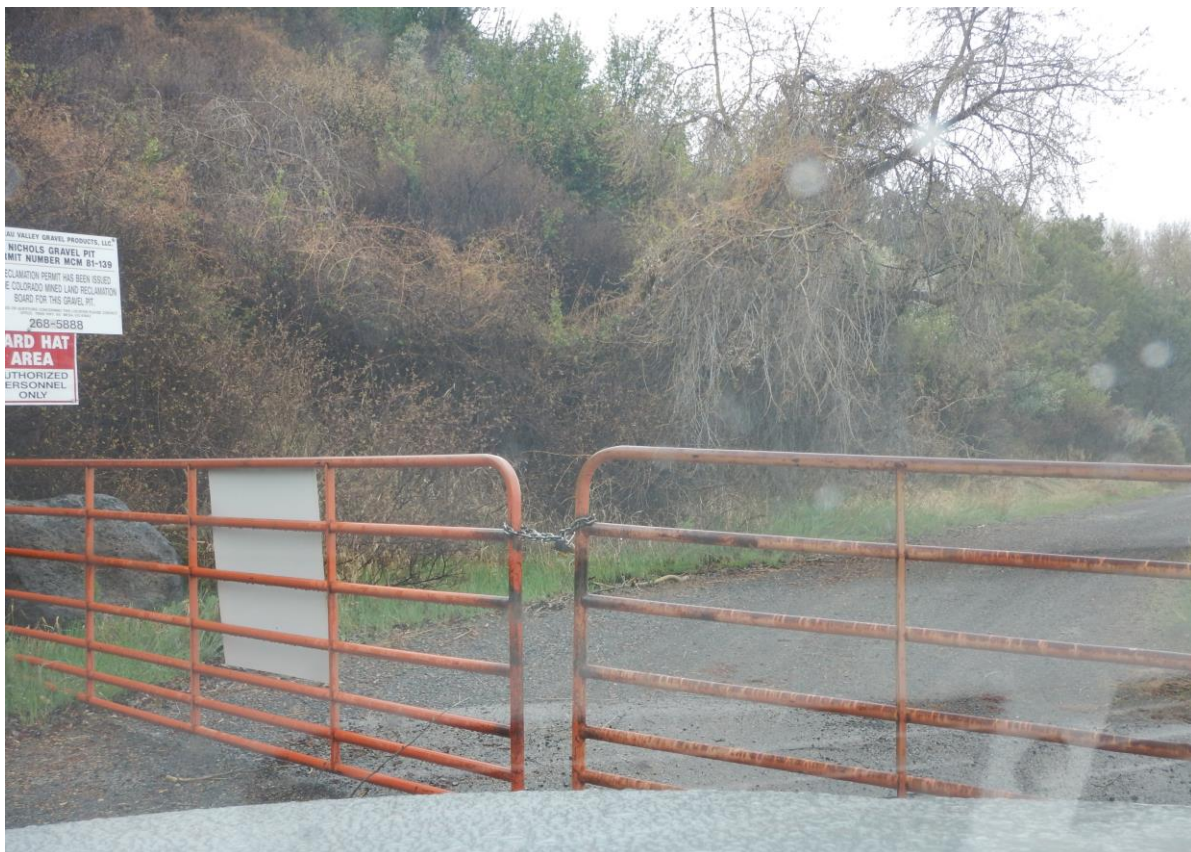
## PHOTOGRAPHS

**PROBLEM/POSSIBLE VIOLATION:** Problem: The mine identification sign posted at the entrance of the mine site displayed incorrect information. This is a problem for failure to post a mine identification sign as required by Section 3.1.12(1) of the rule

The mine sign is noted as a problem. The incorrect permit number is posted on the sign. The permit number is M-1981-013. The number posted is MCM 181-139 which is a withdrawn application in Morgan County. Also the sign lists Plateau Valley Gravel Products, LLC as the operator. The Division has Nichols Gravel Pit, L.L.P. as the operator. If this is no longer the case then a Succession of Operator needs to be filed to transfer the permit. Otherwise the mine sign needs to be corrected to list the correct permittee. The actual operator if sub-contracting may post an additional sign with their information if they wish to do so.

**CORRECTIVE ACTIONS:** The operator shall, at the entrance of the mine site, post a sign which shall be clearly visible from the access road with the following: the name of the operator, a statement that a reclamation permit for the operation has been issued by the Colorado Mined Land Reclamation Board; and the permit number. The operator shall submit photo documentation that a corrected sign has been posted by the corrective action date.

**CORRECTIVE ACTION DUE DATE:** 7/13/18
